# Main Pier Sheet Pile Condition Survey at Daingean FHC, Co. Kerry

## Condition Survey Report

| <b>Document No.</b> | IBM0558/EM/R | | | | | |

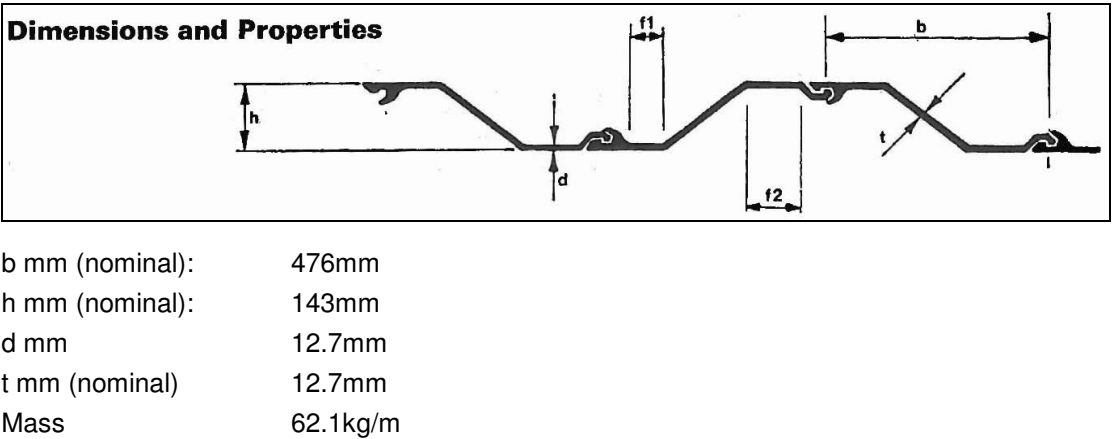
**Figure 1:** Main Pier Sheet Pile Wall – Pile size diagram

Obtained record drawings and report indicate that the original solid masonry pier structure was extended in 1927 and widened in 1975. The works in 1975 included the installation of Frodingham 1BXN steel sheet piles installed on the Eastern side of the pier.

A typical view of the installed cross section of the sheet piles is shown in Figure 1 below with a typical photo elevation in Plate 1.

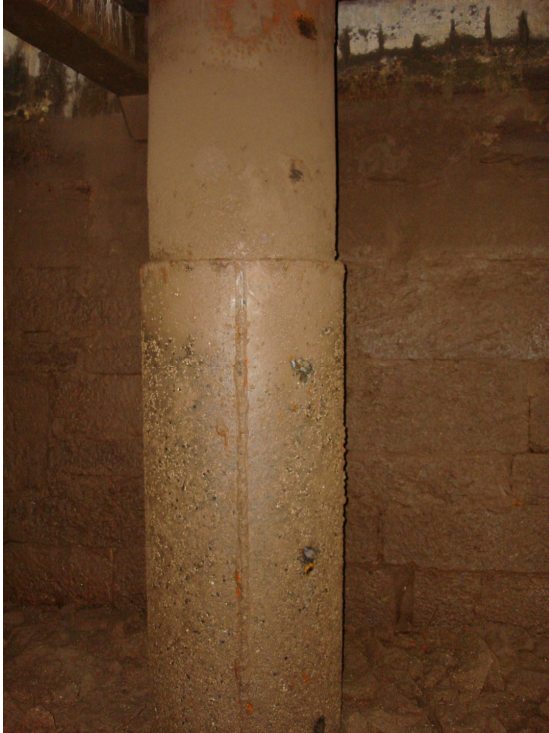
**Plate 2 – Tubular steel bearing pile with collar prepared for testing**

It should also be noted that the presence of steel collars/sleeves of various lengths between existing bed and the soffit of the deck slab was identified on the majority of piles. While further details are not currently available these would appear to be of similar wall thickness to the tubular piles (typical view of this arrangement in plate 2). It is not clear if these are sleeves from installation or collars from post installation repairs/upgrade and thus their function and additional structural contribution cannot be confirmed. Furthermore the extent and installation height does not appear to be consistent across the 35Nr tubular piles.

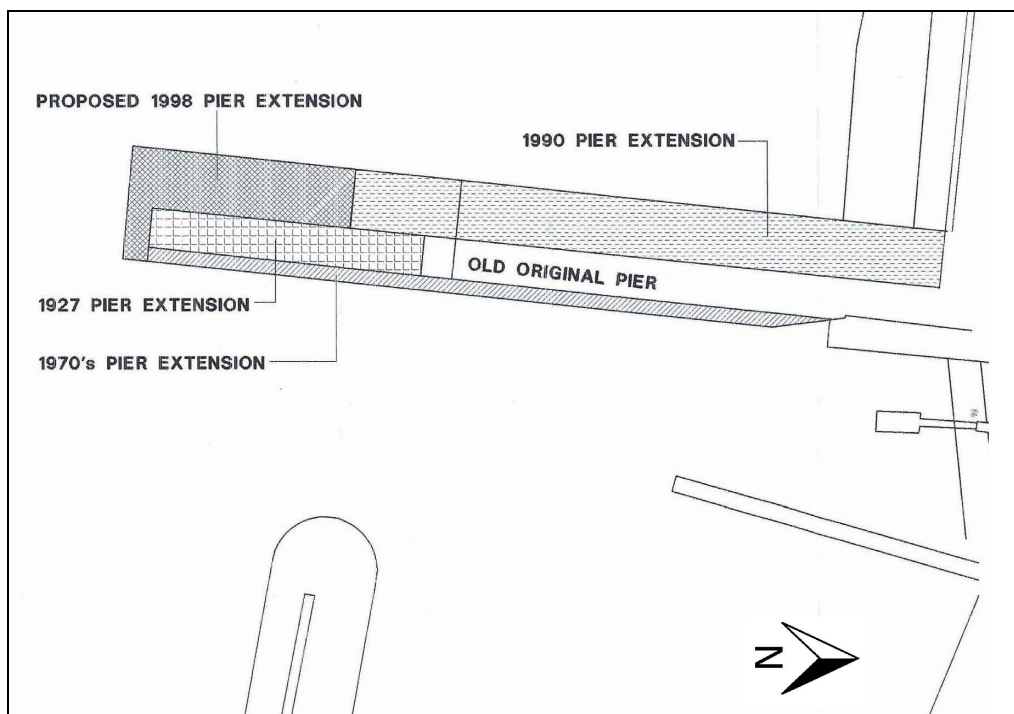
**Figure 2: Structural Development works**

However with the multiple extension and upgrades to the structure to date; it is also relevant to note the current configuration and the structural contribution provided by these elements. This will provide additional clarity and assistance when prioritising any remedial action to elements of major structural or operational significance.

A sketch showing structural developments to the structure is shown in Figure 2 below:

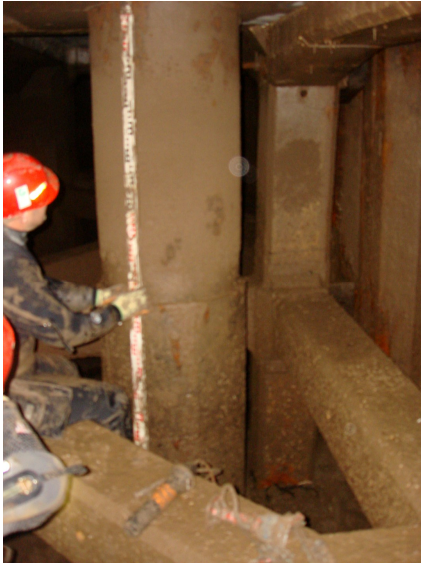
**Plate 3 – Support arrangement below deck including central tubular steel pile**

(Additional vertical support and lateral stability is provided by an arrangement of vertical and horizontal (at multiple heights) concrete members below deck level between the steel tubular piles installed previous to the works of 2000. (Plate 3).
