# Rossmore Monument Monaghan

## Conservation Report: Condition Survey

| CURRENT ISSUE DATE | RECIPIENT | ISSUE |
|---|---|---|
| JANUARY 2026 | MONAGHAN COUNTY COUNCIL | DRAFT 1 |

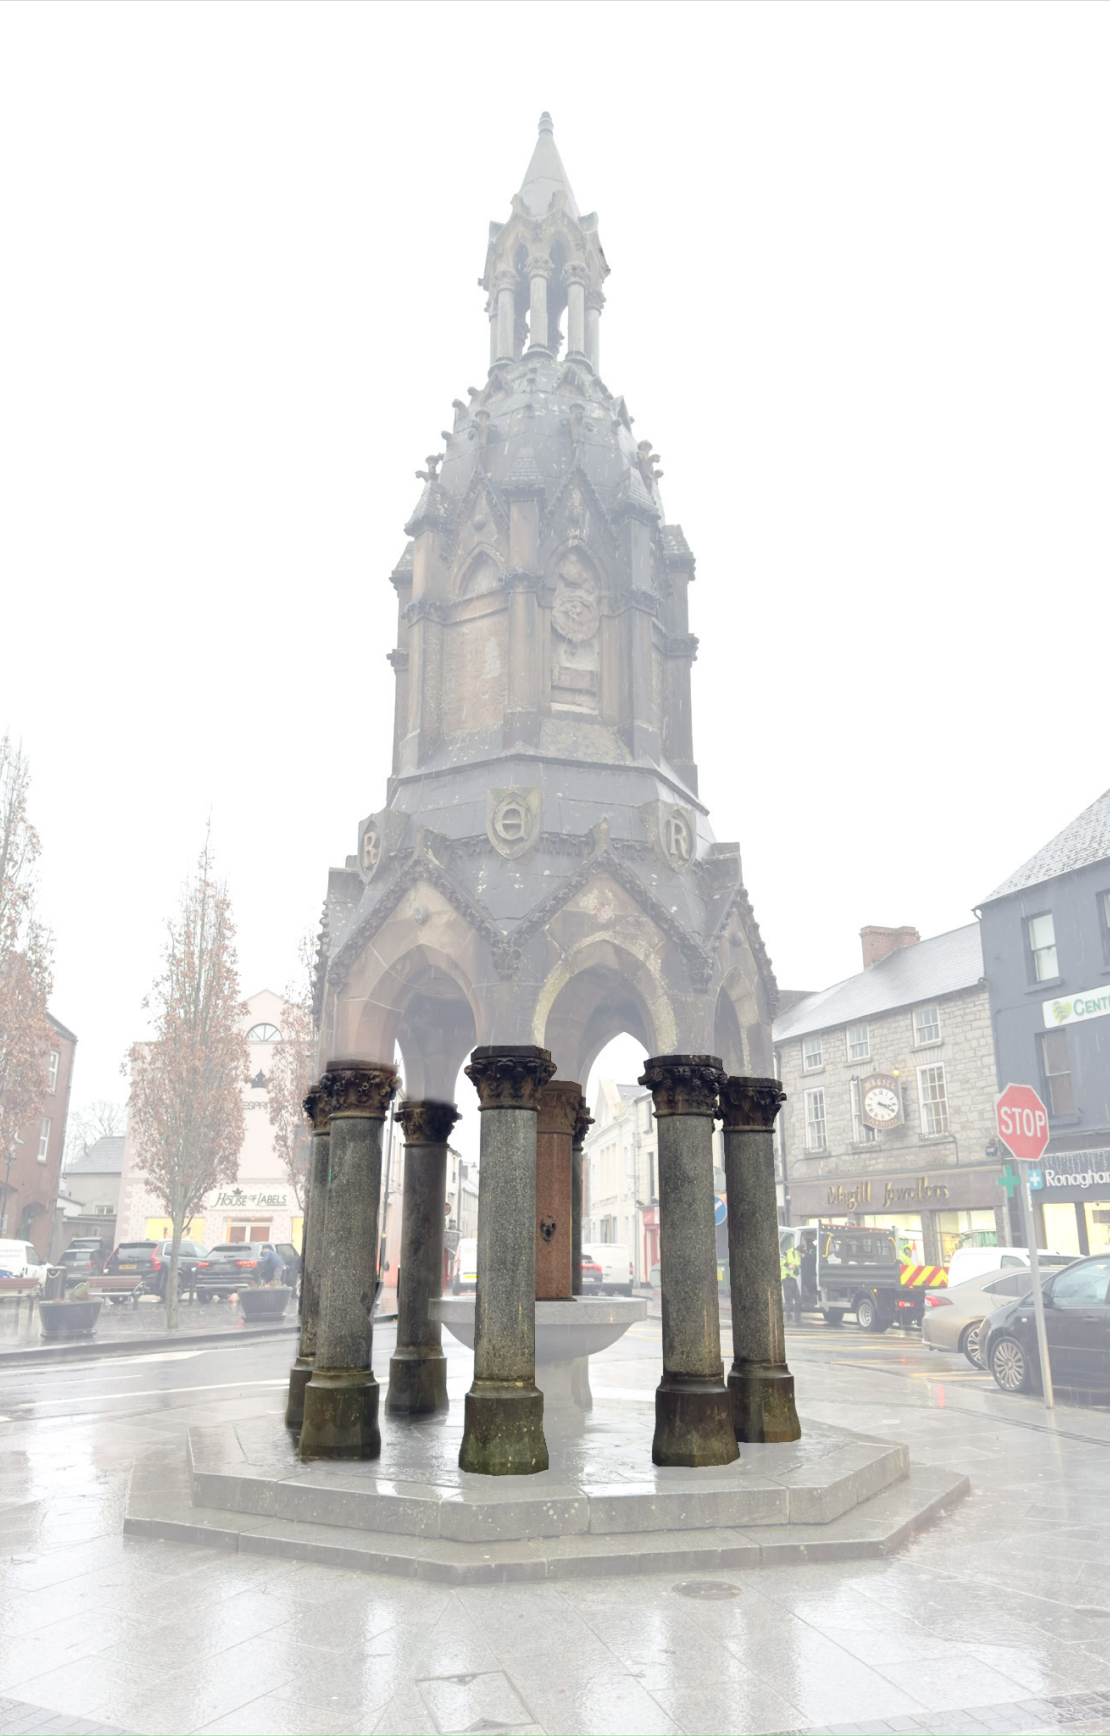
| Element | Description | Condition Notes | Symptom Class |
|---|---|---|---|
| Pillar Capitals | 8xno. decoratively carved sandstone foliate capitals each with their own individual design. | <p>Condition varies across the set. The external faces of the capitals are generally in relatively good condition, retaining a high degree of their carved detail and original profile. In contrast, the internal faces of the capitals, orientated towards the fountain, exhibit significant and in some cases severe deterioration.</p> <p>The internal faces of many capitals display advanced surface loss and hollowing, with several showing near-complete erosion of carved detail and localised loss of the stone fabric itself. This pattern of decay is markedly inconsistent with the condition of the more exposed external faces and is not readily attributable to uniform weathering or gradual erosion alone. The scale and character of the material loss suggests the possibility of past mechanical damage or deliberate interference; however, no definitive evidence is available and the precise cause remains uncertain.</p> <p>The internal faces of the capitals exhibiting the most advanced deterioration also appear to be persistently saturated, indicating prolonged moisture retention. It is considered likely that sustained saturation, coupled with limited drying potential, has significantly increased the vulnerability of the sandstone to decay mechanisms, including accelerated surface breakdown and granular disintegration. The disparity in condition between the sheltered internal faces and the more exposed external faces suggests that restricted drying conditions may be a contributory factor, although this cannot be stated conclusively.</p> <p>Of the eight capitals, six exhibit significant loss of carved detail to their internal faces. One capital in particular shows extensive and likely irreversible loss of profile and ornament, such that the legibility of the original foliate carving has been substantially compromised. Remaining areas of intact carving on the affected capitals are now at heightened risk of further erosion if current moisture conditions persist.</p> <p>Further deterioration is evident in the form of carbon staining, together with minor vegetation growth and lichen colonisation, primarily confined to the internal faces of the lower capitals. These deposits are indicative of prolonged damp conditions and limited environmental drying. The presence of biological growth further contributes to surface breakdown and obscuration of carved detail in already weakened areas of stone.</p> <p>The condition of the lower capitals stands in marked contrast to that of the upper capitals, which remain in excellent condition, retaining crisp detailing, sharp profiles, and minimal evidence of moisture-related decay or biological colonisation. This disparity reinforces the conclusion that the deterioration affecting the lower capitals is not solely attributable to exposure or material quality, but is likely influenced by localised environmental factors, including moisture retention, reduced air movement, and limited drying potential at the lower level of the structure.</p> | <div></div> <div>Images</div> <div></div> <div></div> |

- Prior to any intervention, undertake detailed photographic and drawn recording of each capital, noting that each exhibits a unique carved foliate design. Recording should capture surviving profiles, depth of carving, tool marks, and areas of loss, to ensure that the individuality and evidential value of each capital is fully documented.

- Undertake carefully controlled, low-impact cleaning to remove carbon staining, biological growth, and surface soiling from the capitals, with particular care to fragile and hollowed areas. Cleaning methods should be limited to soft-bristle brushing and low-pressure water misting; abrasive techniques and aggressive chemical treatments should be avoided.

- Investigate and, where feasible, address environmental factors contributing to persistent saturation, including limited air movement and restricted drying at the internal faces of the capitals. Interventions should prioritise improving drying potential rather than excluding moisture, avoiding impermeable coatings or water repellents which may exacerbate decay.

- Re-carving or replication of lost foliate detail is not recommended, given the degree of loss, the uniqueness of each capital's carved design, and the risk of conjectural restoration. Intervention should focus on stabilisation and retention of surviving historic fabric rather than reinstatement of lost ornament.

- Where active decay threatens remaining carved detail, minimal, discreet plastic repairs may be considered solely to protect vulnerable edges or undercut areas, carefully profiled to support existing forms without attempting to recreate missing foliage.

- Implement a regular inspection and maintenance regime, with particular attention to moisture retention, surface biological growth, and progression of erosion at the internal faces of the capitals. Monitoring should inform future intervention and ensure that further loss of surviving detail is identified at an early stage.

The carved sandstone foliate capitals are considered to be of medium–high urgency, with early intervention required to stabilise remaining carved detail, address persistent moisture retention, and prevent further irreversible loss of historic fabric.

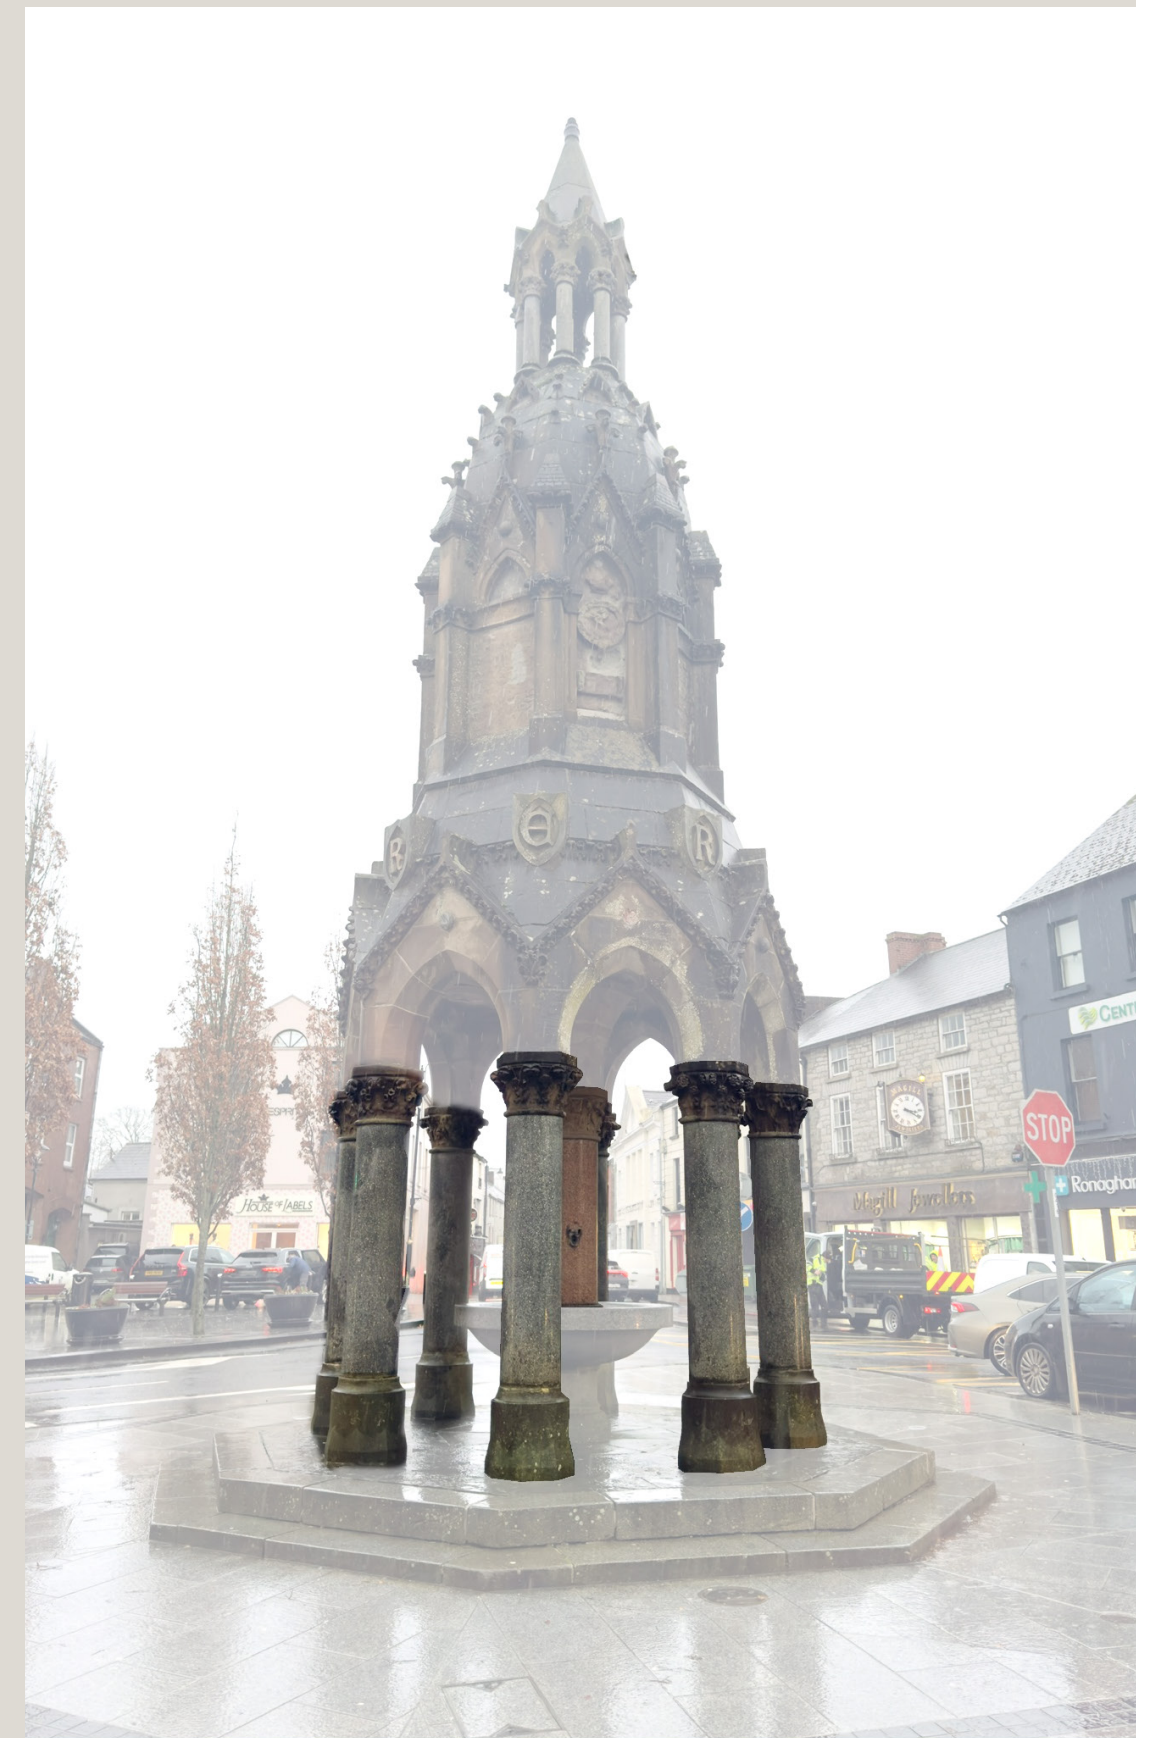
| Central Fountain | <p>The fountain is formed around a central vertical assembly comprising three principal architectural components:</p> <ol style="list-style-type: none"><li>1. a limestone basin,</li><li>2. a pink granite column,</li><li>3. a decoratively carved sandstone foliate capital.</li></ol> | <p>The pink granite column is in excellent condition overall, retaining its surface finish with no evidence of cracking or structural distress. One decorative spout is missing, likely as a result of vandalism or localised removal. Its absence has resulted in localised damage to the column fabric at the point of removal; however, this damage is limited in extent and does not compromise the structural integrity of the column.</p> | |

- Retain the central pink granite column in its present state, as it is in excellent condition and does not require structural intervention. Any works should be limited to protection and monitoring only.

- Address the missing decorative spout by first recording the area of loss in detail. Consider discreet make-good to the point of removal using a compatible mineral repair mortar, limited strictly to stabilising the damaged area and visually recessing the exposed outlet. Full reinstatement of a replacement spout should not be undertaken unless supported by reliable documentary or physical evidence of the original detail and approved as part of a wider conservation strategy.

- Undertake gentle cleaning of the limestone basin and annular trough to reduce surface staining, using low-impact, non-abrasive methods appropriate to limestone. Cleaning should aim to reduce visual prominence of staining rather than achieve uniform appearance,

- recognising that some staining forms part of the historic use patina. The pink-toned staining within the trough should not be aggressively removed, given the uncertainty of its origin and its superficial nature. Trial cleaning should be undertaken to assess the extent to which staining can be moderated without loss of surface integrity.

- Given that the fountain function is redundant, ensure that all redundant pipework is securely capped, drained, or otherwise made safe internally to prevent accidental water ingress or future leakage, without disturbing historic fabric.

The central fountain assembly is considered to be of low urgency, with any remedial works confined to planned maintenance and minor fabric stabilisation rather than immediate intervention.

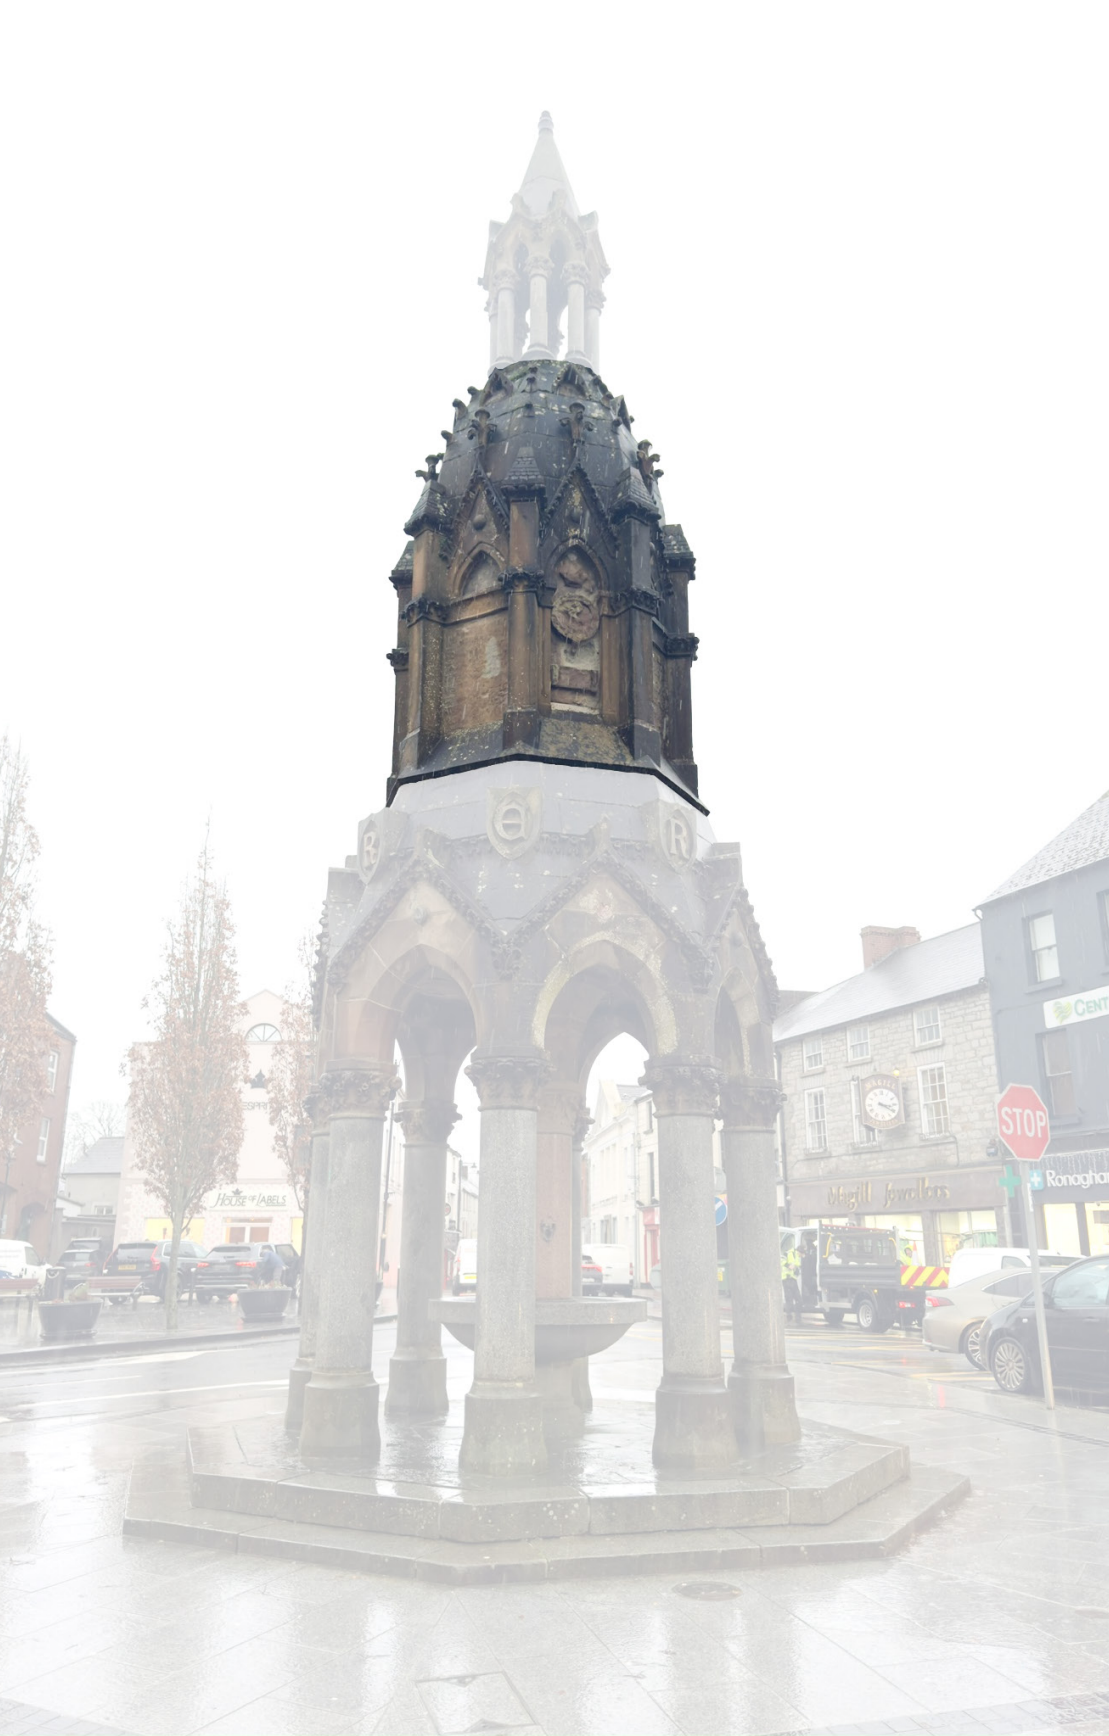
| Element | Description | Condition Notes | Symptom Class |
|---|---|---|---|
| Pinnacle | The monument is crowned by a sandstone pinnacle, rising from a small open arcade formed by a ring of slender granite columns arranged radially beneath it. These columns support a series of pointed arches, creating a visually permeable transition between the octagonal body below and the terminal element above. | The pinnacle and upper colonnade are generally in very good condition, with no evidence of structural instability or significant material degradation. Moderate surface staining is evident to some elements, consistent with long-term exposure at this elevated level. | <div></div> |

| Element | Description | Condition Notes | Symptom Class |
|---|---|---|---|
| REMEDIAL MEASURES | | <ul style="list-style-type: none"><li>Retain the sandstone pinnacle and granite upper colonnade in their current state, as the elements are generally sound and do not require structural intervention.</li><li>Undertake light, non-abrasive cleaning to reduce moderate surface staining where visually intrusive, using methods appropriate to sandstone and granite. Cleaning should be conservative and trialled in inconspicuous locations.</li><li>Inspect the areas of earlier repairs to the granite columns to confirm continued stability and compatibility. No removal or alteration of these repairs is recommended at present, provided they remain sound.</li><li>Monitor the central stainless steel structural tie to ensure it remains secure, free from corrosion-related staining, and does not introduce localised stress or moisture pathways. No alteration is required at this stage.</li><li>Include the pinnacle and upper colonnade within the monument's routine cyclical inspection and maintenance regime, with particular attention to joint integrity, surface weathering, and early signs of movement or cracking.</li></ul> | |
| URGENCY | | <p><b>Low Priority (Routine Maintenance)</b></p> <p>The sandstone pinnacle and granite upper colonnade are considered to be of low urgency, with remedial measures limited to routine maintenance and ongoing monitoring rather than immediate intervention.</p> | |
