# Asbestos Refurbishment Survey

Mervue Training Centre, Wellpark Road,  
Galway

S26-184

Higgins Consultancy Ardrahan Ltd

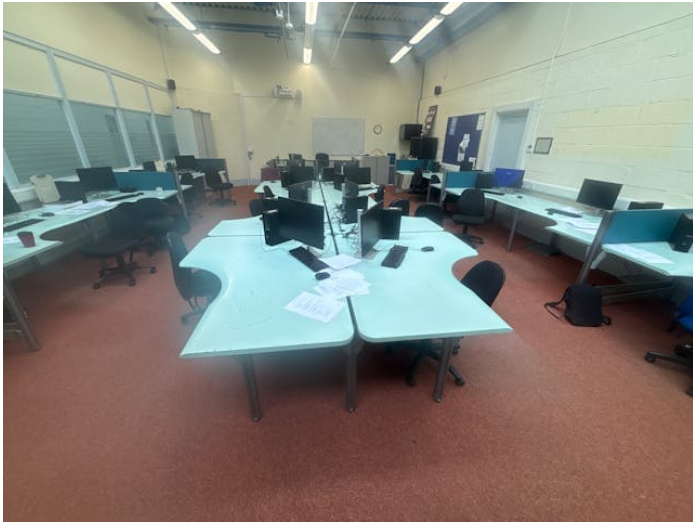
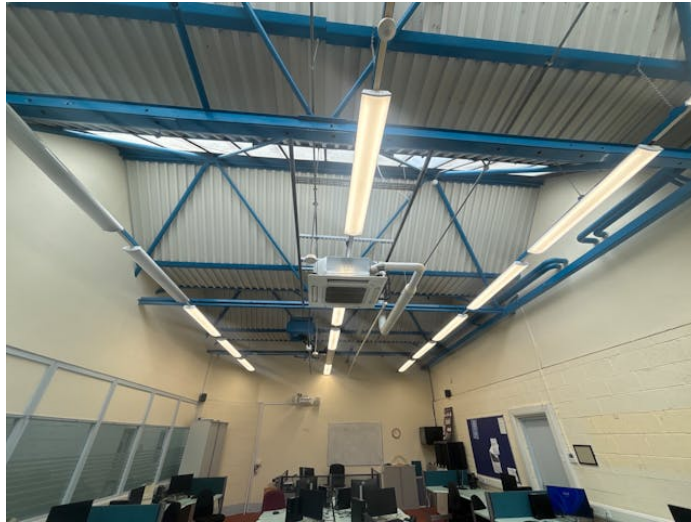
| Location | Computer Classroom (1093) | Item | |

| Location Notes | Carpet flooring over screed compound floor finish. Solid walls throughout. Metal deck roofing visible internally. | | |
| General Comments | No ACM's identified. | | |

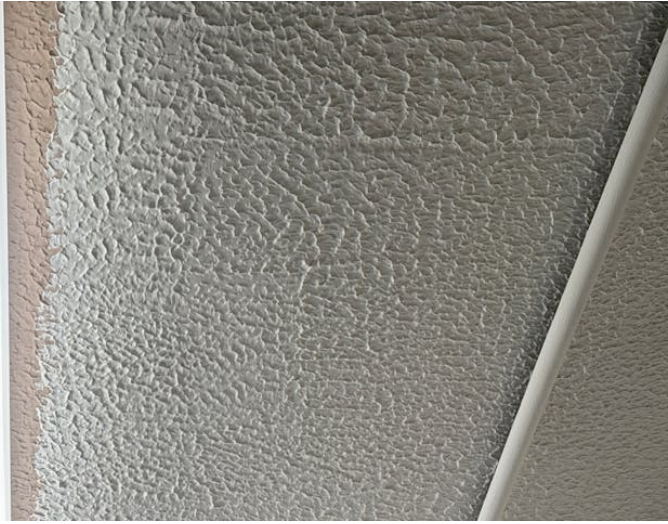
| Location | Finance & Admin (1011) | Item | Texture Coating Decorative Finish |

| Material | Textured Coating | Extent | Approx 120 sq.m |
| Strategy / Sample Id | Sample / S104 | Fibre Type | NADIS |

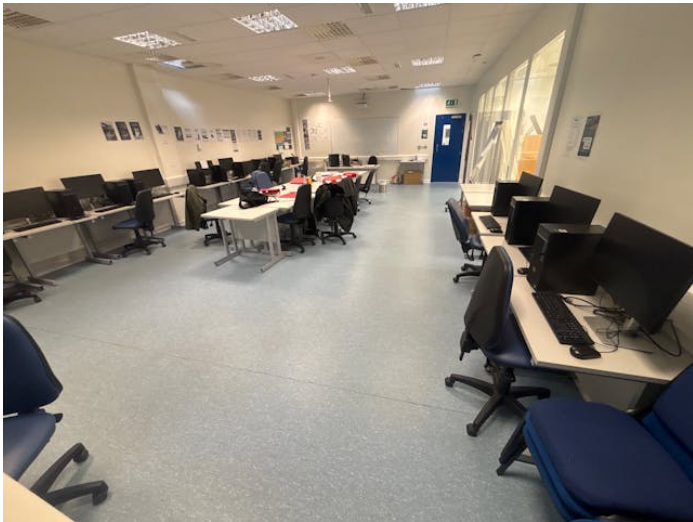
| Location Notes | Vinyl flooring over concrete subfloor finish. Plasterboard lined stud internal walls with non ACM suspended ceilings. | | |
| General Comments | No ACM's identified. | | |

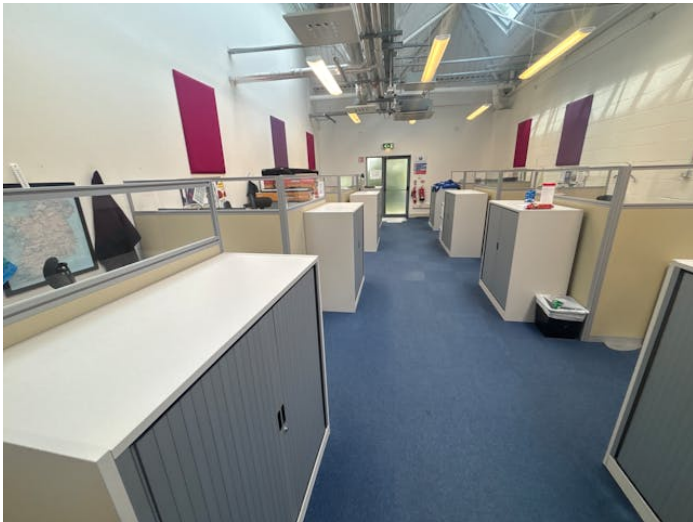
| Location Notes | Carpet flooring over painted concrete subfloors. Plasterboard lined walls with solid external walls. Non ACM suspended ceilings. | | |
| General Comments | No ACM's identified. | | |
