## Building Condition Survey

13 Market Street,  
Galway  
H91 HN72

**Simon Community**

Date: 20 March 2025

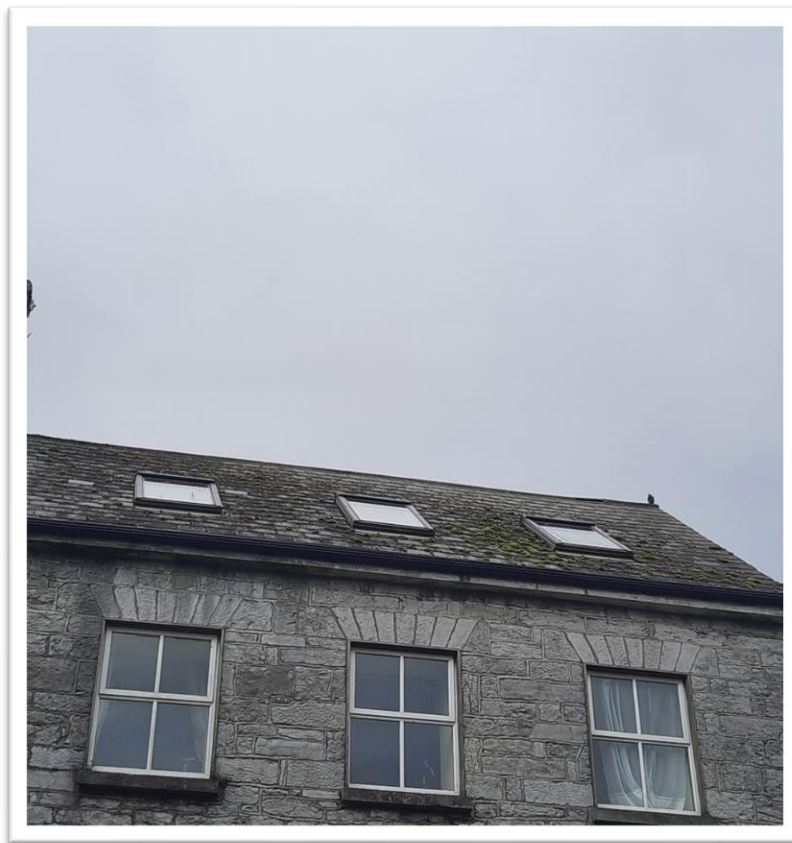
Photo 4 – Front roof slope with velux roof lights

- Recovering of the high-level roof is highly recommended, to secure the long-term lifespan of the building. I.e. new slates, timber battens, breathable underlayment membrane, upgraded thermal insulation, repairs to the chimneys, permanent passive ventilation.

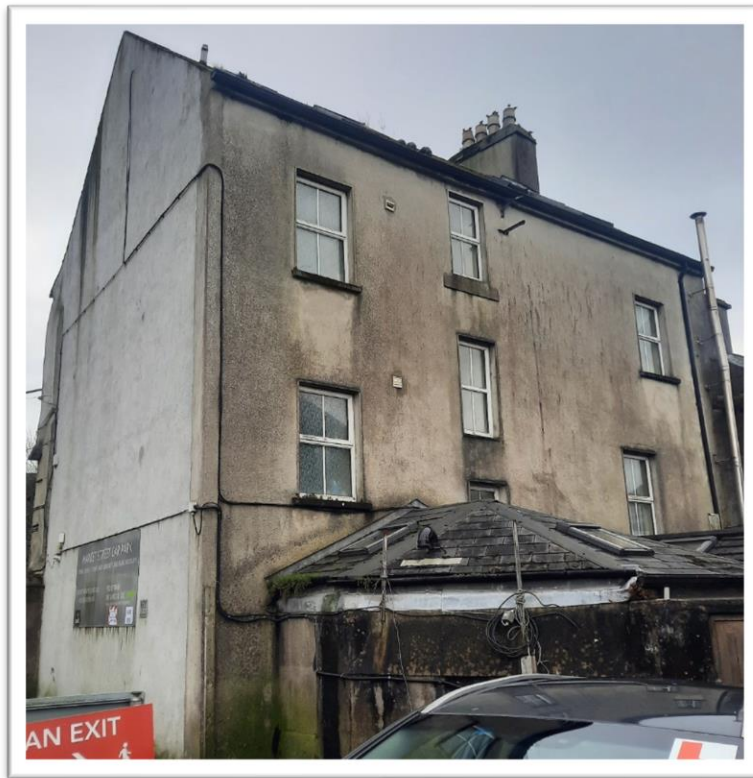
Photo 5 – Rear elevation and gable wall carpark side.

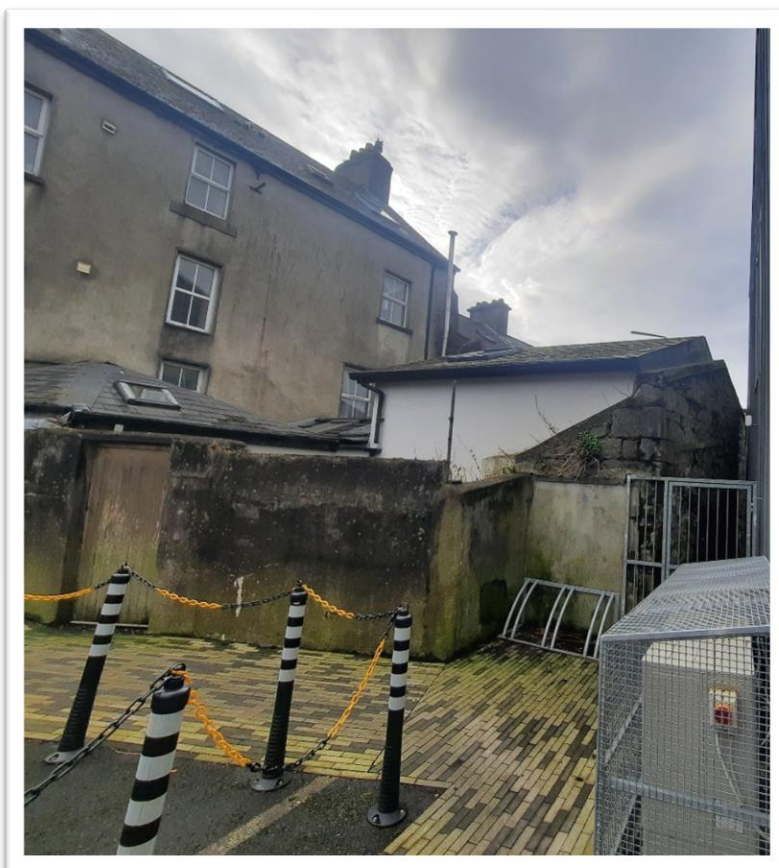
- The ground floor level single storey structures are of reasonable/ fair quality. We understand these sections of the building are marked for demolition and replacement due to proposed plans for redevelopment.

- The rear boundary walls are of fair/ poor condition, these are likely to require alterations in any case to facilitate the construction works.
- The foul sewer system will require realignment and likely relocation of the main manhole at ground level.

Photo 6 – Rear single storey annex buildings and boundary walls

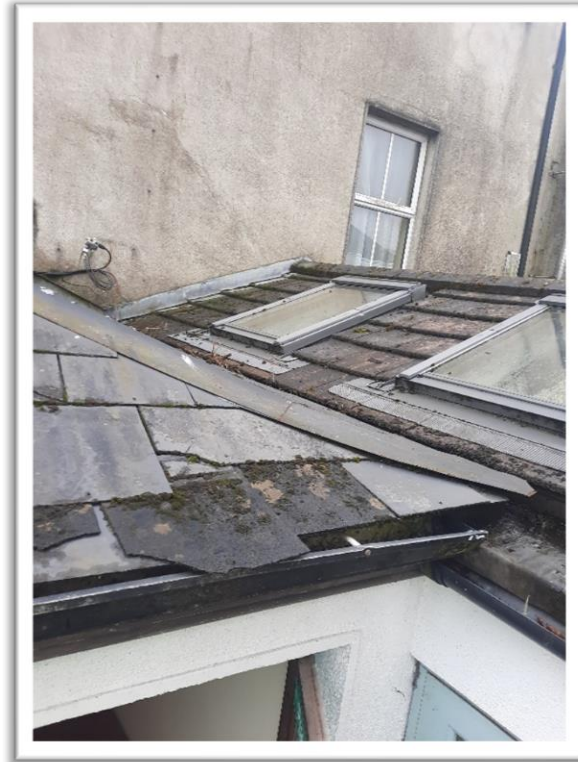
Photo 15 – Roof rear annex ground floor level.

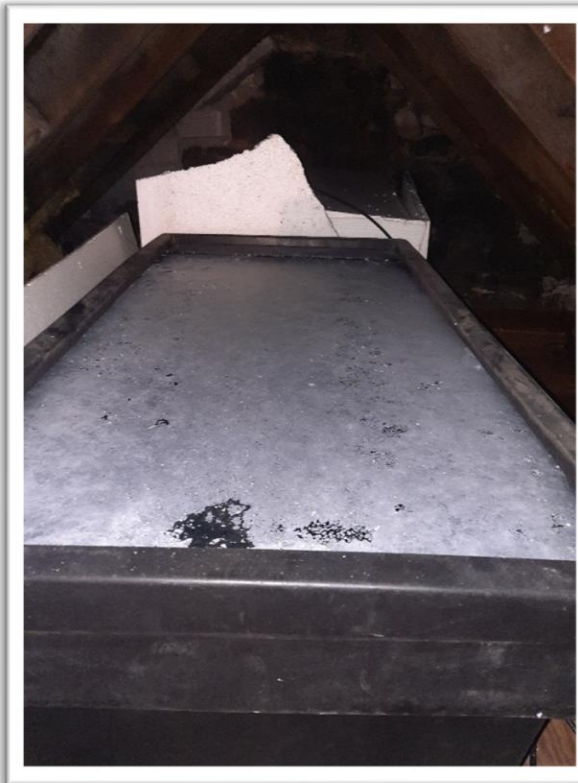
Photo 16 – Cold water storage tank attic

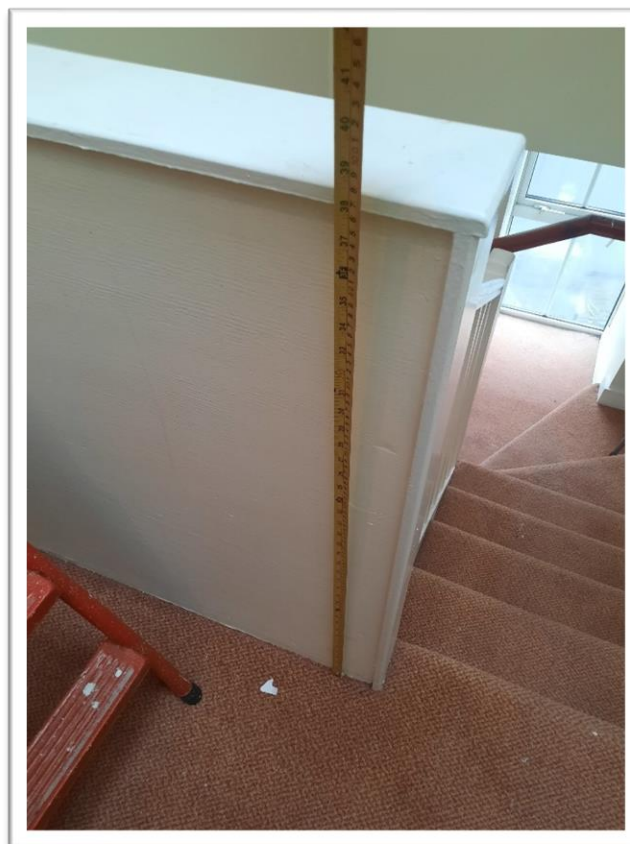
- The existing stairs are of a fair quality which is typical for the type of building. There is high potential for trip hazard with several uneven and tapered steps. Perhaps these could be altered and upgraded as part of renovation works.

Photo 18 – Handrail and stairs 3<sup>rd</sup> floor level

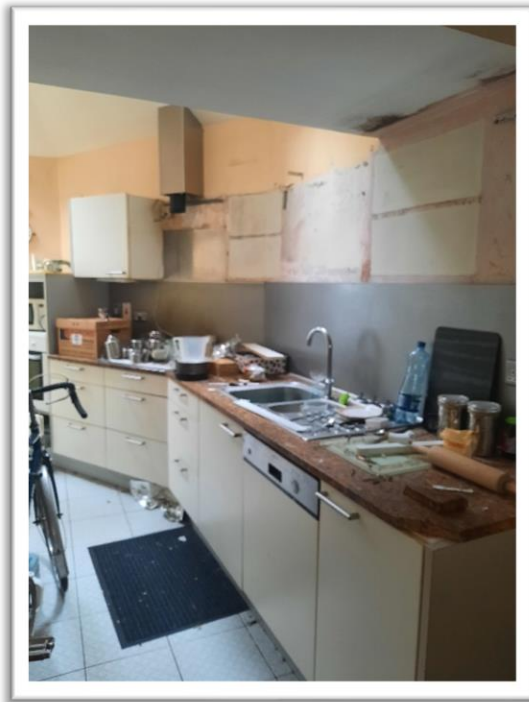
Photo 19 – Kitchen at ground floor

- The electrical and fire alarm infrastructure will require replacement to facilitate sub-division into four new apartments.
- New fit-out of fixtures, fittings and furniture to the kitchens, bathrooms and bedrooms.

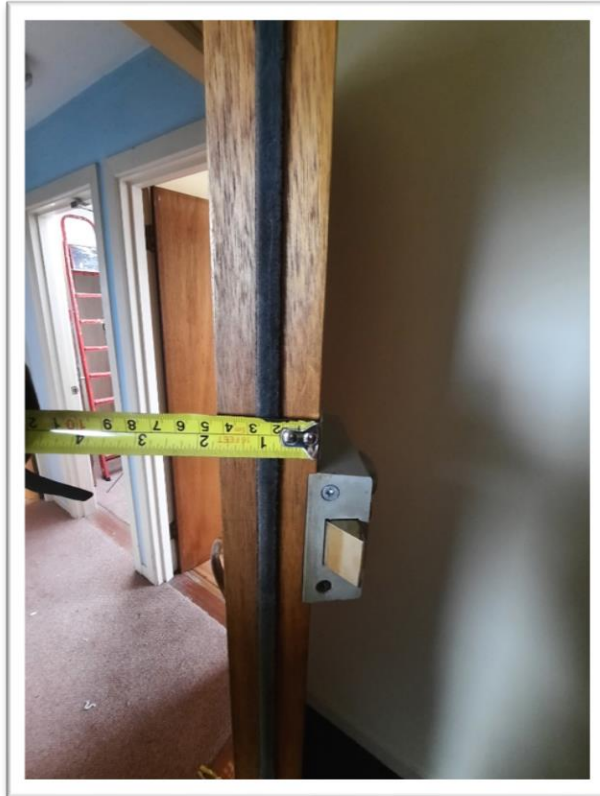
- The existing external doors are in poor condition and require replacement.
- The windows are of fair quality and replacement / upgrading is highly recommended.

Photo 21 – 44mm thick door leaf

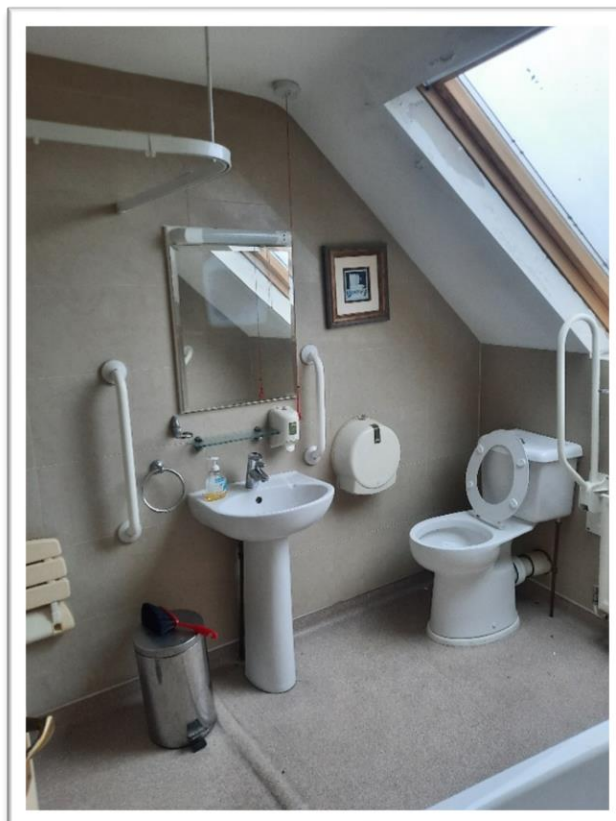
Photo 22 – 3<sup>rd</sup> Floor level bathroom
