# ASBESTOS MANAGEMENT SURVEY REPORT

KGH Main Building

Tralee

| <b>Document Title</b> | Asbestos Management Survey Report |

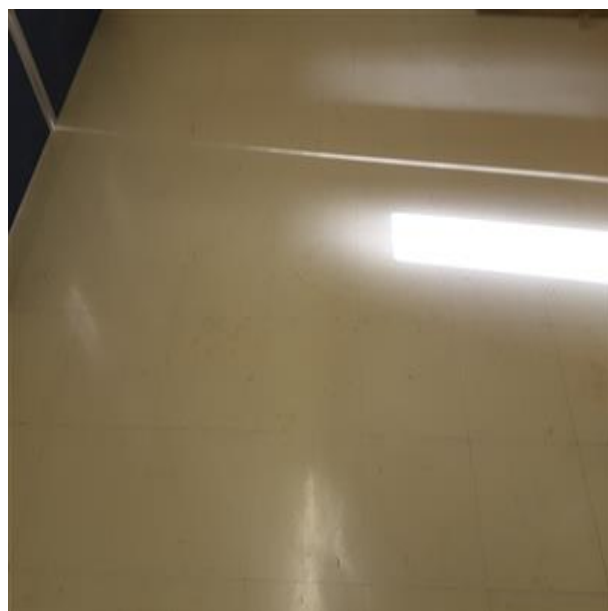
| | Score |
|---|---|
| Surface Treatment : Composite materials containing asbestos | 0 |
| <b>Material Assessment Score :</b> | <b>2</b> |

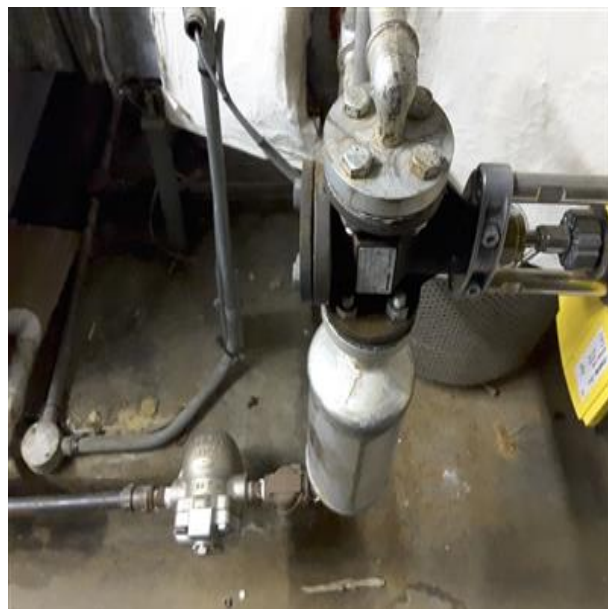
5

Priority 3: Manage in Place & Monitor Periodically.

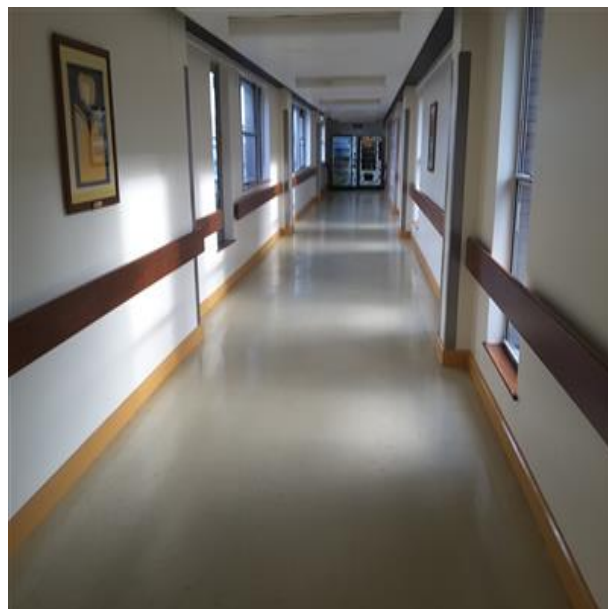
5

Priority 3: Manage in Place & Monitor Periodically.

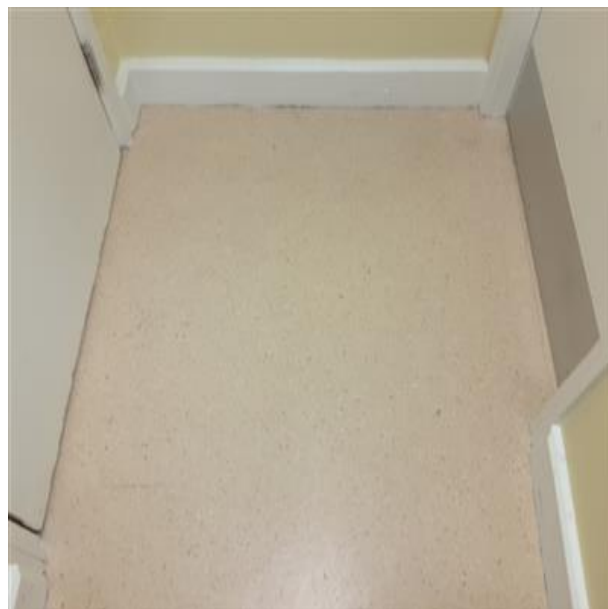
5

Priority 3: Manage in Place & Monitor Periodically.

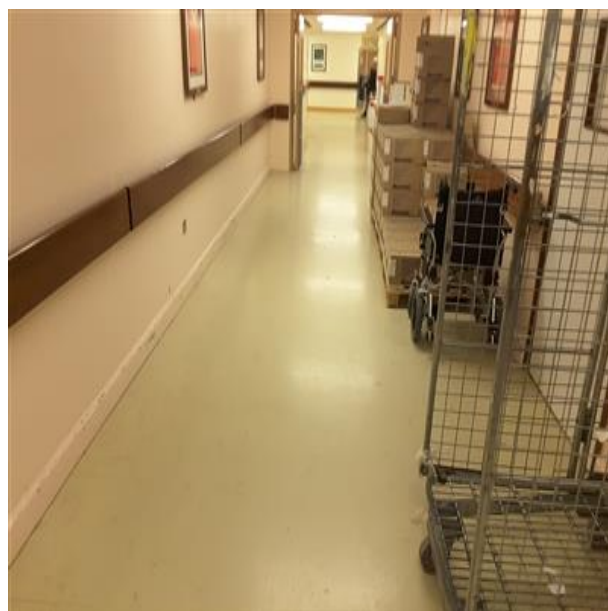
| | Score |
|---|---|
| Condition : Good condition | 0 |
| <b>Material Assessment Score :</b> | <b>2</b> |

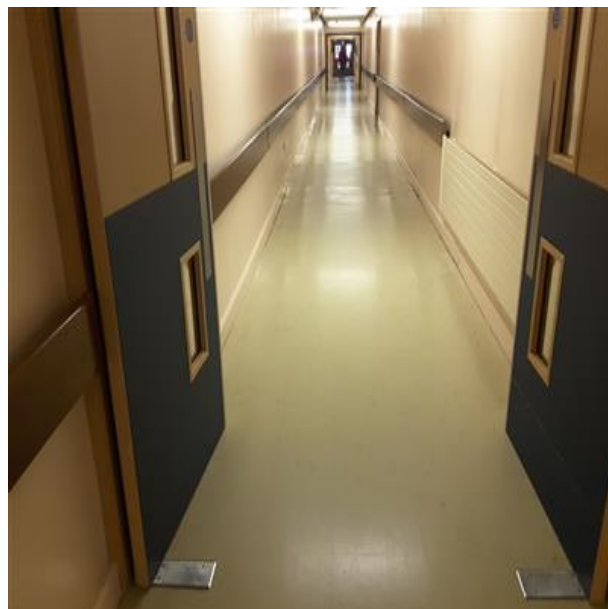
5

Priority 3: Manage in Place & Monitor Periodically.

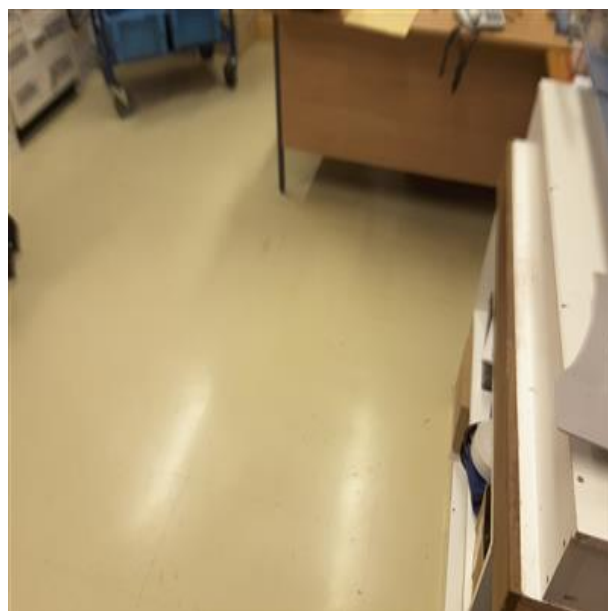
| | Score |
|---|---|
| Condition : Good condition | 0 |
| <b>Material Assessment Score :</b> | <b>2</b> |

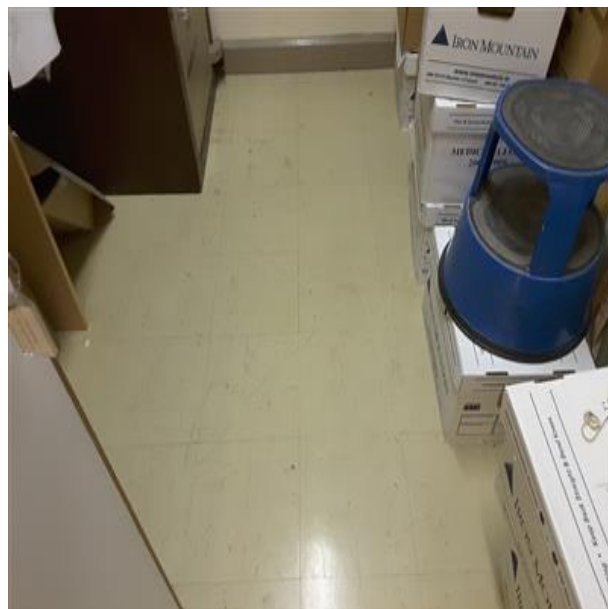
5

Priority 3: Manage in Place & Monitor Periodically.

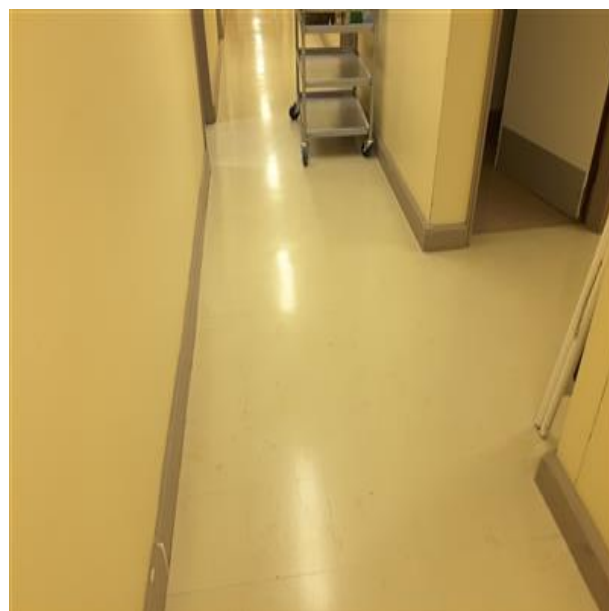
| | Score |
|---|---|
| Condition : Good condition | 0 |
| <b>Material Assessment Score :</b> | <b>2</b> |

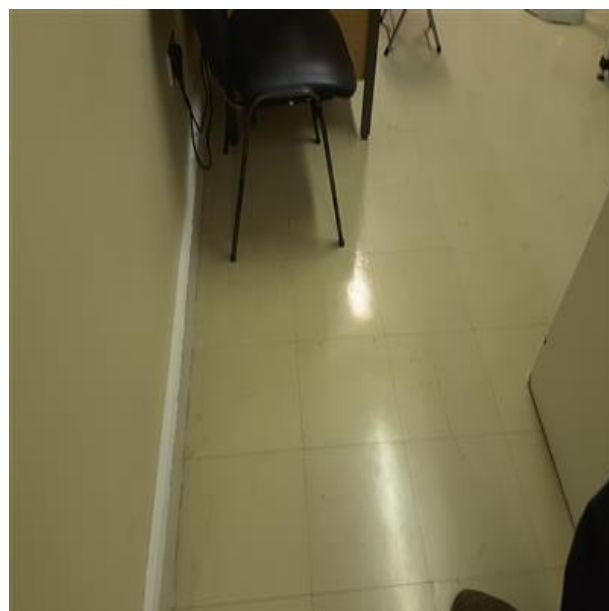
| | Score |
|---|---|
| Condition : Good condition | 0 |
| <b>Material Assessment Score :</b> | <b>2</b> |

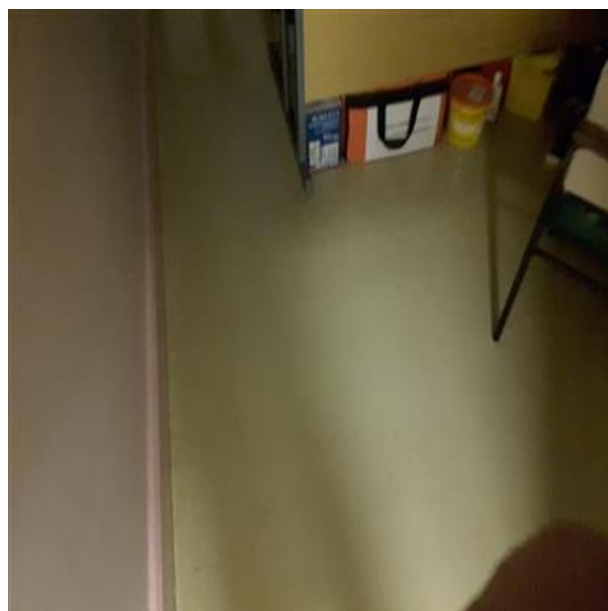
| | Score |
|---|---|
| Condition : Good condition | 0 |
| <b>Material Assessment Score :</b> | <b>2</b> |

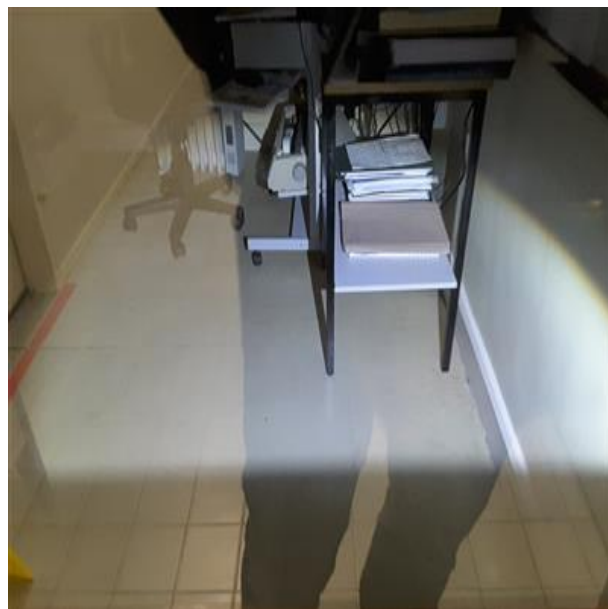
5

Priority 3: Manage in Place & Monitor Periodically.

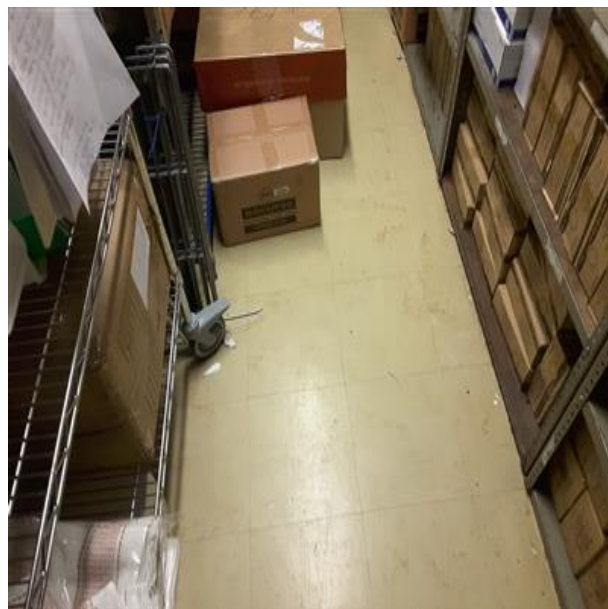
5

Priority 3: Manage in Place & Monitor Periodically.

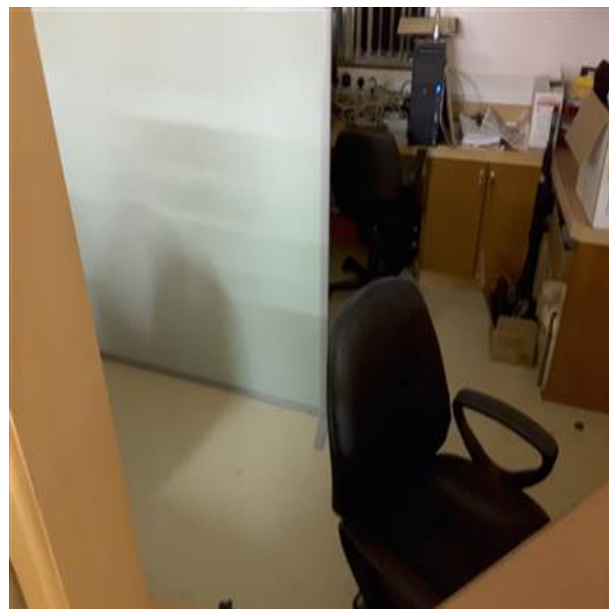
5

Priority 3: Manage in Place & Monitor Periodically.

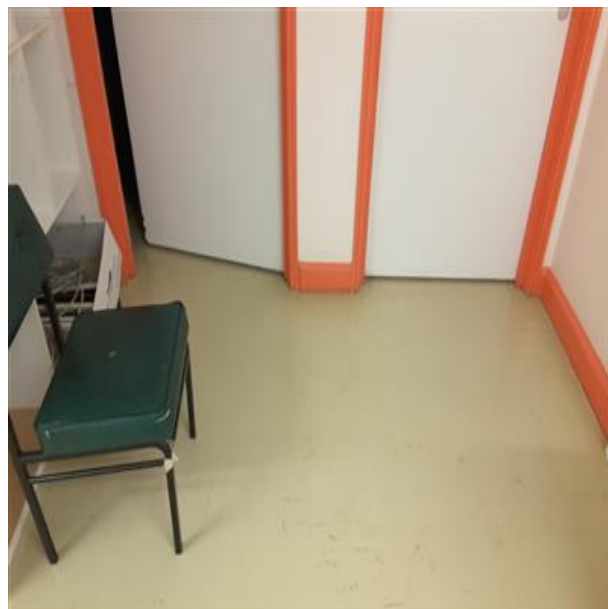
5

Priority 3: Manage in Place & Monitor Periodically.

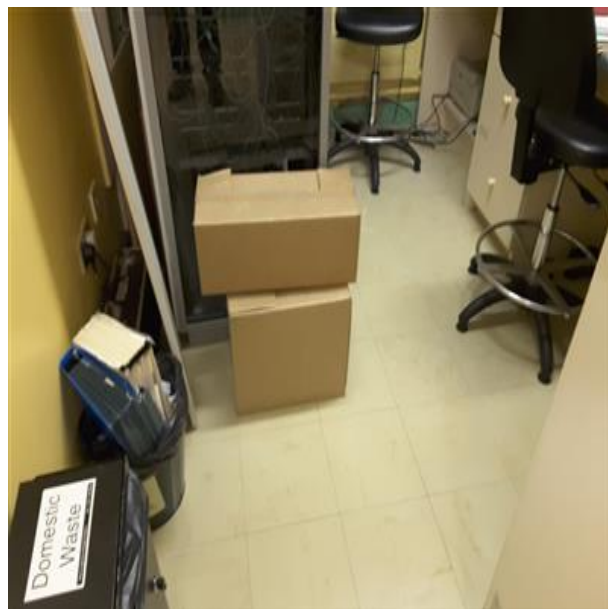
Priority 3: Manage in Place & Monitor Periodically. Solid Ceiling and Walls

Priority 3: Manage in Place & Monitor Periodically.

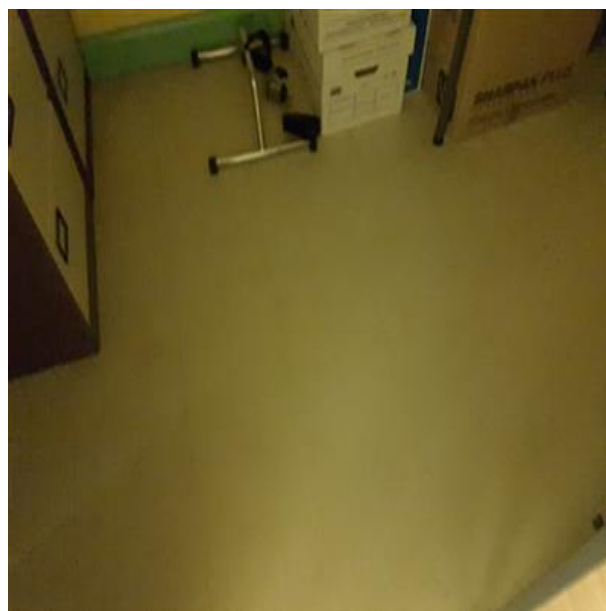
Priority 3: Manage in Place & Monitor Periodically. Solid Walls and MMMF Ceilings

Priority 3: Manage in Place & Monitor Periodically.

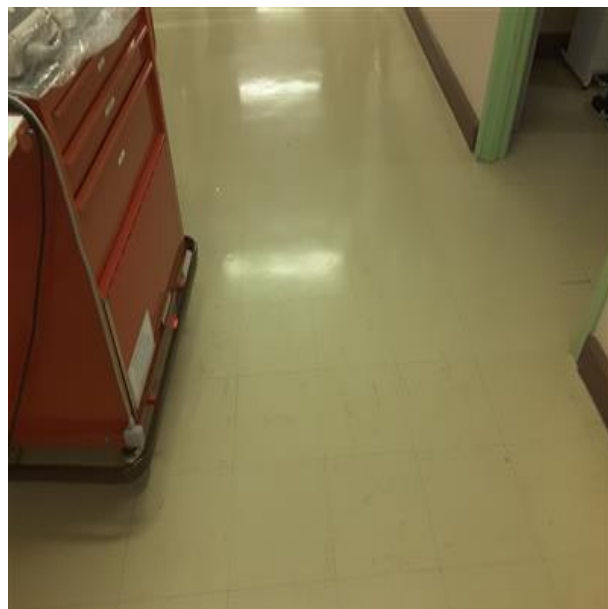
5

Priority 3: Manage in Place & Monitor Periodically.

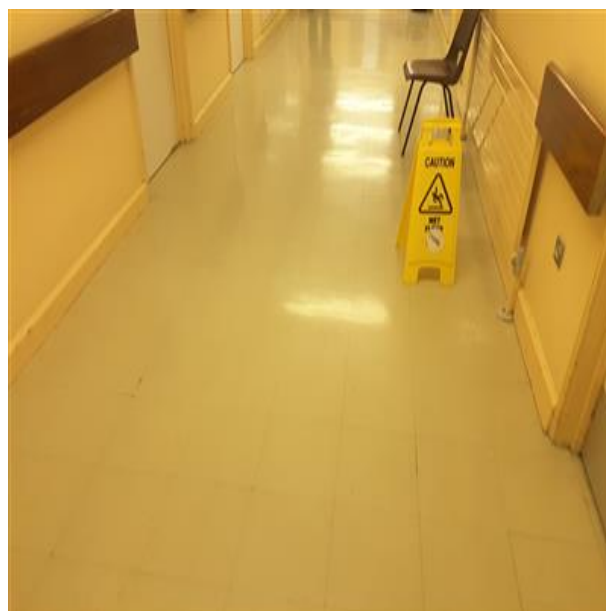
Priority 3: Manage in Place & Monitor Periodically. Solid Walls and MMMF Ceilings

Priority 3: Manage in Place & Monitor Periodically.

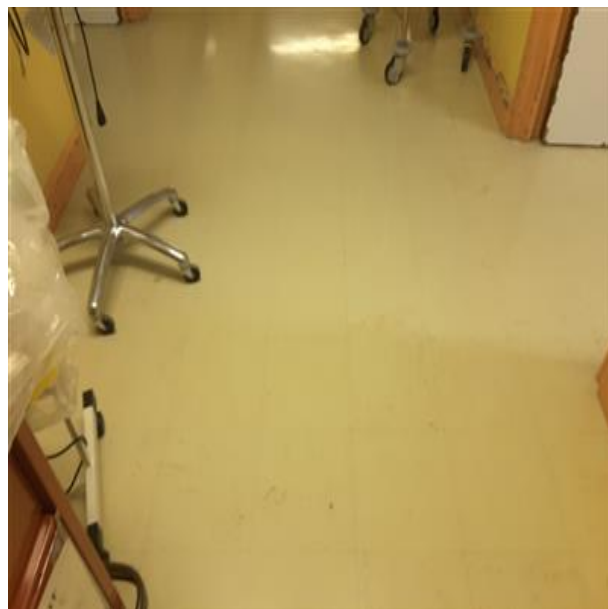
5

Priority 3: Manage in Place & Monitor Periodically.

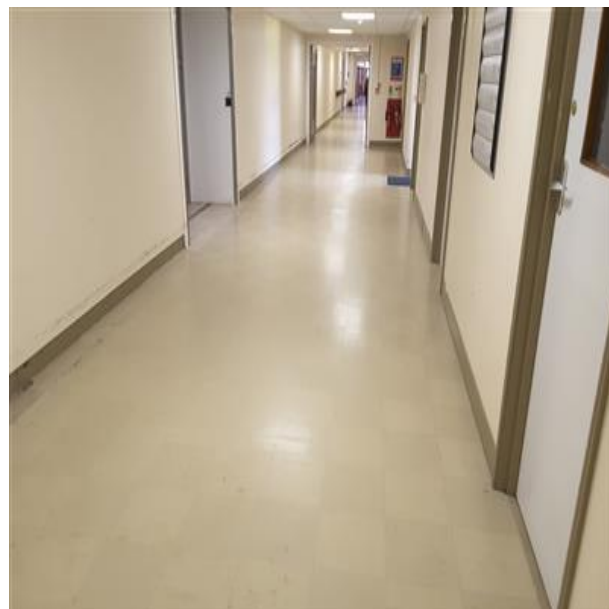
4

Priority 3: Manage in Place & Monitor Periodically.

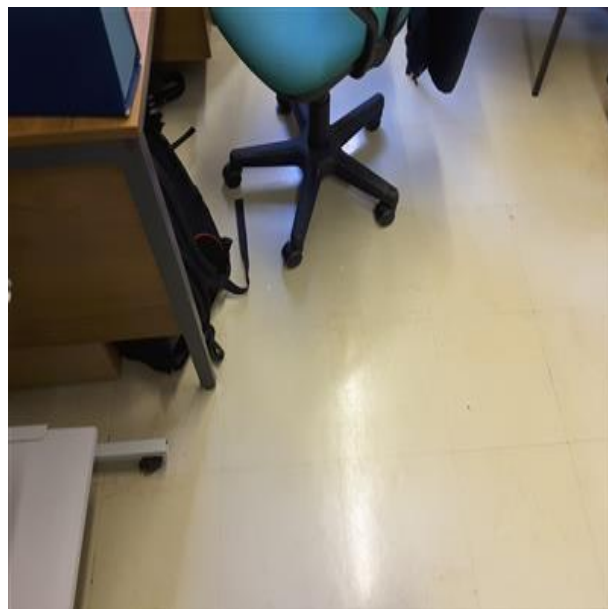
4

Priority 3: Manage in Place & Monitor Periodically.

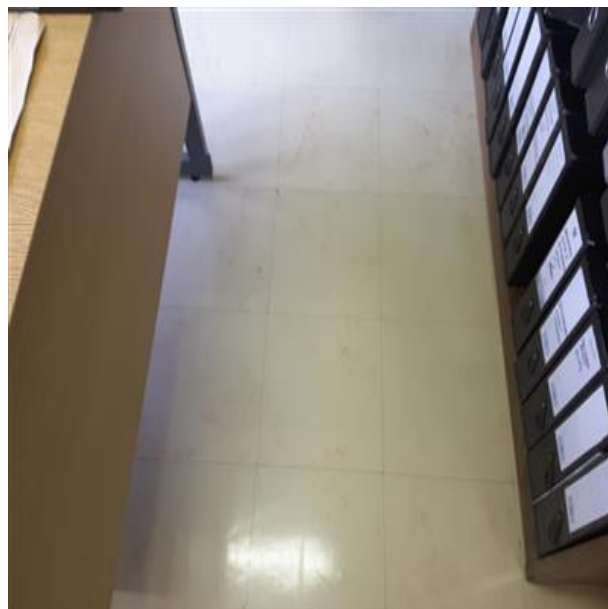
4

Priority 3: Manage in Place & Monitor Periodically.

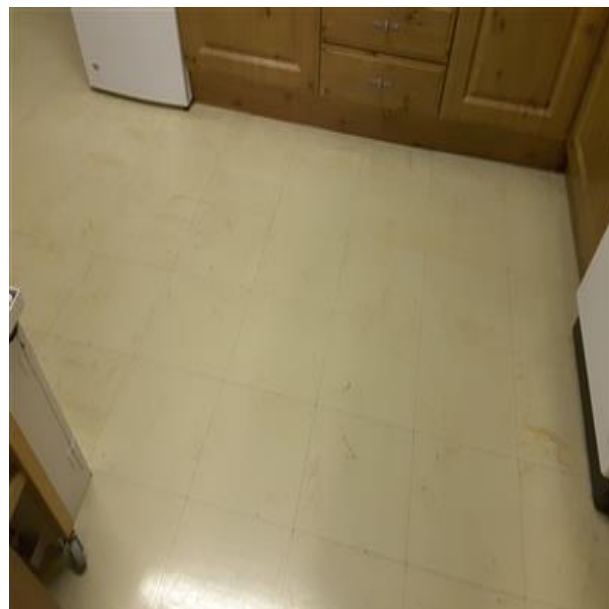
4

Priority 3: Manage in Place & Monitor Periodically.

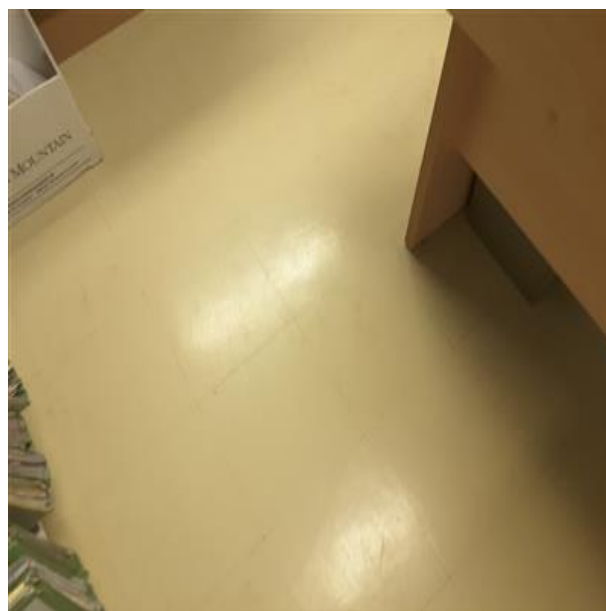
4

Priority 3: Manage in Place & Monitor Periodically.

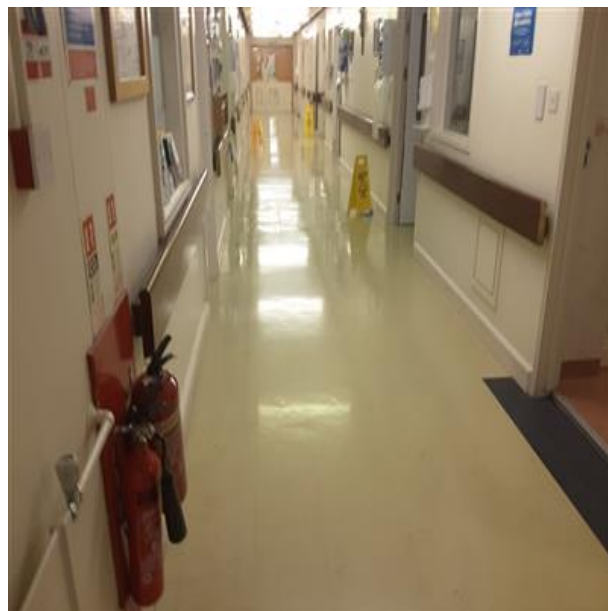
4

Priority 3: Manage in Place & Monitor Periodically.

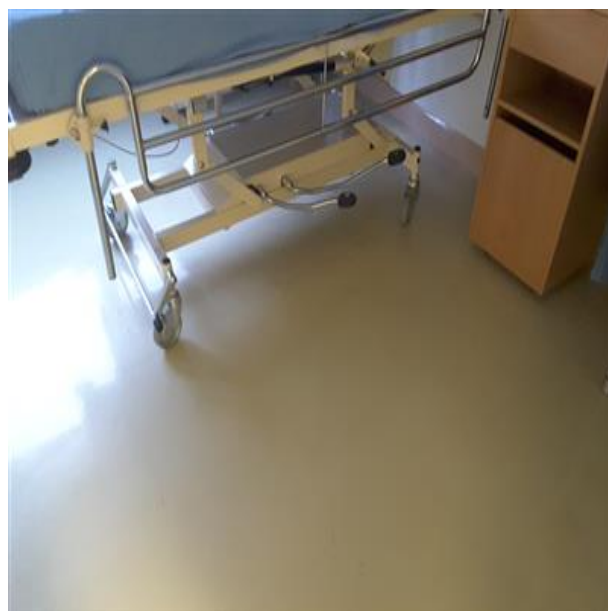
4

Priority 3: Manage in Place & Monitor Periodically.

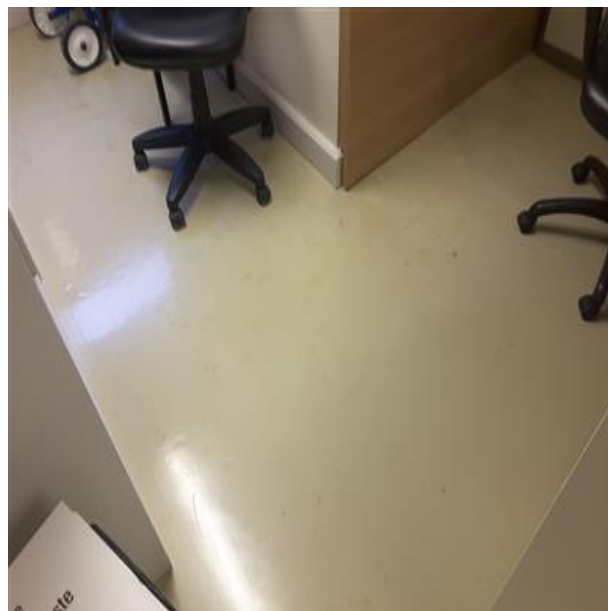
4

Priority 3: Manage in Place & Monitor Periodically.

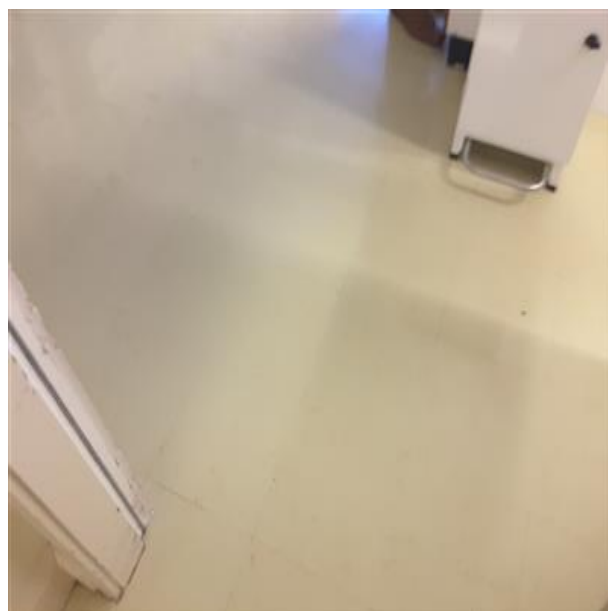
4

Priority 3: Manage in Place & Monitor Periodically.

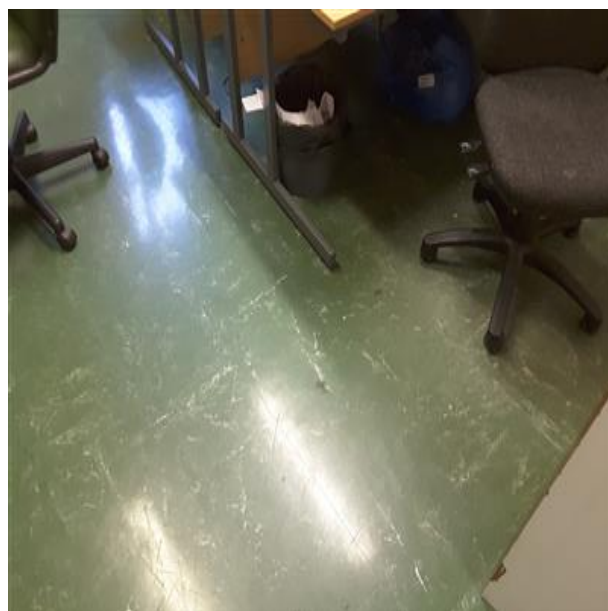
4

Priority 3: Manage in Place & Monitor Periodically.

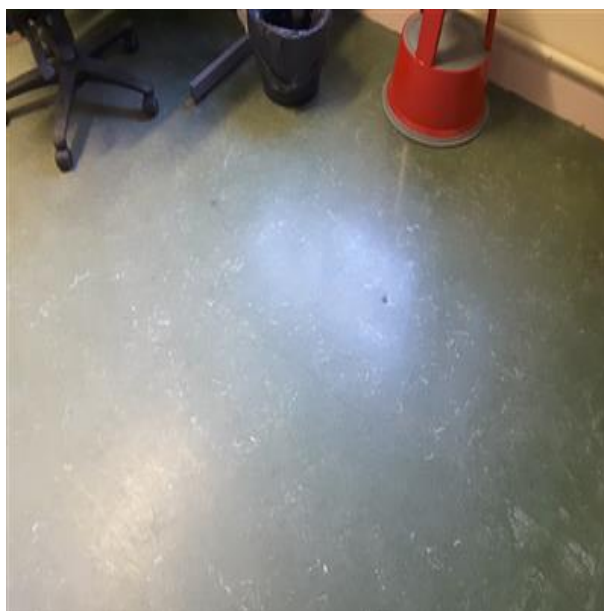
4

Priority 3: Manage in Place & Monitor Periodically.

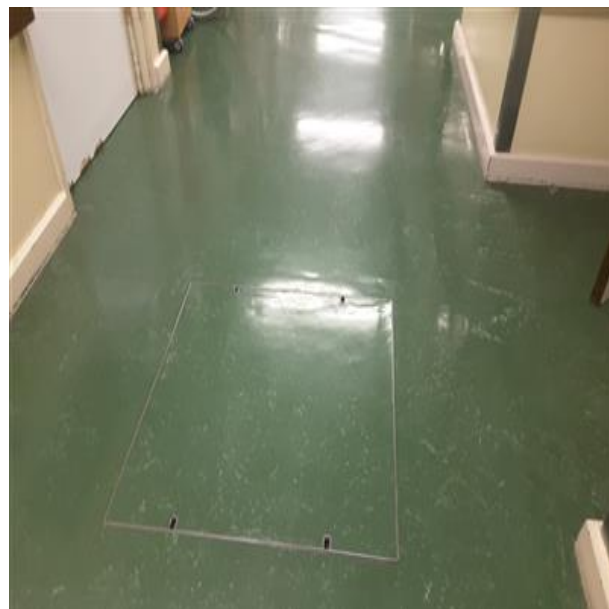
4

Priority 3: Manage in Place & Monitor Periodically.

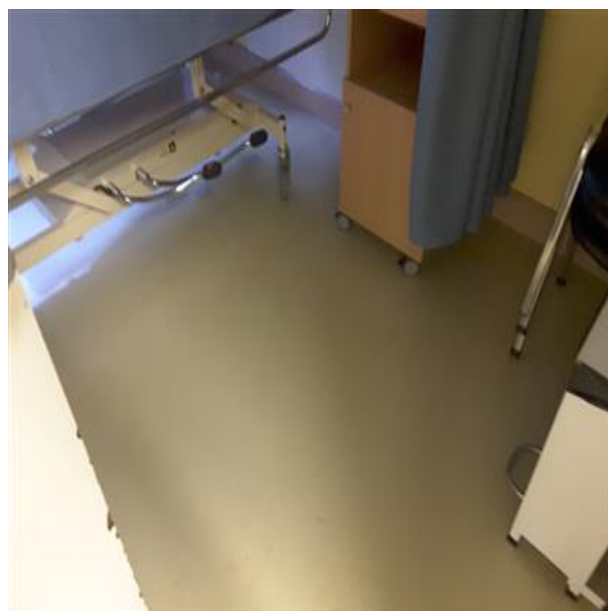
Condition : Good condition

Priority 3: Manage in Place & Monitor Periodically.

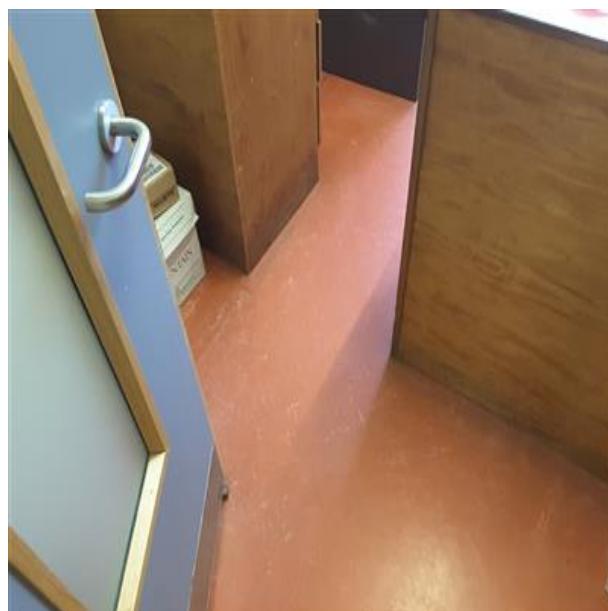
Condition : Good condition

Priority 3: Manage in Place & Monitor Periodically.

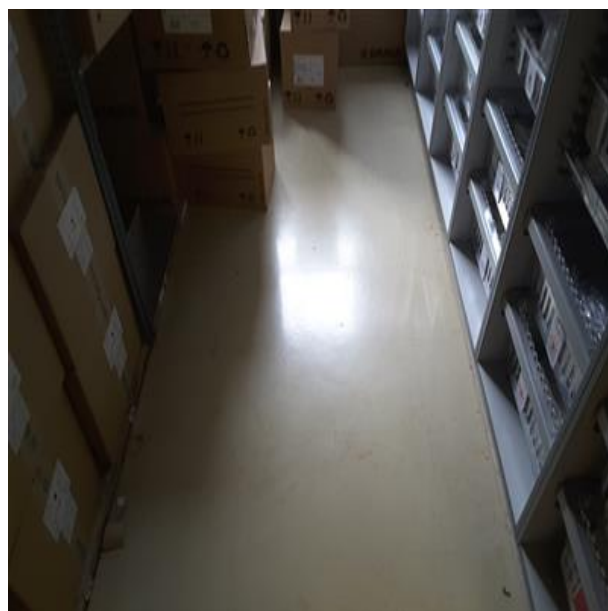
Condition : Good condition

Priority 3: Manage in Place & Monitor Periodically.

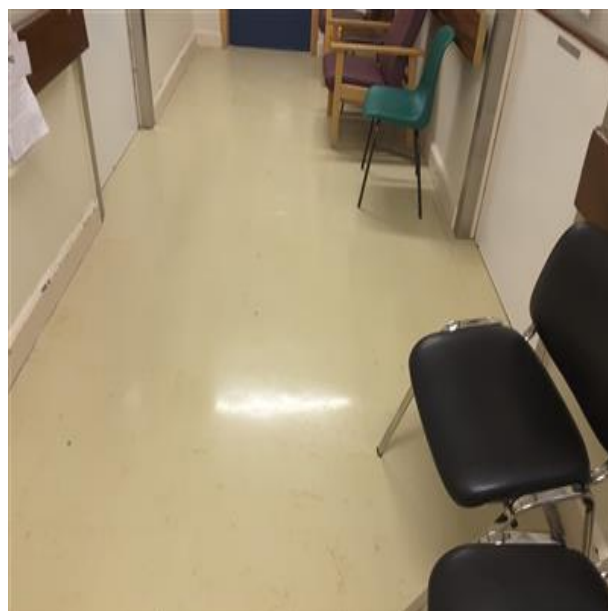
Condition : Good condition

Priority 3: Manage in Place & Monitor Periodically.

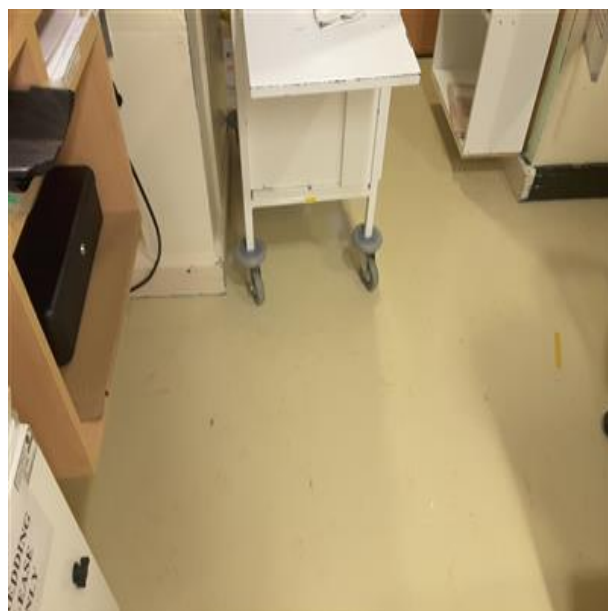
Condition : Good condition

Priority 3: Manage in Place & Monitor Periodically.

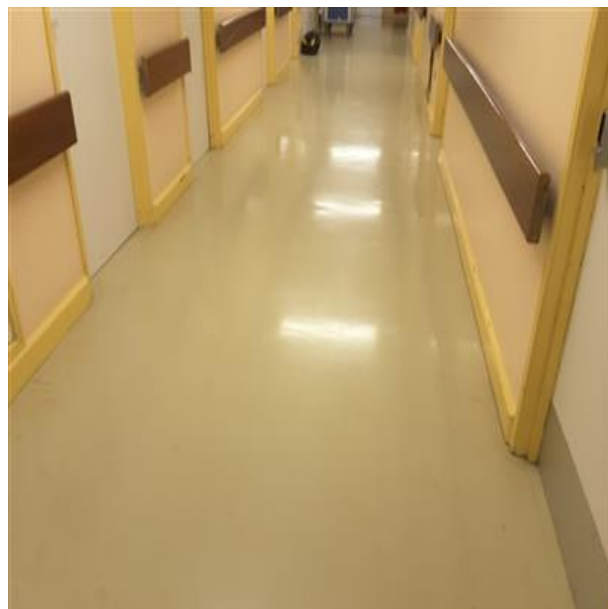
Condition : Good condition

Priority 3: Manage in Place & Monitor Periodically.

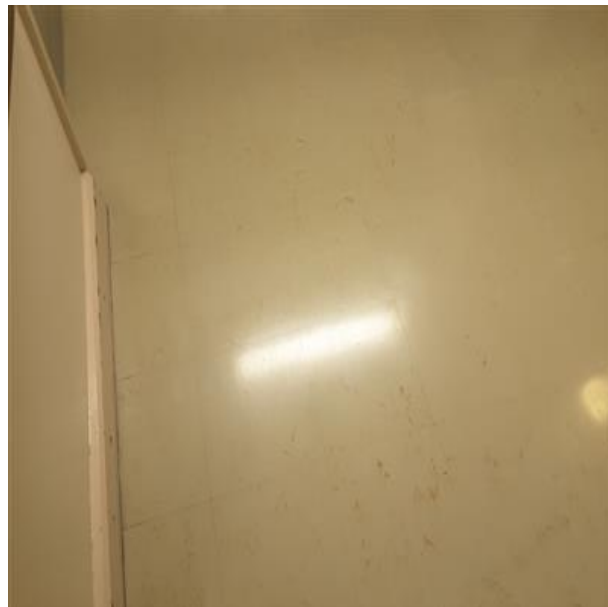
Condition : Good condition

Priority 3: Manage in Place & Monitor Periodically.

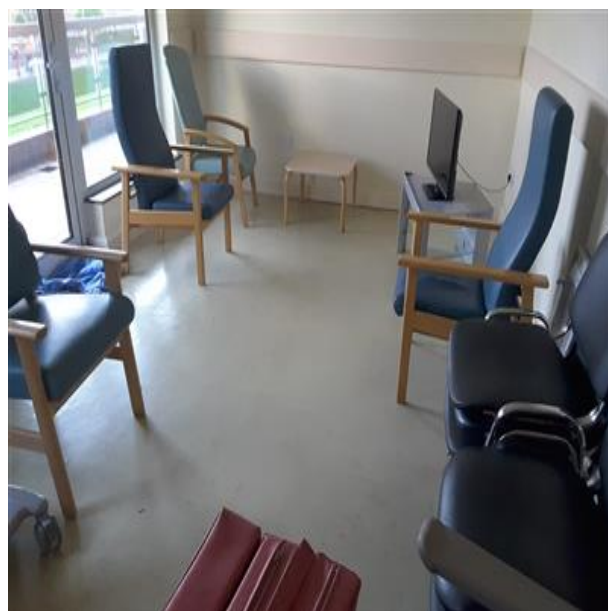
Condition : Good condition

Priority 3: Manage in Place & Monitor Periodically.

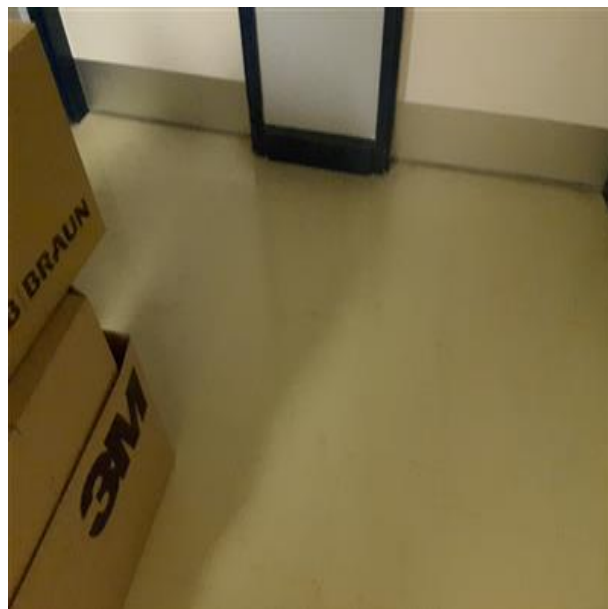
Asbestos Type : Chrysotile  
Type Of Product : Vinyl Floor Tiles & Bitumen  
Condition : Good condition  
Surface Treatment : Composite materials containing asbestos

Priority 3: Manage in Place & Monitor Periodically. Solid Walls and MMMF Ceilings

Priority 3: Manage in Place & Monitor Periodically.

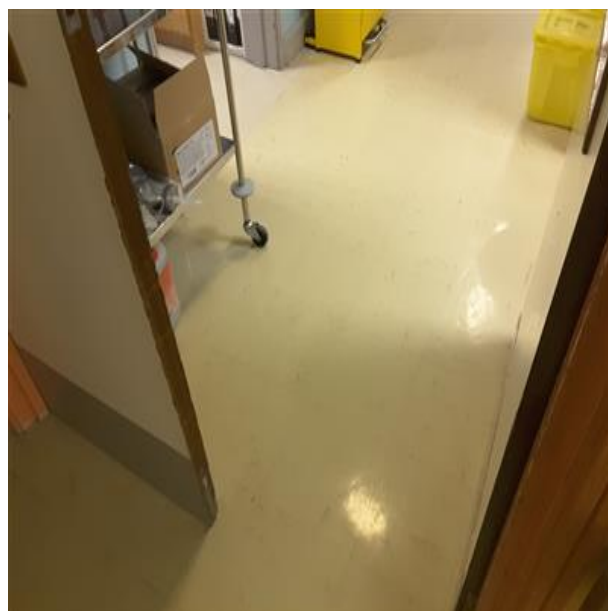
Condition : Good condition

Priority 3: Manage in Place & Monitor Periodically.

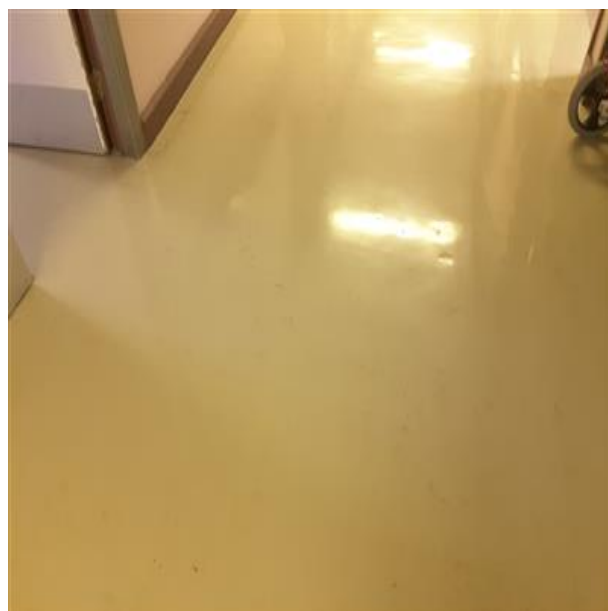
Asbestos Type : Chrysotile  
Type Of Product : Vinyl Floor Tiles & Bitumen  
Condition : Good condition  
Surface Treatment : Composite materials containing asbestos

Priority 3: Manage in Place & Monitor Periodically. Solid Walls and MMMF Ceilings

Priority 3: Manage in Place & Monitor Periodically.

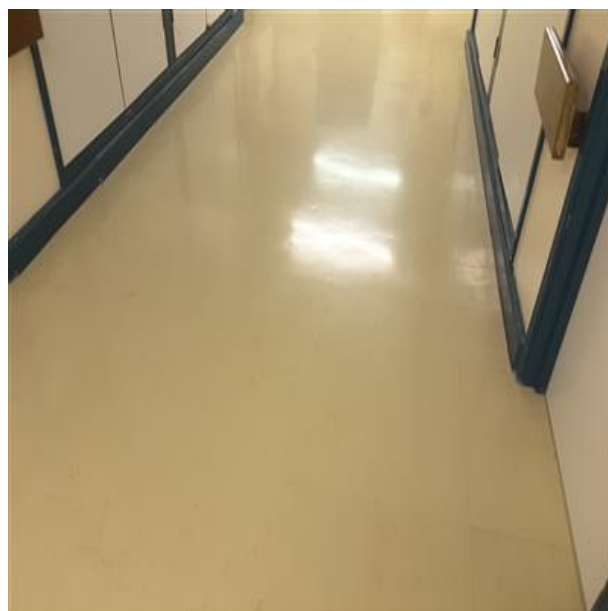
Condition : Good condition

Priority 3: Manage in Place & Monitor Periodically. Solid Walls MMMF Ceilings

Priority 3: Manage in Place & Monitor Periodically.

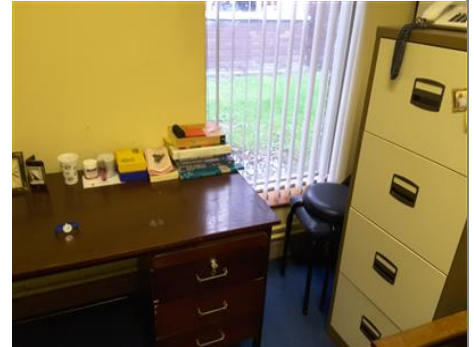
## Location Details 197903 No Asbestos Found

Building/Area : KGH  
Room/Section : G594  
Location : Chapel Office  
Description : Solid Walls Floor and Ceilings  
Sample No. :  
Confirmation : --N/A--  
Access : Full Access  
Normal Use :  
Recommendations :

; No ACM's identified in this area. A more detailed survey will be required prior to any refurbishment or demolition works.

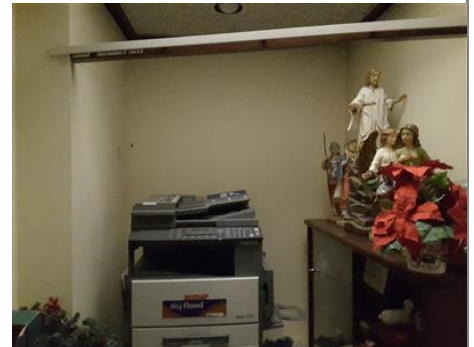
## Location Details 197904 No Asbestos Found

Building/Area : KGH  
Room/Section : G180 181  
Location : Utility  
Description : Solid Walls Floor and Ceilings  
Sample No. :  
Confirmation : --N/A--  
Access : Full Access  
Normal Use :  
Recommendations :

; No ACM's identified in this area. A more detailed survey will be required prior to any refurbishment or demolition works.

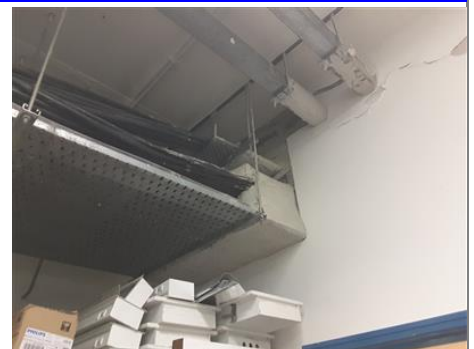
## Location Details 197873 No Asbestos Found

Building/Area : KGH  
Room/Section : G415  
Location : Stores  
Description : MMMF Insulation on Pipe  
Sample No. :  
Confirmation : --N/A--  
Access : Full Access  
Normal Use :  
Recommendations :

; No ACM's identified in this area. A more detailed survey will be required prior to any refurbishment or demolition works.

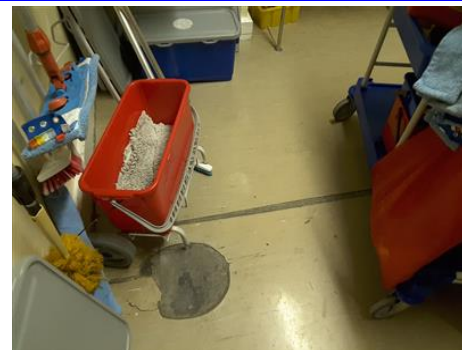
## Location Details 197909 No Asbestos Found

Building/Area : KGH  
Room/Section : G180 181  
Location : Utility  
Description : Solid Walls Floor and Ceilings  
Sample No. :  
Confirmation : --N/A--  
Access : Full Access  
Normal Use :  
Recommendations :

; No ACM's identified in this area. A more detailed survey will be required prior to any refurbishment or demolition works.

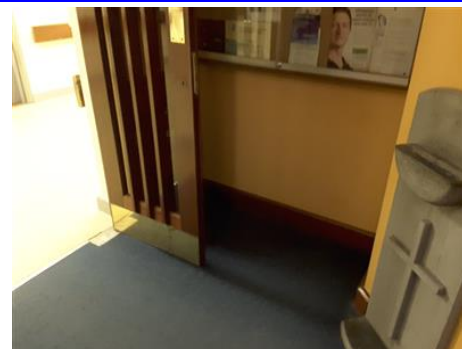
## Location Details 197898 No Asbestos Found

Building/Area : KGH  
Room/Section : G590  
Location : Chapel Reception  
Description : Solid Walls Floor and Ceilings  
Sample No. :  
Confirmation : --N/A--  
Access : Full Access  
Normal Use :  
Recommendations :

; No ACM's identified in this area. A more detailed survey will be required prior to any refurbishment or demolition works.

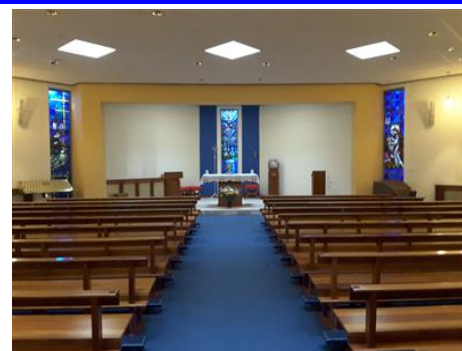
## Location Details 197899 No Asbestos Found

Building/Area : KGH  
Room/Section : G595  
Location : Chapel  
Description : Solid Walls Floor and Ceilings  
Sample No. :  
Confirmation : --N/A--  
Access : Full Access  
Normal Use :  
Recommendations :

; No ACM's identified in this area. A more detailed survey will be required prior to any refurbishment or demolition works.

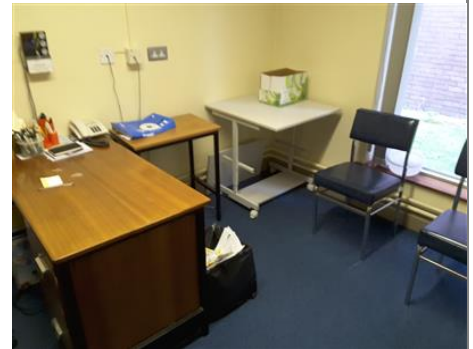
## Location Details 197900 No Asbestos Found

Building/Area : KGH  
Room/Section : G592  
Location : Chapel Office  
Description : Solid Walls Floor and Ceilings  
Sample No. :  
Confirmation : --N/A--  
Access : Full Access  
Normal Use :  
Recommendations :

; No ACM's identified in this area. A more detailed survey will be required prior to any refurbishment or demolition works.

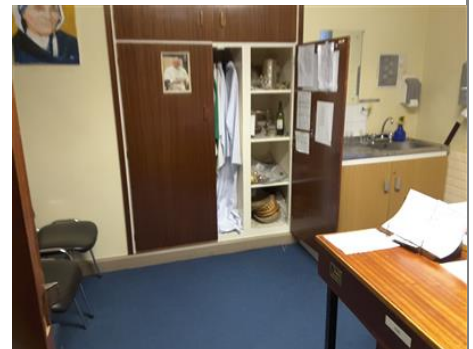
## Location Details 197901 No Asbestos Found

Building/Area : KGH  
Room/Section : G590 , 593a  
Location : Chapel Office  
Description : Solid Walls Floor and Ceilings  
Sample No. :  
Confirmation : --N/A--  
Access : Full Access  
Normal Use :  
Recommendations :

; No ACM's identified in this area. A more detailed survey will be required prior to any refurbishment or demolition works.

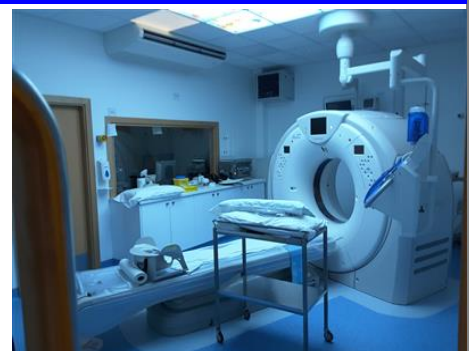
## Location Details 197932 No Asbestos Found

Building/Area : KGH  
Room/Section : G317  
Location : X-ray 1  
Description : Solid Walls Floor and MMMF Ceilings  
Sample No. :  
Confirmation : --N/A--  
Access : Full Access  
Normal Use :  
Recommendations :

; No ACM's identified in this area. A more detailed survey will be required prior to any refurbishment or demolition works.

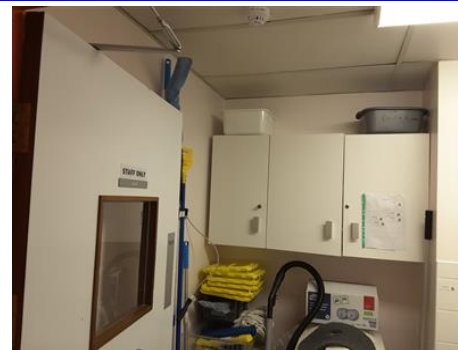
## Location Details 197933 No Asbestos Found

Building/Area : KGH  
Room/Section : G321  
Location : X-ray Sluice  
Description : Solid Walls Floor and MMMF Ceilings  
Sample No. :  
Confirmation : --N/A--  
Access : Full Access  
Normal Use :  
Recommendations :

; No ACM's identified in this area. A more detailed survey will be required prior to any refurbishment or demolition works.

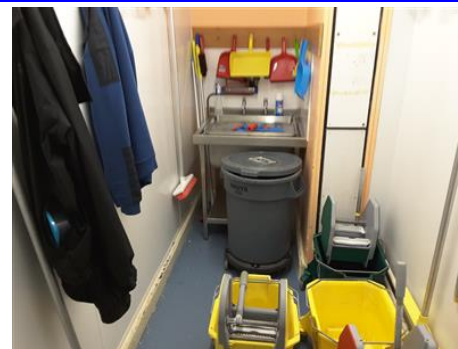
## Location Details 197918 No Asbestos Found

Building/Area : KGH  
Room/Section : G253  
Location : Kitchen Wash  
Description : Solid Walls Floor and Supalux Ceilings  
Sample No. :  
Confirmation : --N/A--  
Access : Full Access  
Normal Use :  
Recommendations :

; No ACM's identified in this area. A more detailed survey will be required prior to any refurbishment or demolition works.

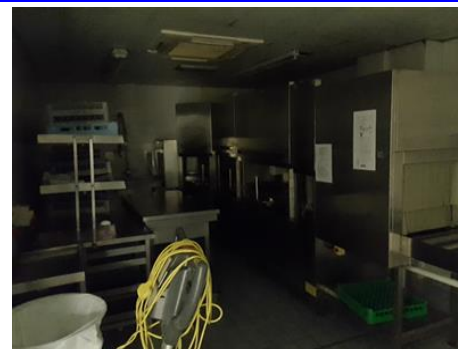
## Location Details 197919 No Asbestos Found

Building/Area : KGH  
Room/Section : G252  
Location : Kitchen Wash  
Description : Solid Walls Floor and Supalux Ceilings  
Sample No. :  
Confirmation : --N/A--  
Access : Full Access  
Normal Use :  
Recommendations :

; No ACM's identified in this area. A more detailed survey will be required prior to any refurbishment or demolition works.

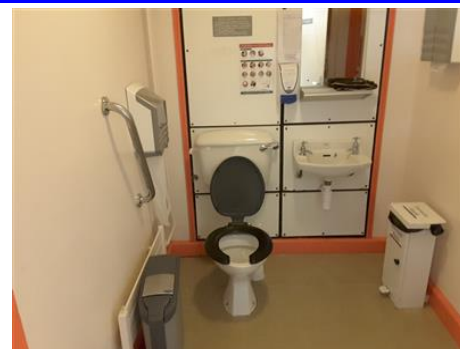
## Location Details 197928 No Asbestos Found

Building/Area : KGH  
Room/Section : G313  
Location : X-ray Toilets  
Description : Solid Walls Floor and MMMF Ceilings  
Sample No. :  
Confirmation : --N/A--  
Access : Full Access  
Normal Use :  
Recommendations :

; No ACM's identified in this area. A more detailed survey will be required prior to any refurbishment or demolition works.

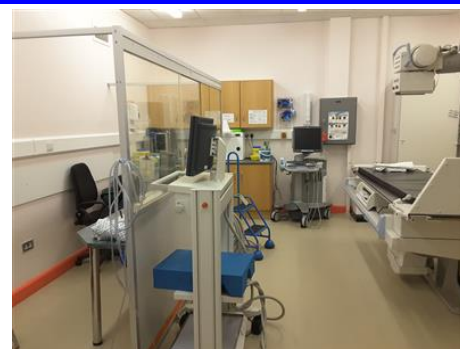
## Location Details 197929 No Asbestos Found

Building/Area : KGH  
Room/Section : G311  
Location : X-ray 2  
Description : Solid Walls Floor and MMMF Ceilings  
Sample No. :  
Confirmation : --N/A--  
Access : Full Access  
Normal Use :  
Recommendations :

; No ACM's identified in this area. A more detailed survey will be required prior to any refurbishment or demolition works.

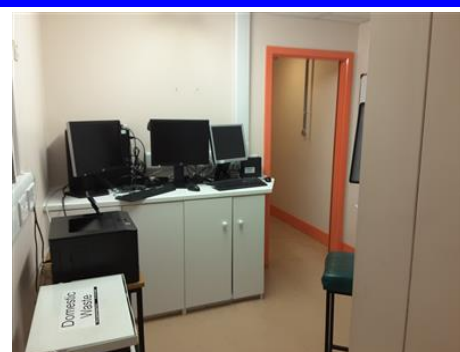
## Location Details 197930 No Asbestos Found

Building/Area : KGH  
Room/Section : G315  
Location : X-ray Sorting  
Description : Solid Walls Floor and MMMF Ceilings  
Sample No. :  
Confirmation : --N/A--  
Access : Full Access  
Normal Use :  
Recommendations :

; No ACM's identified in this area. A more detailed survey will be required prior to any refurbishment or demolition works.

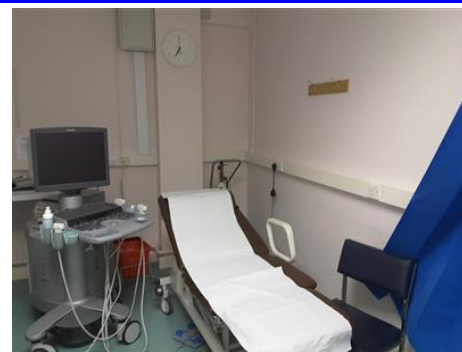
## Location Details 197926 No Asbestos Found

Building/Area : KGH  
Room/Section : G303-301  
Location : X-ray Ultrasound  
Description : Solid Walls Floor and MMMF Ceilings  
Sample No. :  
Confirmation : --N/A--  
Access : Full Access  
Normal Use :  
Recommendations :

; No ACM's identified in this area. A more detailed survey will be required prior to any refurbishment or demolition works.

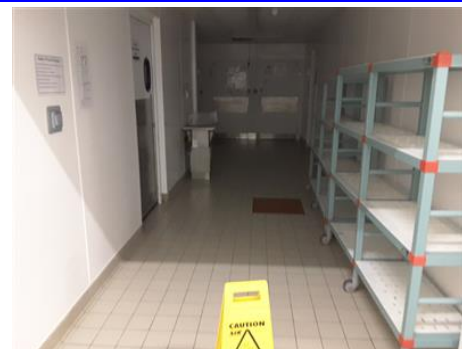
## Location Details 197912 No Asbestos Found

Building/Area : KGH  
Room/Section : G263-268  
Location : Kitchen Stores  
Description : Solid Walls Floor and Ceilings  
Sample No. :  
Confirmation : --N/A--  
Access : Full Access  
Normal Use :  
Recommendations :

; No ACM's identified in this area. A more detailed survey will be required prior to any refurbishment or demolition works.

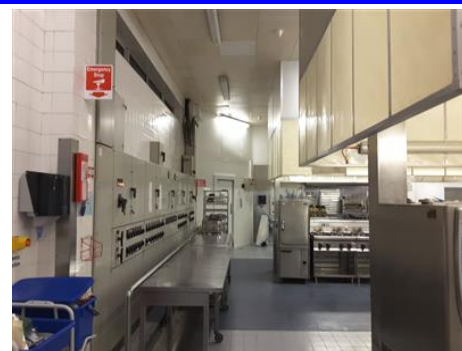
## Location Details 197913 No Asbestos Found

Building/Area : KGH  
Room/Section : G261  
Location : Kitchen Ovens  
Description : Solid Walls Floor and Supalux Ceilings  
Sample No. :  
Confirmation : --N/A--  
Access : Full Access  
Normal Use :  
Recommendations :

; No ACM's identified in this area. A more detailed survey will be required prior to any refurbishment or demolition works.

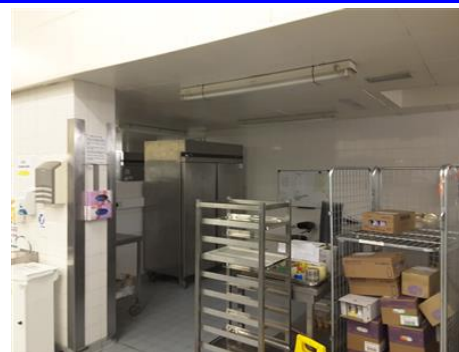
## Location Details 197914 No Asbestos Found

Building/Area : KGH  
Room/Section : G261  
Location : Kitchen Ovens  
Description : Solid Walls Floor and Supalux Ceilings  
Sample No. :  
Confirmation : --N/A--  
Access : Full Access  
Normal Use :  
Recommendations :

; No ACM's identified in this area. A more detailed survey will be required prior to any refurbishment or demolition works.

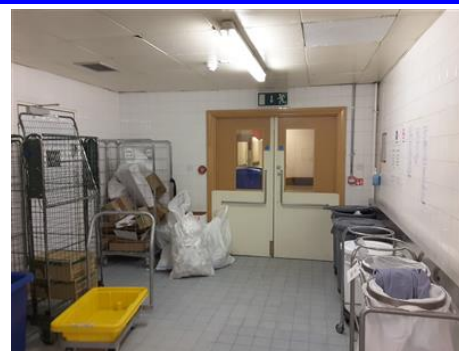
## Location Details 197915 No Asbestos Found

Building/Area : KGH  
Room/Section : G276  
Location : Kitchen Corridor  
Description : Solid Walls Floor and Supalux Ceilings  
Sample No. :  
Confirmation : --N/A--  
Access : Full Access  
Normal Use :  
Recommendations :

; No ACM's identified in this area. A more detailed survey will be required prior to any refurbishment or demolition works.

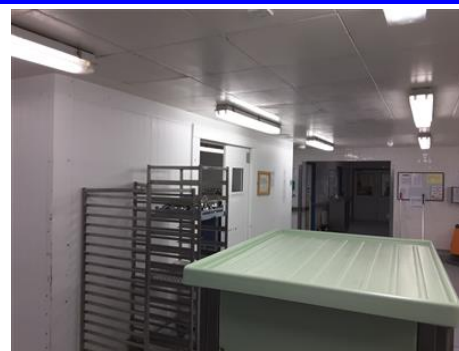
## Location Details 197916 No Asbestos Found

Building/Area : KGH  
Room/Section : G286  
Location : Kitchen Wash  
Description : Solid Walls Floor and Supalux Ceilings  
Sample No. :  
Confirmation : --N/A--  
Access : Full Access  
Normal Use :  
Recommendations :

; No ACM's identified in this area. A more detailed survey will be required prior to any refurbishment or demolition works.
