# ASBESTOS MANAGEMENT SURVEY REPORT

KGH Main Building

Tralee

| <b>Document Title</b> | Asbestos Management Survey Report |

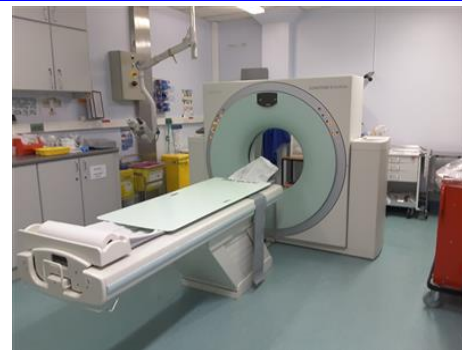
## Location Details 197935 No Asbestos Found

Building/Area : KGH  
Room/Section : G323  
Location : X-ray  
Description : Solid Walls Floor and MMMF Ceilings  
Sample No. :  
Confirmation : --N/A--  
Access : Full Access  
Normal Use :  
Recommendations :

; No ACM's identified in this area. A more detailed survey will be required prior to any refurbishment or demolition works.

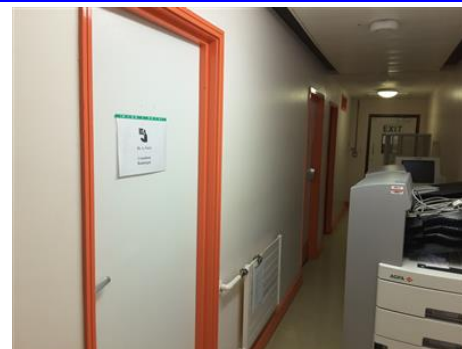
## Location Details 197936 No Asbestos Found

Building/Area : KGH  
Room/Section : G338-336  
Location : X-ray Offices  
Description : Solid Walls Floor and MMMF Ceilings  
Sample No. :  
Confirmation : --N/A--  
Access : Full Access  
Normal Use :  
Recommendations :

; No ACM's identified in this area. A more detailed survey will be required prior to any refurbishment or demolition works.

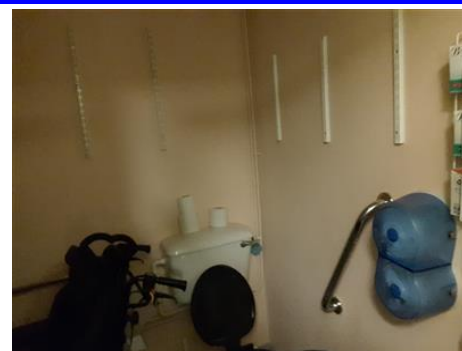
## Location Details 197950 No Asbestos Found

Building/Area : KGH  
Room/Section : OT  
Location : Toilet  
Description : Solid Walls Floor and MMMF Ceilings  
Sample No. :  
Confirmation : --N/A--  
Access : Full Access  
Normal Use :  
Recommendations :

; No ACM's identified in this area. A more detailed survey will be required prior to any refurbishment or demolition works.

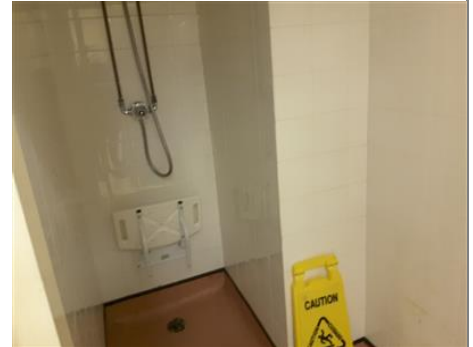
## Location Details 197951 No Asbestos Found

Building/Area : KGH  
Room/Section : OT  
Location : Toilet  
Description : Solid Walls Floor and MMMF Ceilings  
Sample No. :  
Confirmation : --N/A--  
Access : Full Access  
Normal Use :  
Recommendations :

; No ACM's identified in this area. A more detailed survey will be required prior to any refurbishment or demolition works.

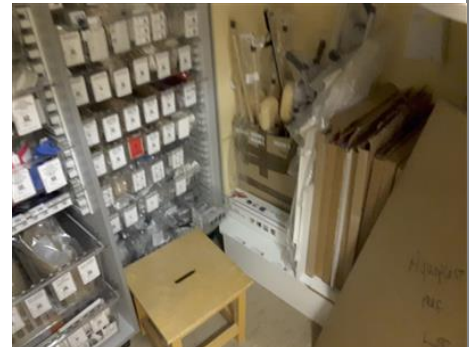
## Location Details 197952 No Asbestos Found

Building/Area : KGH  
Room/Section : OT  
Location : Stores  
Description : Solid Walls Floor and MMMF Ceilings  
Sample No. :  
Confirmation : --N/A--  
Access : Full Access  
Normal Use :  
Recommendations :

; No ACM's identified in this area. A more detailed survey will be required prior to any refurbishment or demolition works.

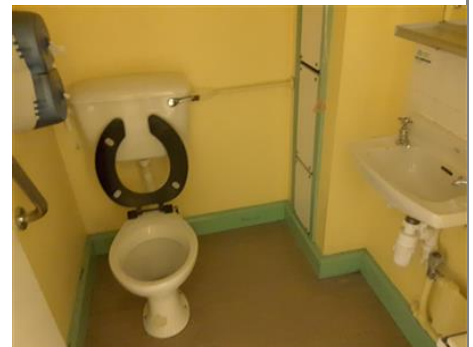
## Location Details 197953 No Asbestos Found

Building/Area : KGH  
Room/Section : Physio  
Location : Toilet  
Description : Solid Walls Floor and MMMF Ceilings  
Sample No. :  
Confirmation : --N/A--  
Access : Full Access  
Normal Use :  
Recommendations :

; No ACM's identified in this area. A more detailed survey will be required prior to any refurbishment or demolition works.

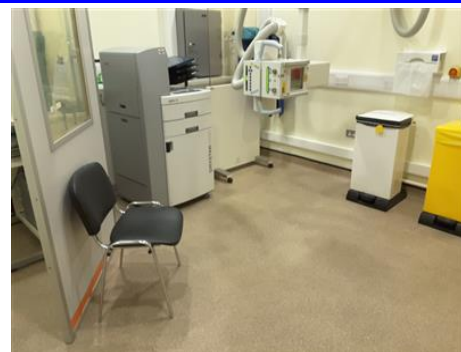
## Location Details 197940 No Asbestos Found

Building/Area : KGH  
Room/Section : G318  
Location : X-ray 1  
Description : Solid Walls Floor and MMMF Ceilings  
Sample No. :  
Confirmation : --N/A--  
Access : Full Access  
Normal Use :  
Recommendations :

; No ACM's identified in this area. A more detailed survey will be required prior to any refurbishment or demolition works.

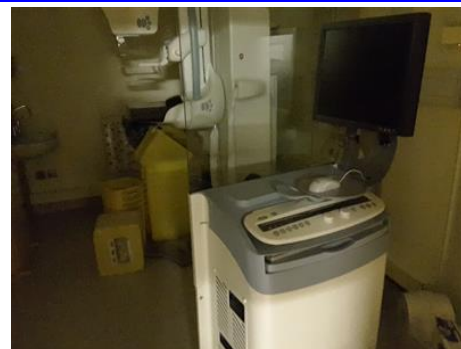
## Location Details 197941 No Asbestos Found

Building/Area : KGH  
Room/Section : G318  
Location : X-ray 1  
Description : Solid Walls Floor and MMMF Ceilings  
Sample No. :  
Confirmation : --N/A--  
Access : Full Access  
Normal Use :  
Recommendations :

; No ACM's identified in this area. A more detailed survey will be required prior to any refurbishment or demolition works.

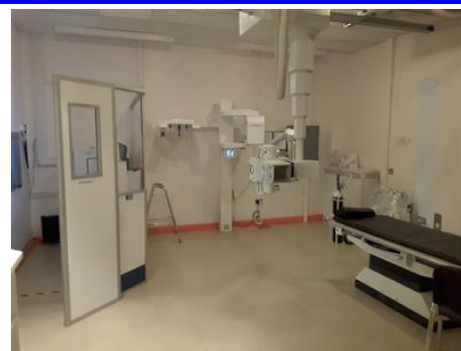
## Location Details 197942 No Asbestos Found

Building/Area : KGH  
Room/Section : G316  
Location : X-ray 3  
Description : Solid Walls Floor and MMMF Ceilings  
Sample No. :  
Confirmation : --N/A--  
Access : Full Access  
Normal Use :  
Recommendations :

; No ACM's identified in this area. A more detailed survey will be required prior to any refurbishment or demolition works.

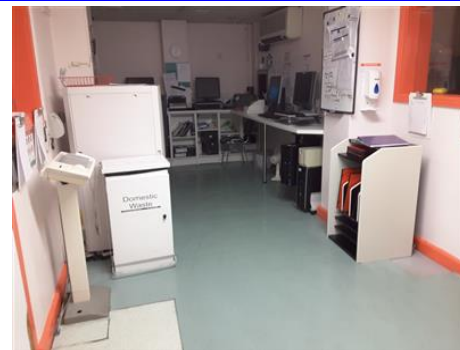
## Location Details 197943 No Asbestos Found

Building/Area : KGH  
Room/Section : G314  
Location : X-ray 3  
Description : Solid Walls Floor and MMMF Ceilings  
Sample No. :  
Confirmation : --N/A--  
Access : Full Access  
Normal Use :  
Recommendations :

; No ACM's identified in this area. A more detailed survey will be required prior to any refurbishment or demolition works.

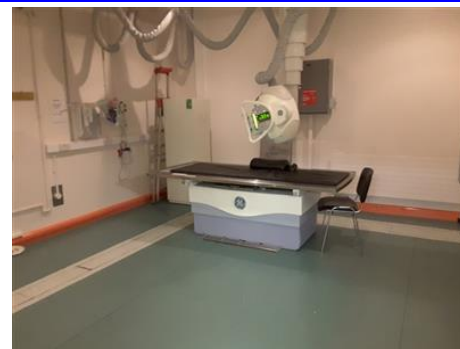
## Location Details 197944 No Asbestos Found

Building/Area : KGH  
Room/Section : G312  
Location : X-ray 4  
Description : Solid Walls Floor and MMMF Ceilings  
Sample No. :  
Confirmation : --N/A--  
Access : Full Access  
Normal Use :  
Recommendations :

; No ACM's identified in this area. A more detailed survey will be required prior to any refurbishment or demolition works.

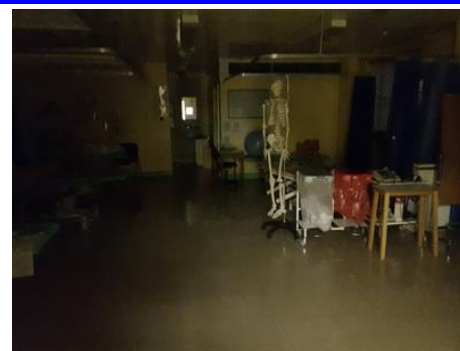
## Location Details 197960 No Asbestos Found

Building/Area : KGH  
Room/Section : Physio  
Location : Out Patients  
Description : Solid Walls Floor and MMMF Ceilings  
Sample No. :  
Confirmation : --N/A--  
Access : Full Access  
Normal Use :  
Recommendations :

; No ACM's identified in this area. A more detailed survey will be required prior to any refurbishment or demolition works.

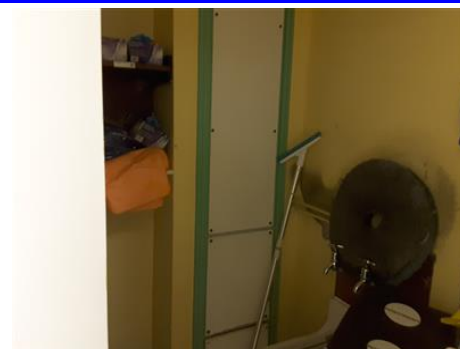
## Location Details 197957 No Asbestos Found

Building/Area : KGH  
Room/Section : Physio  
Location : Stores  
Description : Solid Walls Floor and MMMF Ceilings  
Sample No. :  
Confirmation : --N/A--  
Access : Full Access  
Normal Use :  
Recommendations :

; No ACM's identified in this area. A more detailed survey will be required prior to any refurbishment or demolition works.

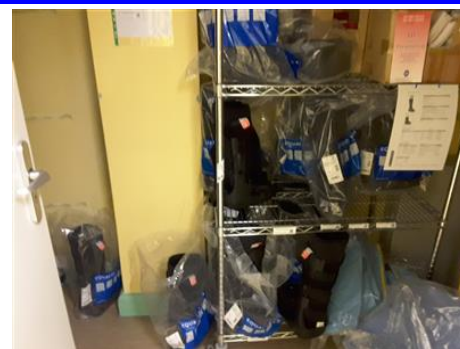
## Location Details 197958 No Asbestos Found

Building/Area : KGH  
Room/Section : Physio  
Location : Stores  
Description : Solid Walls Floor and MMMF Ceilings  
Sample No. :  
Confirmation : --N/A--  
Access : Full Access  
Normal Use :  
Recommendations :

; No ACM's identified in this area. A more detailed survey will be required prior to any refurbishment or demolition works.

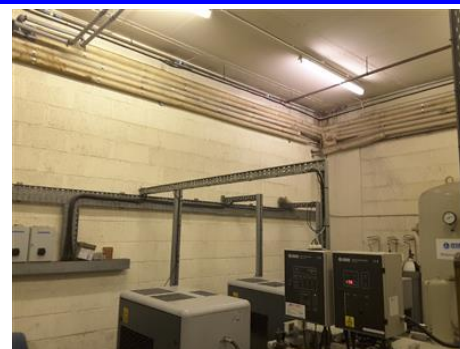
## Location Details 197972 No Asbestos Found

Building/Area : KGH  
Room/Section : G1133  
Location : Air Bottle Store  
Description : Solid Walls Floor and Ceilings  
Sample No. :  
Confirmation : --N/A--  
Access : Full Access  
Normal Use :  
Recommendations :

; No ACM's identified in this area. A more detailed survey will be required prior to any refurbishment or demolition works.

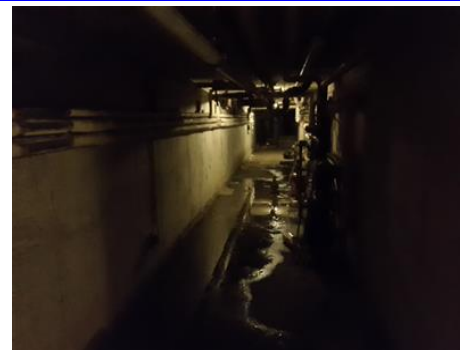
## Location Details 197973 No Asbestos Found

Building/Area : KGH  
Room/Section : Ducts under Kitchen  
Location :  
Description : Solid Walls Floor and Ceilings  
Sample No. :  
Confirmation : --N/A--  
Access : Full Access  
Normal Use :  
Recommendations :

; No ACM's identified in this area. A more detailed survey will be required prior to any refurbishment or demolition works.

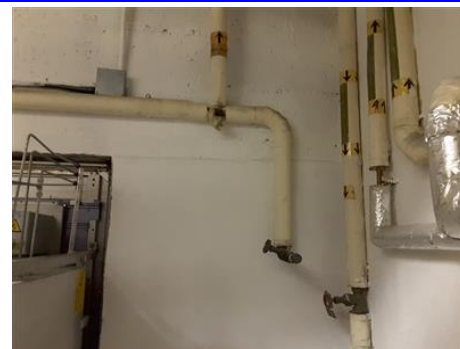
## Location Details 197965 No Asbestos Found

Building/Area : KGH  
Room/Section : CSSD  
Location : Autoclave  
Description : Solid Walls Floor and Ceilings  
Sample No. :  
Confirmation : --N/A--  
Access : Full Access  
Normal Use :  
Recommendations :

; No ACM's identified in this area. A more detailed survey will be required prior to any refurbishment or demolition works.

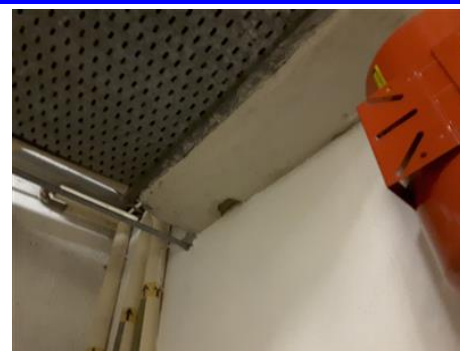
## Location Details 197966 No Asbestos Found

Building/Area : KGH  
Room/Section : CSSD  
Location : Autoclave  
Description : MMMF Insulation  
Sample No. :  
Confirmation : --N/A--  
Access : Full Access  
Normal Use :  
Recommendations :

; No ACM's identified in this area. A more detailed survey will be required prior to any refurbishment or demolition works.

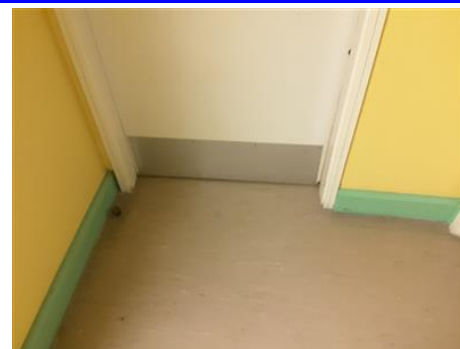
## Location Details 197962 No Asbestos Found

Building/Area : KGH  
Room/Section : Physio  
Location : Changing  
Description : Solid Walls Floor and MMMF Ceilings  
Sample No. :  
Confirmation : --N/A--  
Access : Full Access  
Normal Use :  
Recommendations :

; No ACM's identified in this area. A more detailed survey will be required prior to any refurbishment or demolition works.

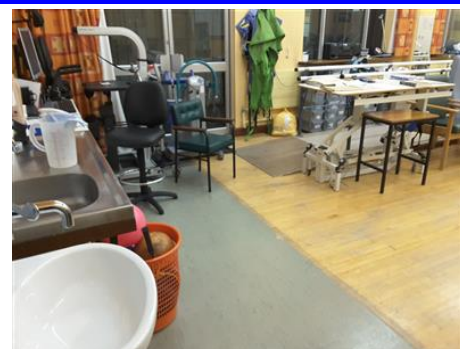
## Location Details 197963 No Asbestos Found

Building/Area : KGH  
Room/Section : Physio  
Location : GYM  
Description : Solid Walls Floor and MMMF Ceilings  
Sample No. :  
Confirmation : --N/A--  
Access : Full Access  
Normal Use :  
Recommendations :

; No ACM's identified in this area. A more detailed survey will be required prior to any refurbishment or demolition works.

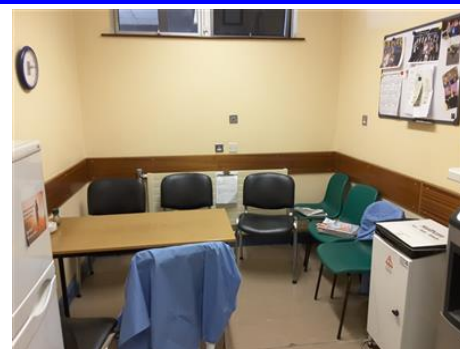
## Location Details 197857 No Asbestos Found

Building/Area : KGH  
Room/Section : G451  
Location : CSSD Tea Room  
Description : Solid Ceiling Walls and Floor  
Sample No. :  
Confirmation : --N/A--  
Access : Full Access  
Normal Use :  
Recommendations :

; No ACM's identified in this area. A more detailed survey will be required prior to any refurbishment or demolition works.

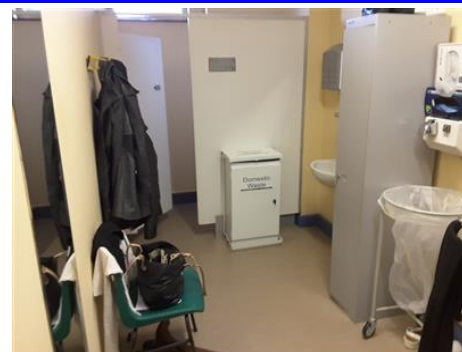
## Location Details 197858 No Asbestos Found

Building/Area : KGH  
Room/Section : G453  
Location : CSSD Changing Room  
Description : Solid Ceiling Walls and Floor  
Sample No. :  
Confirmation : --N/A--  
Access : Full Access  
Normal Use :  
Recommendations :

; No ACM's identified in this area. A more detailed survey will be required prior to any refurbishment or demolition works.

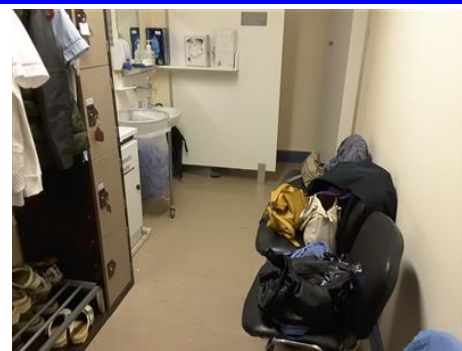
## Location Details 197859 No Asbestos Found

Building/Area : KGH  
Room/Section : G452  
Location : CSSD Changing Room  
Description : Solid Ceiling Walls and Floor  
Sample No. :  
Confirmation : --N/A--  
Access : Full Access  
Normal Use :  
Recommendations :

; No ACM's identified in this area. A more detailed survey will be required prior to any refurbishment or demolition works.

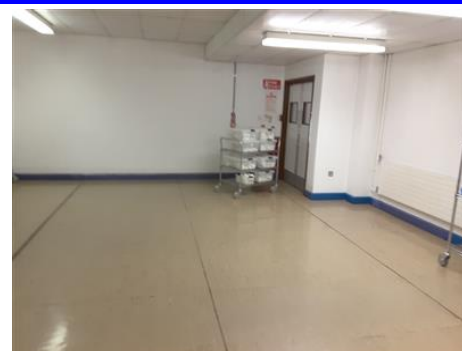
## Location Details 197860 No Asbestos Found

Building/Area : KGH  
Room/Section : G459  
Location : CSSD Despatch  
Description : Solid Ceiling Walls and Floor  
Sample No. :  
Confirmation : --N/A--  
Access : Full Access  
Normal Use :  
Recommendations :

; No ACM's identified in this area. A more detailed survey will be required prior to any refurbishment or demolition works.

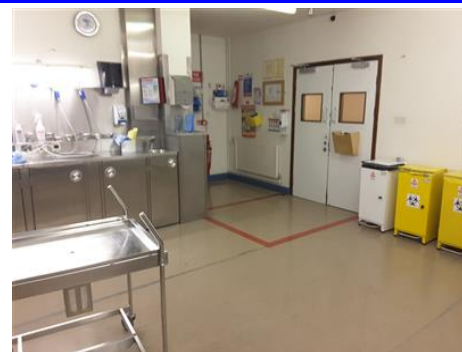
## Location Details 197861 No Asbestos Found

Building/Area : KGH  
Room/Section : G457  
Location : CSSD Despatch  
Description : Solid Ceiling Walls and Floor  
Sample No. :  
Confirmation : --N/A--  
Access : Full Access  
Normal Use :  
Recommendations :

; No ACM's identified in this area. A more detailed survey will be required prior to any refurbishment or demolition works.

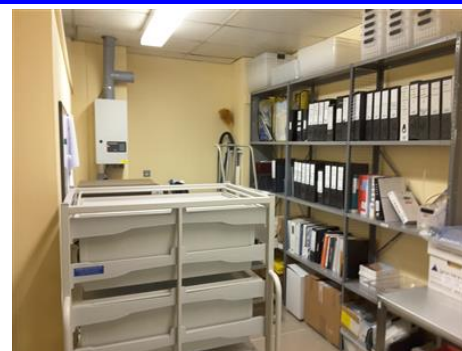
## Location Details 197862 No Asbestos Found

Building/Area : KGH  
Room/Section : G450  
Location : CSSD Reception  
Description : Solid Ceiling Walls and Floor  
Sample No. :  
Confirmation : --N/A--  
Access : Full Access  
Normal Use :  
Recommendations :

; No ACM's identified in this area. A more detailed survey will be required prior to any refurbishment or demolition works.

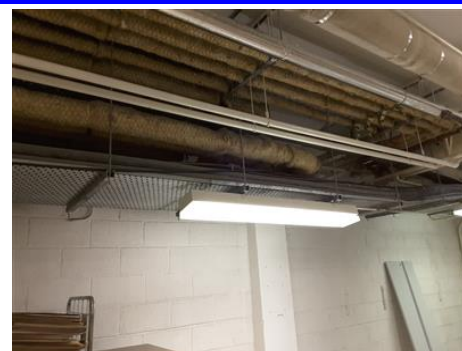
## Location Details 197866 No Asbestos Found

Building/Area : KGH  
Room/Section : G415  
Location : Stores  
Description : MMMF Insulation on Pipe  
Sample No. :  
Confirmation : --N/A--  
Access : Full Access  
Normal Use :  
Recommendations :

; No ACM's identified in this area. A more detailed survey will be required prior to any refurbishment or demolition works.

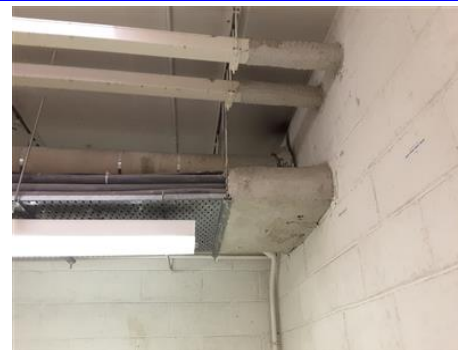
## Location Details 197867 No Asbestos Found

Building/Area : KGH  
Room/Section : G415  
Location : Stores  
Description : MMMF Insulation on Pipe  
Sample No. :  
Confirmation : --N/A--  
Access : Full Access  
Normal Use :  
Recommendations :

; No ACM's identified in this area. A more detailed survey will be required prior to any refurbishment or demolition works.

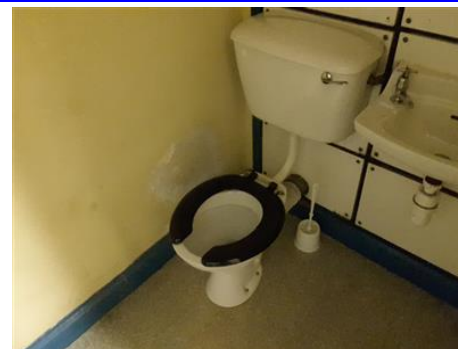
## Location Details 197869 No Asbestos Found

Building/Area : KGH  
Room/Section : G419  
Location : Stores Toilets  
Description : Solid Walls and Floor  
Sample No. :  
Confirmation : --N/A--  
Access : Full Access  
Normal Use :  
Recommendations :

; No ACM's identified in this area. A more detailed survey will be required prior to any refurbishment or demolition works.

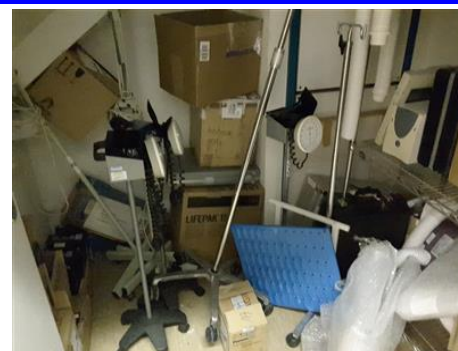
## Location Details 197871 No Asbestos Found

Building/Area : KGH  
Room/Section : G430A  
Location : Stores  
Description : Solid Walls and Floor  
Sample No. :  
Confirmation : --N/A--  
Access : Full Access  
Normal Use :  
Recommendations :

; No ACM's identified in this area. A more detailed survey will be required prior to any refurbishment or demolition works.

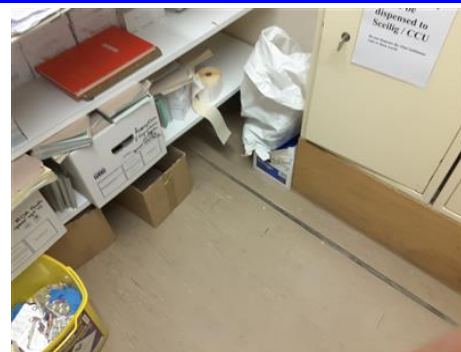
## Location Details 197881 No Asbestos Found

Building/Area : KGH  
Room/Section : G401a  
Location : Pharmacy Stores  
Description : Solid Walls and Floor MMMF Ceilings  
Sample No. :  
Confirmation : --N/A--  
Access : Full Access  
Normal Use :  
Recommendations :

; No ACM's identified in this area. A more detailed survey will be required prior to any refurbishment or demolition works.

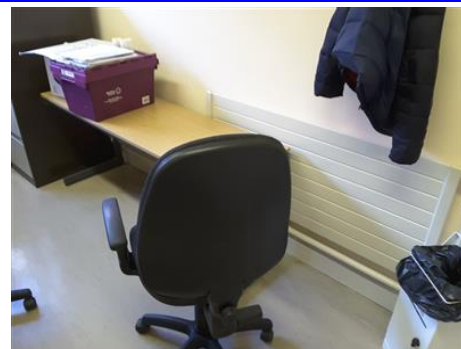
## Location Details 197882 No Asbestos Found

Building/Area : KGH  
Room/Section : G403  
Location : Pharmacy Office  
Description : Solid Walls and Floor MMMF Ceilings  
Sample No. :  
Confirmation : --N/A--  
Access : Full Access  
Normal Use :  
Recommendations :

; No ACM's identified in this area. A more detailed survey will be required prior to any refurbishment or demolition works.

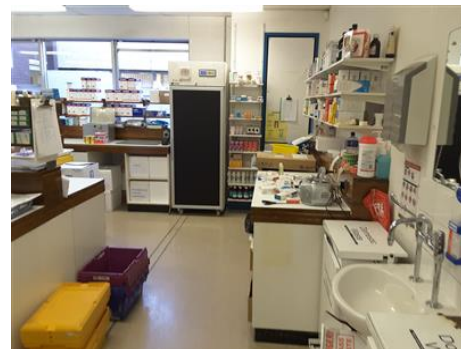
## Location Details 197883 No Asbestos Found

Building/Area : KGH  
Room/Section : G404  
Location : Pharmacy Prep  
Description : Solid Walls and Floor MMMF Ceilings  
Sample No. :  
Confirmation : --N/A--  
Access : Full Access  
Normal Use :  
Recommendations :

; No ACM's identified in this area. A more detailed survey will be required prior to any refurbishment or demolition works.

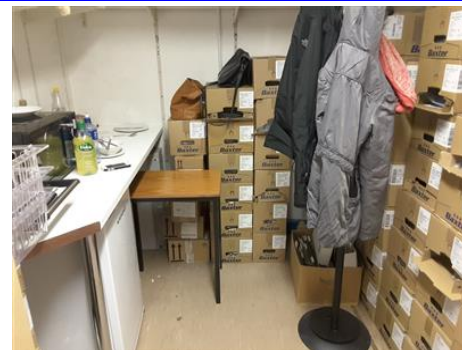
## Location Details 197878 No Asbestos Found

Building/Area : KGH  
Room/Section : G401a  
Location : Pharmacy Stores  
Description : Solid Walls and Floor MMMF Ceilings  
Sample No. :  
Confirmation : --N/A--  
Access : Full Access  
Normal Use :  
Recommendations :

; No ACM's identified in this area. A more detailed survey will be required prior to any refurbishment or demolition works.

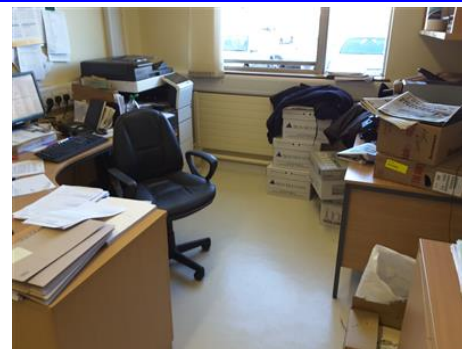
## Location Details 197888 No Asbestos Found

Building/Area : KGH  
Room/Section : G114  
Location : Secretary  
Description : Solid Walls and Floor MMMF Ceilings  
Sample No. :  
Confirmation : --N/A--  
Access : Full Access  
Normal Use :  
Recommendations :

; No ACM's identified in this area. A more detailed survey will be required prior to any refurbishment or demolition works.

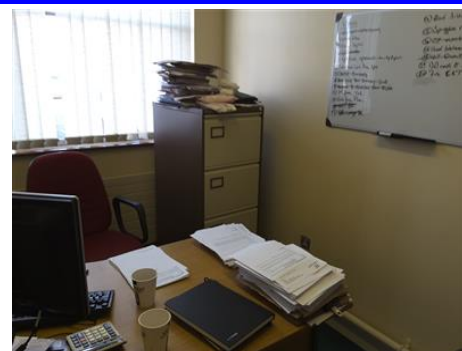
## Location Details 197889 No Asbestos Found

Building/Area : KGH  
Room/Section : G114, 120  
Location : Office  
Description : Walls and Floor MMMF Ceilings  
Sample No. :  
Confirmation : --N/A--  
Access : Full Access  
Normal Use :  
Recommendations :

; No ACM's identified in this area. A more detailed survey will be required prior to any refurbishment or demolition works.

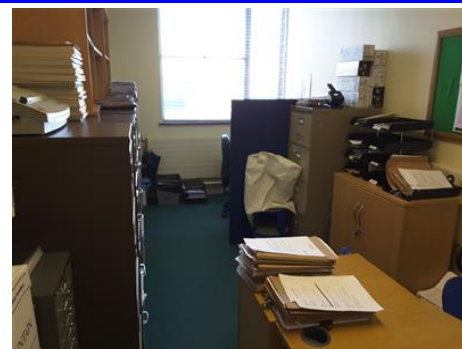
## Location Details 197890 No Asbestos Found

Building/Area : KGH  
Room/Section : G114, 120  
Location : Office  
Description : Walls and Floor MMMF Ceilings  
Sample No. :  
Confirmation : --N\A--  
Access : Full Access  
Normal Use :  
Recommendations :

; No ACM's identified in this area. A more detailed survey will be required prior to any refurbishment or demolition works.

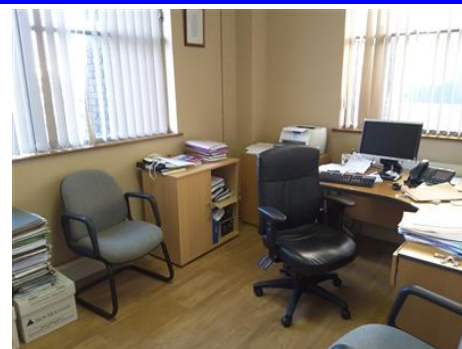
## Location Details 197891 No Asbestos Found

Building/Area : KGH  
Room/Section : G122  
Location : Office  
Description : Walls and Floor MMMF Ceilings  
Sample No. :  
Confirmation : --N\A--  
Access : Full Access  
Normal Use :  
Recommendations :

; No ACM's identified in this area. A more detailed survey will be required prior to any refurbishment or demolition works.

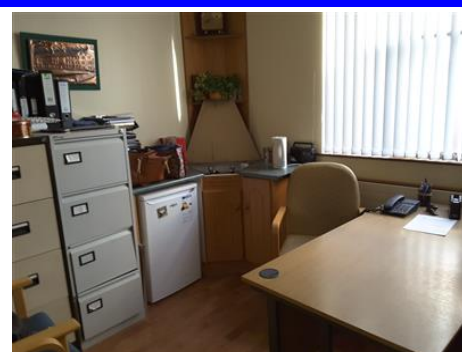
## Location Details 197892 No Asbestos Found

Building/Area : KGH  
Room/Section : G124  
Location : Office  
Description : Walls and Floor MMMF Ceilings  
Sample No. :  
Confirmation : --N\A--  
Access : Full Access  
Normal Use :  
Recommendations :

; No ACM's identified in this area. A more detailed survey will be required prior to any refurbishment or demolition works.

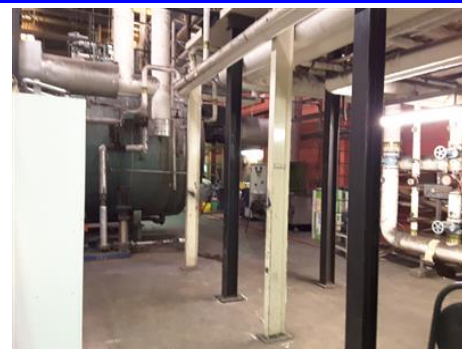
## Location Details 197827 No Asbestos Found

Building/Area : KGH  
Room/Section : G1120  
Location : Boiler House  
Description : Solid Walls Floor and Ceilings  
Sample No. :  
Confirmation : --N\A--  
Access : Full Access  
Normal Use :  
Recommendations :

; No ACM's identified in this area. A more detailed survey will be required prior to any refurbishment or demolition works.

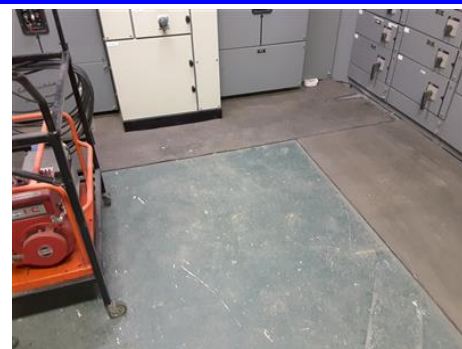
## Location Details 197852 No Asbestos Found

Building/Area : KGH  
Room/Section : G1125  
Location : MV Switch  
Description : Solid Ceiling Walls and Floor  
Sample No. :  
Confirmation : --N\A--  
Access : Full Access  
Normal Use :  
Recommendations :

; No ACM's identified in this area. A more detailed survey will be required prior to any refurbishment or demolition works.

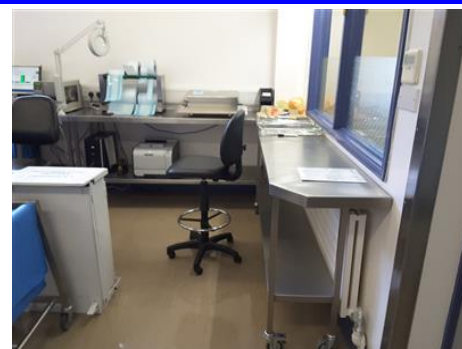
## Location Details 197854 No Asbestos Found

Building/Area : KGH  
Room/Section : G458  
Location : CSSD  
Description : Solid Ceiling Walls and Floor  
Sample No. :  
Confirmation : --N\A--  
Access : Full Access  
Normal Use :  
Recommendations :

; No ACM's identified in this area. A more detailed survey will be required prior to any refurbishment or demolition works.

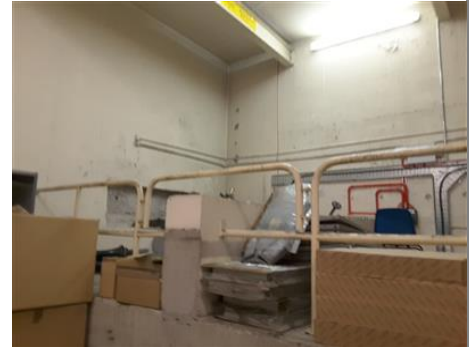
## Location Details 197822 No Asbestos Found

Building/Area : KGH  
Room/Section : Lift 5 and 6  
Location : Motor room  
Description : Solid Walls Floor and Ceilings  
Sample No. :  
Confirmation : --N/A--  
Access : Full Access  
Normal Use :  
Recommendations :

; No ACM's identified in this area. A more detailed survey will be required prior to any refurbishment or demolition works.

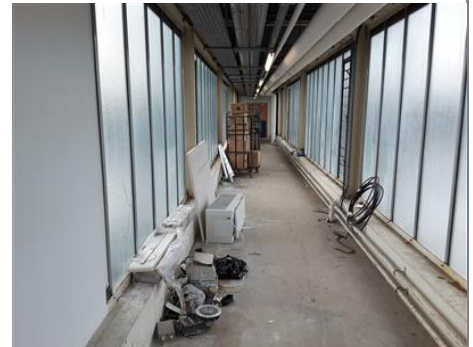
## Location Details 197812 No Asbestos Found

Building/Area : KGH  
Room/Section : 2nd Floor  
Location : SC601  
Description : Glazing Solid and Metal  
Sample No. :  
Confirmation : --N/A--  
Access : Full Access  
Normal Use :  
Recommendations :

; No ACM's identified in this area. A more detailed survey will be required prior to any refurbishment or demolition works.

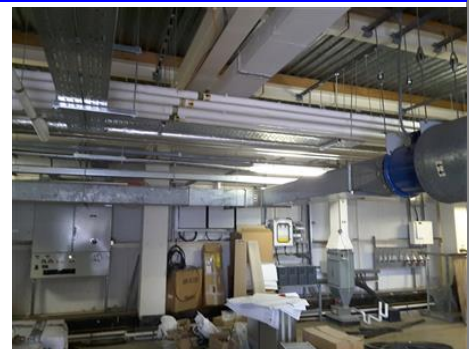
## Location Details 197813 No Asbestos Found

Building/Area : KGH  
Room/Section : 2nd Floor  
Location : S601  
Description : All walls floor and ceiling  
Sample No. :  
Confirmation : --N/A--  
Access : Full Access  
Normal Use :  
Recommendations :

; No ACM's identified in this area. A more detailed survey will be required prior to any refurbishment or demolition works.

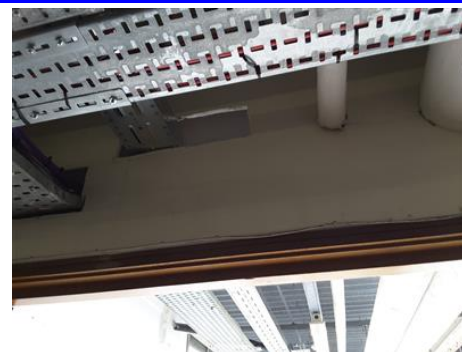
## Location Details 197814 No Asbestos Found

Building/Area : KGH  
Room/Section : 2nd Floor  
Location : S601  
Description : Supalux over Door  
Sample No. :  
Confirmation : --N/A--  
Access : Full Access  
Normal Use :  
Recommendations :

; No ACM's identified in this area. A more detailed survey will be required prior to any refurbishment or demolition works.

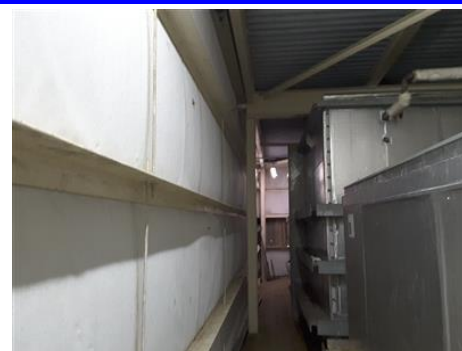
## Location Details 197818 No Asbestos Found

Building/Area : KGH  
Room/Section : Stairwell number 2  
Location : Water Tank Room  
Description : Metal and MMMF walls and Ceilings  
Sample No. :  
Confirmation : --N/A--  
Access : Full Access  
Normal Use :  
Recommendations :

; No ACM's identified in this area. A more detailed survey will be required prior to any refurbishment or demolition works.

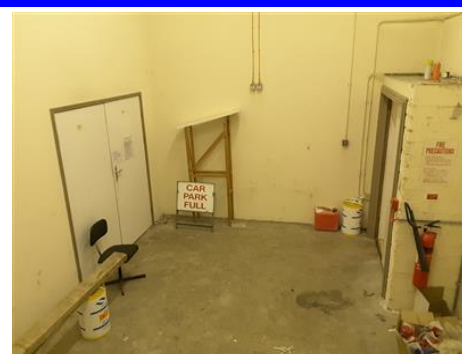
## Location Details 197819 No Asbestos Found

Building/Area : KGH  
Room/Section : L1080-L1081  
Location : Store  
Description : Solid Walls Floor and Ceilings  
Sample No. :  
Confirmation : --N/A--  
Access : Full Access  
Normal Use :  
Recommendations :

; No ACM's identified in this area. A more detailed survey will be required prior to any refurbishment or demolition works.

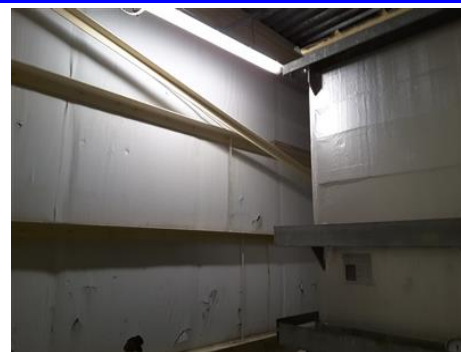
## Location Details 197820 No Asbestos Found

Building/Area : KGH  
Room/Section : L1086  
Location : Water Tank Store  
Description : Metal and MMMF Walls and Ceilings  
Sample No. :  
Confirmation : --N/A--  
Access : Full Access  
Normal Use :  
Recommendations :

; No ACM's identified in this area. A more detailed survey will be required prior to any refurbishment or demolition works.

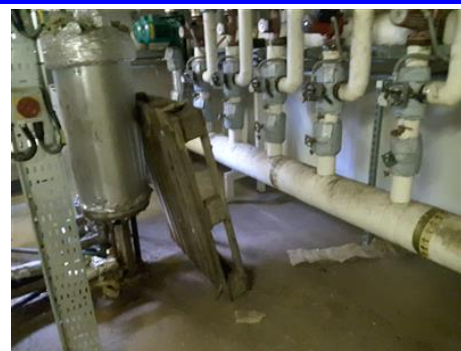
## Location Details 197831 No Asbestos Found

Building/Area : KGH  
Room/Section : Sub plantroom No 2  
Location :  
Description : Solid Walls Floor and Ceilings  
Sample No. :  
Confirmation : --N/A--  
Access : Full Access  
Normal Use :  
Recommendations :

; No ACM's identified in this area. A more detailed survey will be required prior to any refurbishment or demolition works.

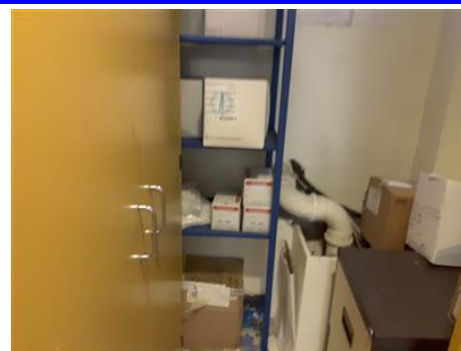
## Location Details 197832 No Asbestos Found

Building/Area : KGH  
Room/Section : F310  
Location : Stores  
Description : Solid Walls Floor and Ceilings  
Sample No. :  
Confirmation : --N/A--  
Access : Full Access  
Normal Use :  
Recommendations :

; No ACM's identified in this area. A more detailed survey will be required prior to any refurbishment or demolition works.

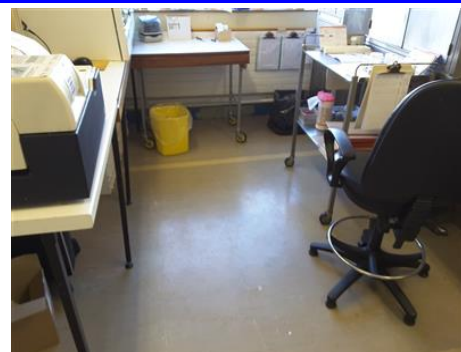
## Location Details 197833 No Asbestos Found

Building/Area : KGH  
Room/Section : F310, 311,312  
Location : Histology  
Description : Metal Ceiling Solid Walls and Floor  
Sample No. :  
Confirmation : --N\A--  
Access : Full Access  
Normal Use :  
Recommendations :

; No ACM's identified in this area. A more detailed survey will be required prior to any refurbishment or demolition works.

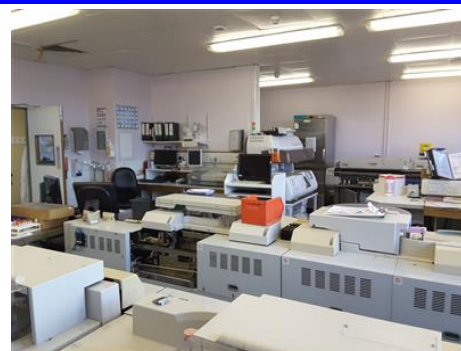
## Location Details 197834 No Asbestos Found

Building/Area : KGH  
Room/Section : F314  
Location : Biochemistry  
Description : Metal Ceiling Solid Walls and Floor  
Sample No. :  
Confirmation : --N\A--  
Access : Full Access  
Normal Use :  
Recommendations :

; No ACM's identified in this area. A more detailed survey will be required prior to any refurbishment or demolition works.

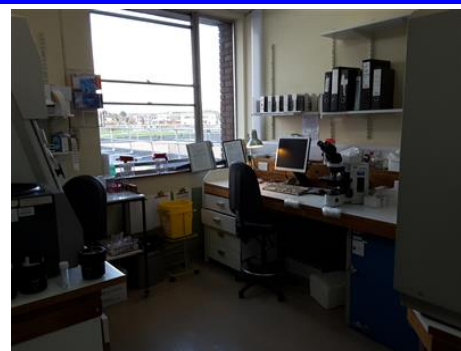
## Location Details 197835 No Asbestos Found

Building/Area : KGH  
Room/Section : F310, 317,318  
Location : Micro  
Description : Metal Ceiling Solid Walls and Floor  
Sample No. :  
Confirmation : --N\A--  
Access : Full Access  
Normal Use :  
Recommendations :

; No ACM's identified in this area. A more detailed survey will be required prior to any refurbishment or demolition works.

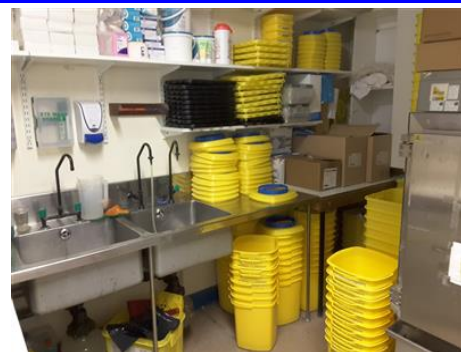
## Location Details 197836 No Asbestos Found

Building/Area : KGH  
Room/Section : F307  
Location : Autoclave  
Description : MMMF Ceiling Solid Walls and Floor  
Sample No. :  
Confirmation : --N\A--  
Access : Full Access  
Normal Use :  
Recommendations :

; No ACM's identified in this area. A more detailed survey will be required prior to any refurbishment or demolition works.

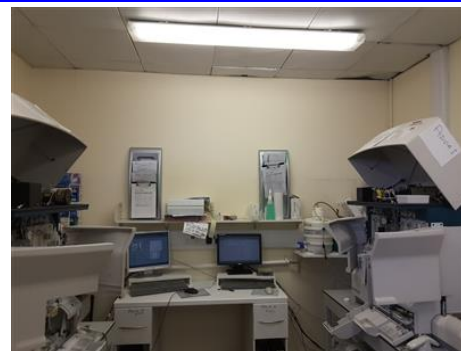
## Location Details 197837 No Asbestos Found

Building/Area : KGH  
Room/Section : F319  
Location : Haematology  
Description : Metal Ceiling Solid Walls and Floor  
Sample No. :  
Confirmation : --N\A--  
Access : Full Access  
Normal Use :  
Recommendations :

; No ACM's identified in this area. A more detailed survey will be required prior to any refurbishment or demolition works.

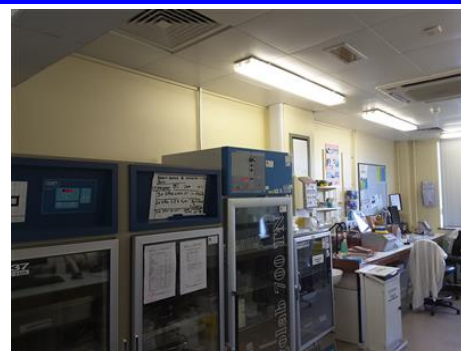
## Location Details 197838 No Asbestos Found

Building/Area : KGH  
Room/Section : F320  
Location : Blood Bank  
Description : Metal Ceiling Solid Walls and Floor  
Sample No. :  
Confirmation : --N\A--  
Access : Full Access  
Normal Use :  
Recommendations :

; No ACM's identified in this area. A more detailed survey will be required prior to any refurbishment or demolition works.

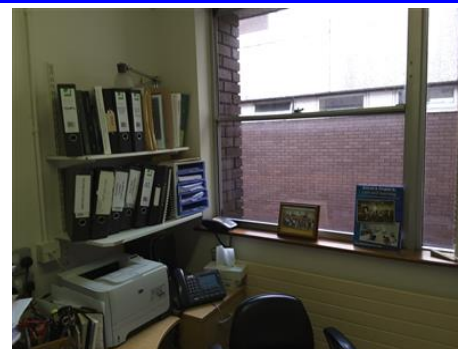
## Location Details 197839 No Asbestos Found

Building/Area : KGH  
Room/Section : F321  
Location : Office  
Description : MMMF Ceiling Solid Walls  
Sample No. :  
Confirmation : --N/A--  
Access : Full Access  
Normal Use :  
Recommendations :

; No ACM's identified in this area. A more detailed survey will be required prior to any refurbishment or demolition works.

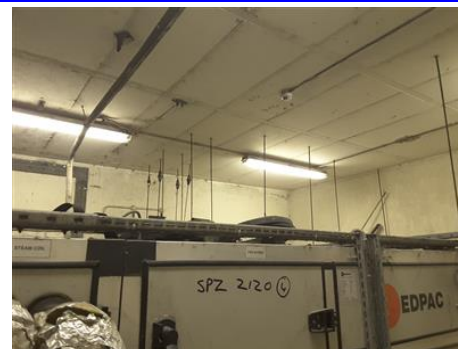
## Location Details 198049 No Asbestos Found

Building/Area : KGH  
Room/Section : F1253  
Location : Plant Room  
Description : Solid Walls Floor and Ceilings  
Sample No. :  
Confirmation : --N/A--  
Access : Full Access  
Normal Use :  
Recommendations :

; No ACM's identified in this area. A more detailed survey will be required prior to any refurbishment or demolition works.

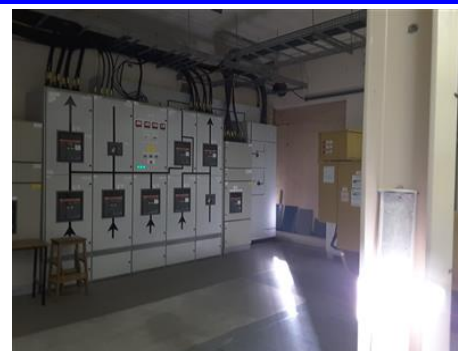
## Location Details 198050 No Asbestos Found

Building/Area : KGH  
Room/Section : G1129  
Location : Generator Room  
Description : Solid Walls Floor and Ceilings  
Sample No. :  
Confirmation : --N/A--  
Access : Full Access  
Normal Use :  
Recommendations :

; No ACM's identified in this area. A more detailed survey will be required prior to any refurbishment or demolition works.

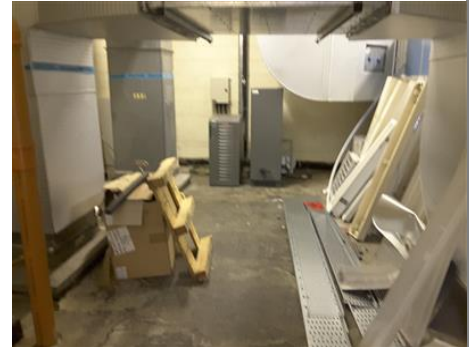
## Location Details 198046 No Asbestos Found

Solid Walls MMMF Ceilings; No ACM's identified in this area. A more detailed survey will be required prior to any refurbishment or demolition works.

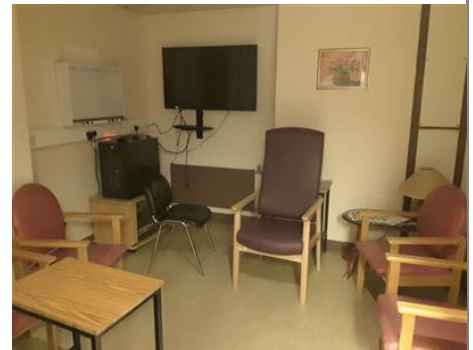
## Location Details 198017 No Asbestos Found

; No ACM's identified in this area. A more detailed survey will be required prior to any refurbishment or demolition works.

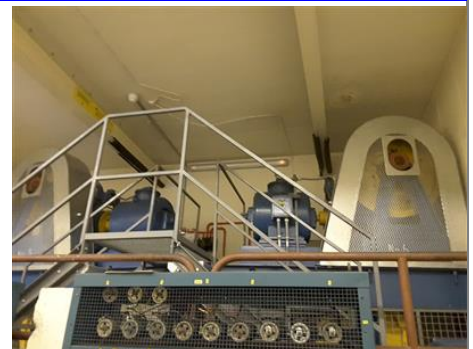
## Location Details 198018 No Asbestos Found

; No ACM's identified in this area. A more detailed survey will be required prior to any refurbishment or demolition works.

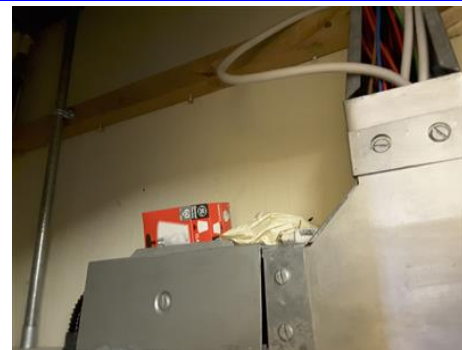
## Location Details 198019 No Asbestos Found

; No ACM's identified in this area. A more detailed survey will be required prior to any refurbishment or demolition works.

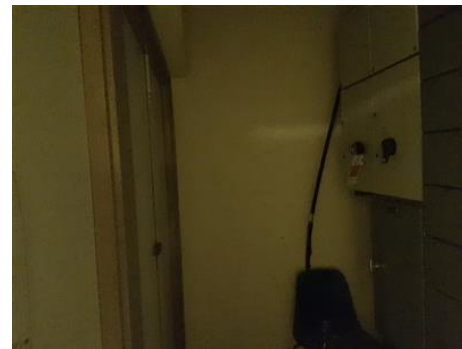
## Location Details 198013 No Asbestos Found

; No ACM's identified in this area. A more detailed survey will be required prior to any refurbishment or demolition works.

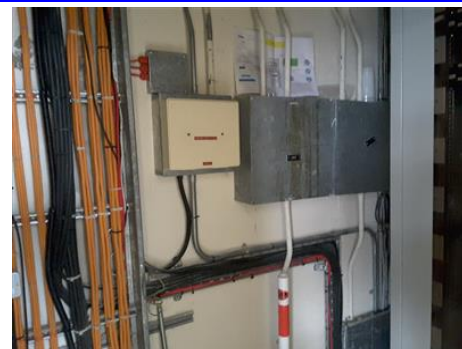
## Location Details 198015 No Asbestos Found

; No ACM's identified in this area. A more detailed survey will be required prior to any refurbishment or demolition works.

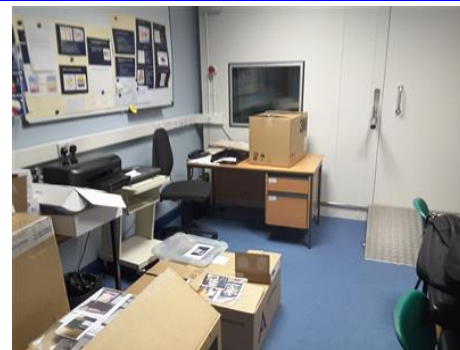
## Location Details 198011 No Asbestos Found

Solid Walls and MMMF Ceilings; No ACM's identified in this area. A more detailed survey will be required prior to any refurbishment or demolition works.

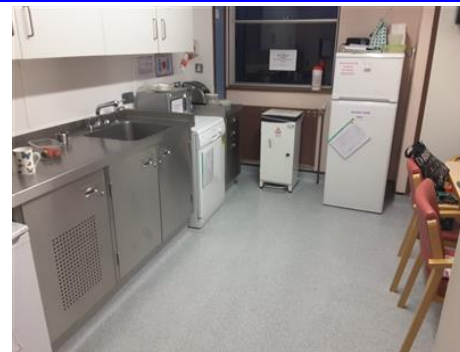
## Location Details 198021 No Asbestos Found

; No ACM's identified in this area. A more detailed survey will be required prior to any refurbishment or demolition works.

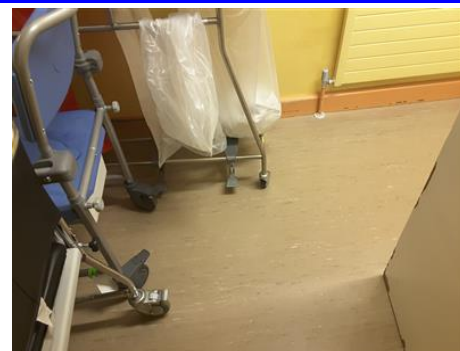
## Location Details 198025 No Asbestos Found

; No ACM's identified in this area. A more detailed survey will be required prior to any refurbishment or demolition works.

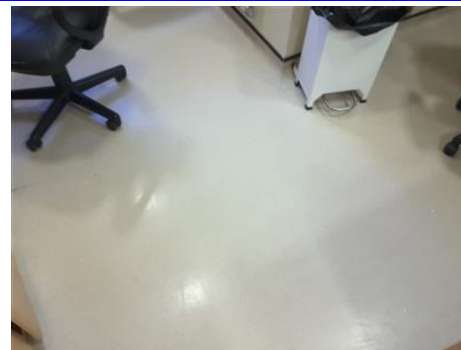
## Location Details 198042 No Asbestos Found

Solid Walls MMMF Ceilings; No ACM's identified in this area. A more detailed survey will be required prior to any refurbishment or demolition works.

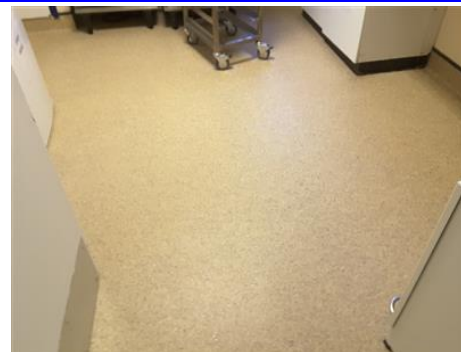
## Location Details 198040 No Asbestos Found

Solid Walls MMMF Ceilings; No ACM's identified in this area. A more detailed survey will be required prior to any refurbishment or demolition works.

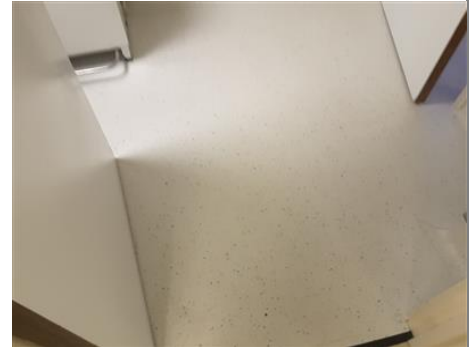
## Location Details 198035 No Asbestos Found

Solid Walls MMMF Ceilings; No ACM's identified in this area. A more detailed survey will be required prior to any refurbishment or demolition works.

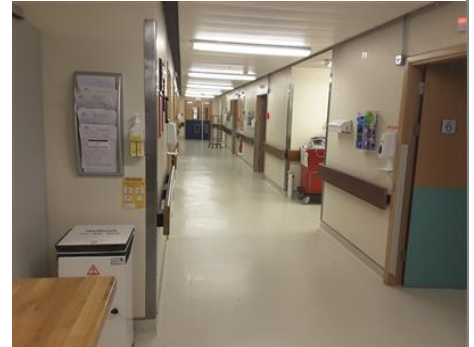
## Location Details 198033 No Asbestos Found

Solid Walls MMMF Ceilings; No ACM's identified in this area. A more detailed survey will be required prior to any refurbishment or demolition works.

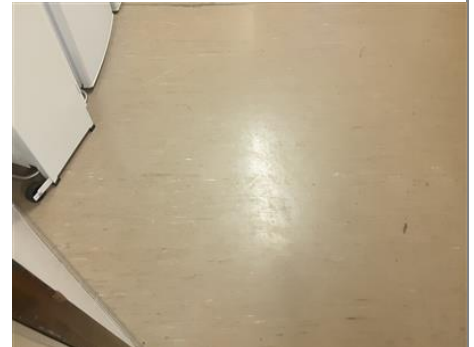
## Location Details 198031 No Asbestos Found

Solid Walls MMMF Ceilings; No ACM's identified in this area. A more detailed survey will be required prior to any refurbishment or demolition works.

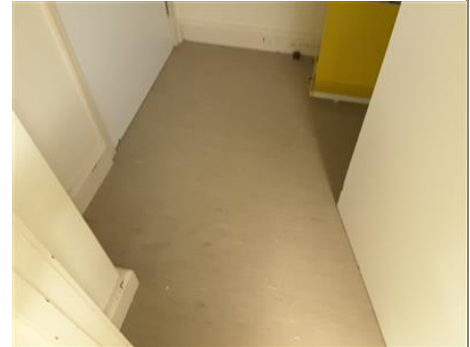
## Location Details 198029 No Asbestos Found

; No ACM's identified in this area. A more detailed survey will be required prior to any refurbishment or demolition works.

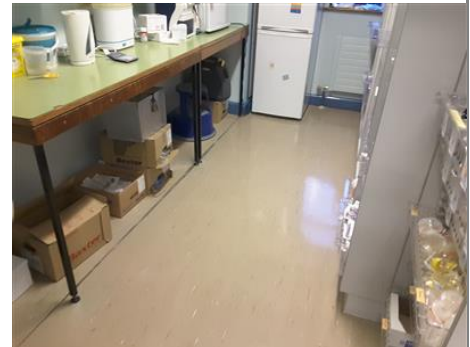
## Location Details 198027 No Asbestos Found

; No ACM's identified in this area. A more detailed survey will be required prior to any refurbishment or demolition works.

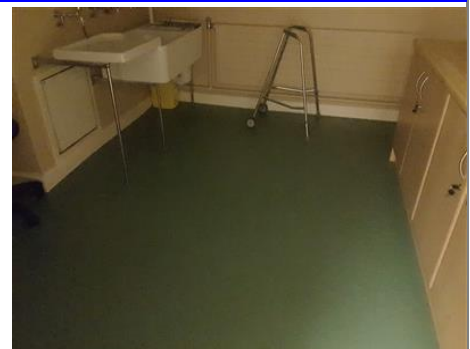
## Location Details 198009 No Asbestos Found

Solid Walls and MMMF Ceilings; No ACM's identified in this area. A more detailed survey will be required prior to any refurbishment or demolition works.

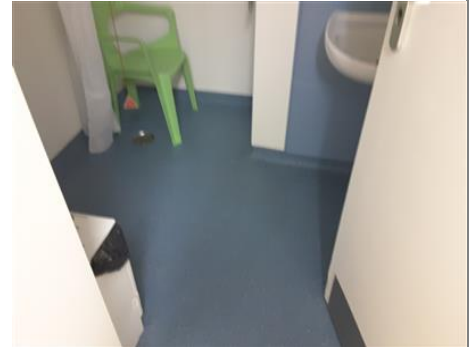
## Location Details 197993 No Asbestos Found

Solid Walls and MMMF Ceilings; No ACM's identified in this area. A more detailed survey will be required prior to any refurbishment or demolition works.

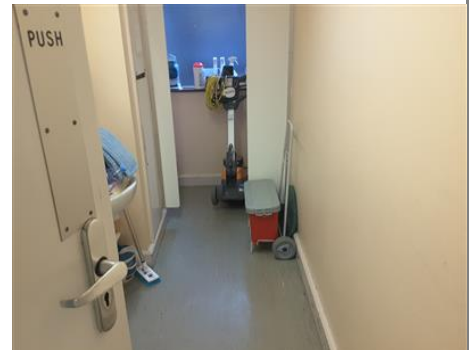
## Location Details 197998 No Asbestos Found

Solid Walls and MMMF Ceilings; No ACM's identified in this area. A more detailed survey will be required prior to any refurbishment or demolition works.

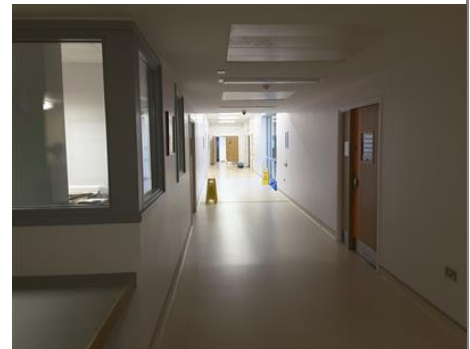
## Location Details 198004 No Asbestos Found

Solid Walls and MMMF Ceilings; No ACM's identified in this area. A more detailed survey will be required prior to any refurbishment or demolition works.

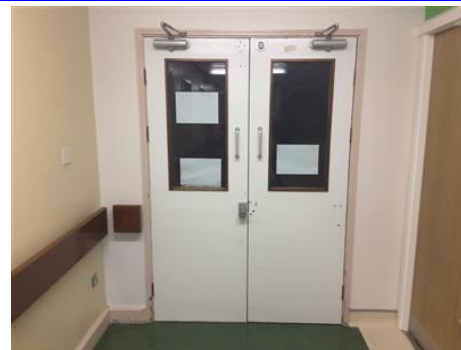
## Location Details 198005 No Asbestos Found

Solid Walls and MMMF Ceilings; No ACM's identified in this area. A more detailed survey will be required prior to any refurbishment or demolition works.

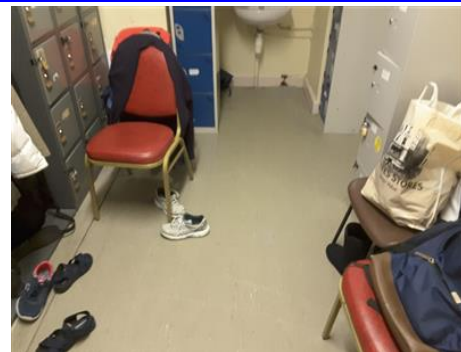
## Location Details 198006 No Asbestos Found

Solid Walls and MMMF Ceilings; No ACM's identified in this area. A more detailed survey will be required prior to any refurbishment or demolition works.

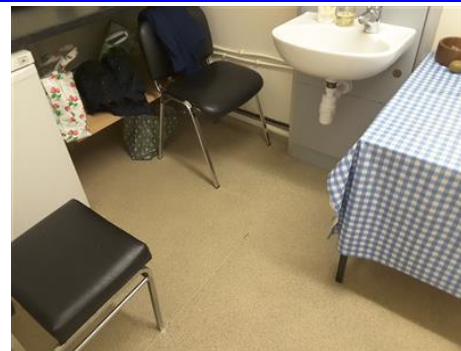
## Location Details 197990 No Asbestos Found

Solid Walls and MMMF Ceilings; No ACM's identified in this area. A more detailed survey will be required prior to any refurbishment or demolition works.

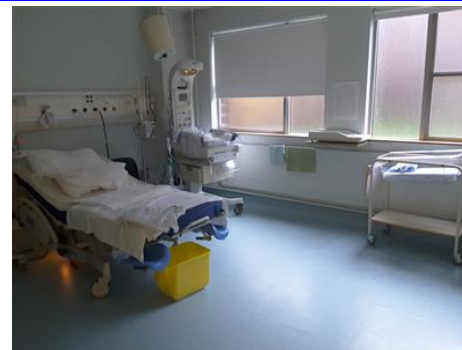
## Location Details 197979 No Asbestos Found

; No ACM's identified in this area. A more detailed survey will be required prior to any refurbishment or demolition works.

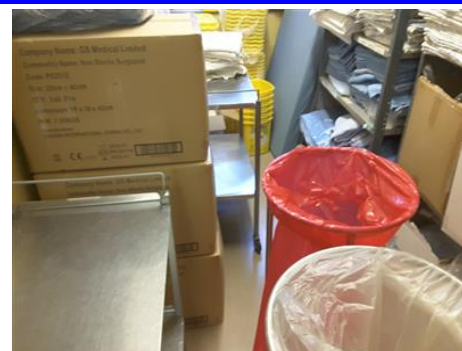
## Location Details 197981 No Asbestos Found

; No ACM's identified in this area. A more detailed survey will be required prior to any refurbishment or demolition works.

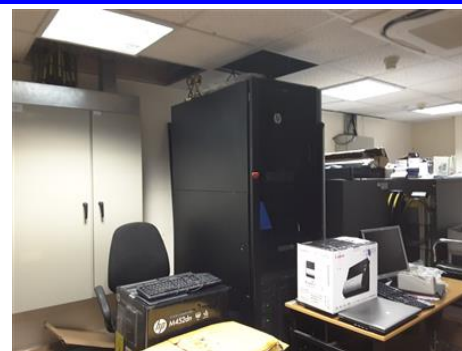
## Location Details 197968 No Asbestos Found

; No ACM's identified in this area. A more detailed survey will be required prior to any refurbishment or demolition works.

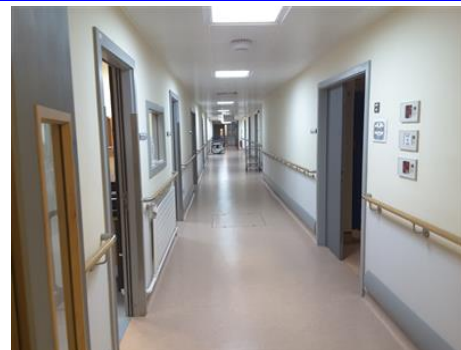
## Location Details 197969 No Asbestos Found

; No ACM's identified in this area. A more detailed survey will be required prior to any refurbishment or demolition works.
