# ASBESTOS MANAGEMENT SURVEY REPORT

KGH Main Building

Tralee

| <b>Document Title</b> | Asbestos Management Survey Report |

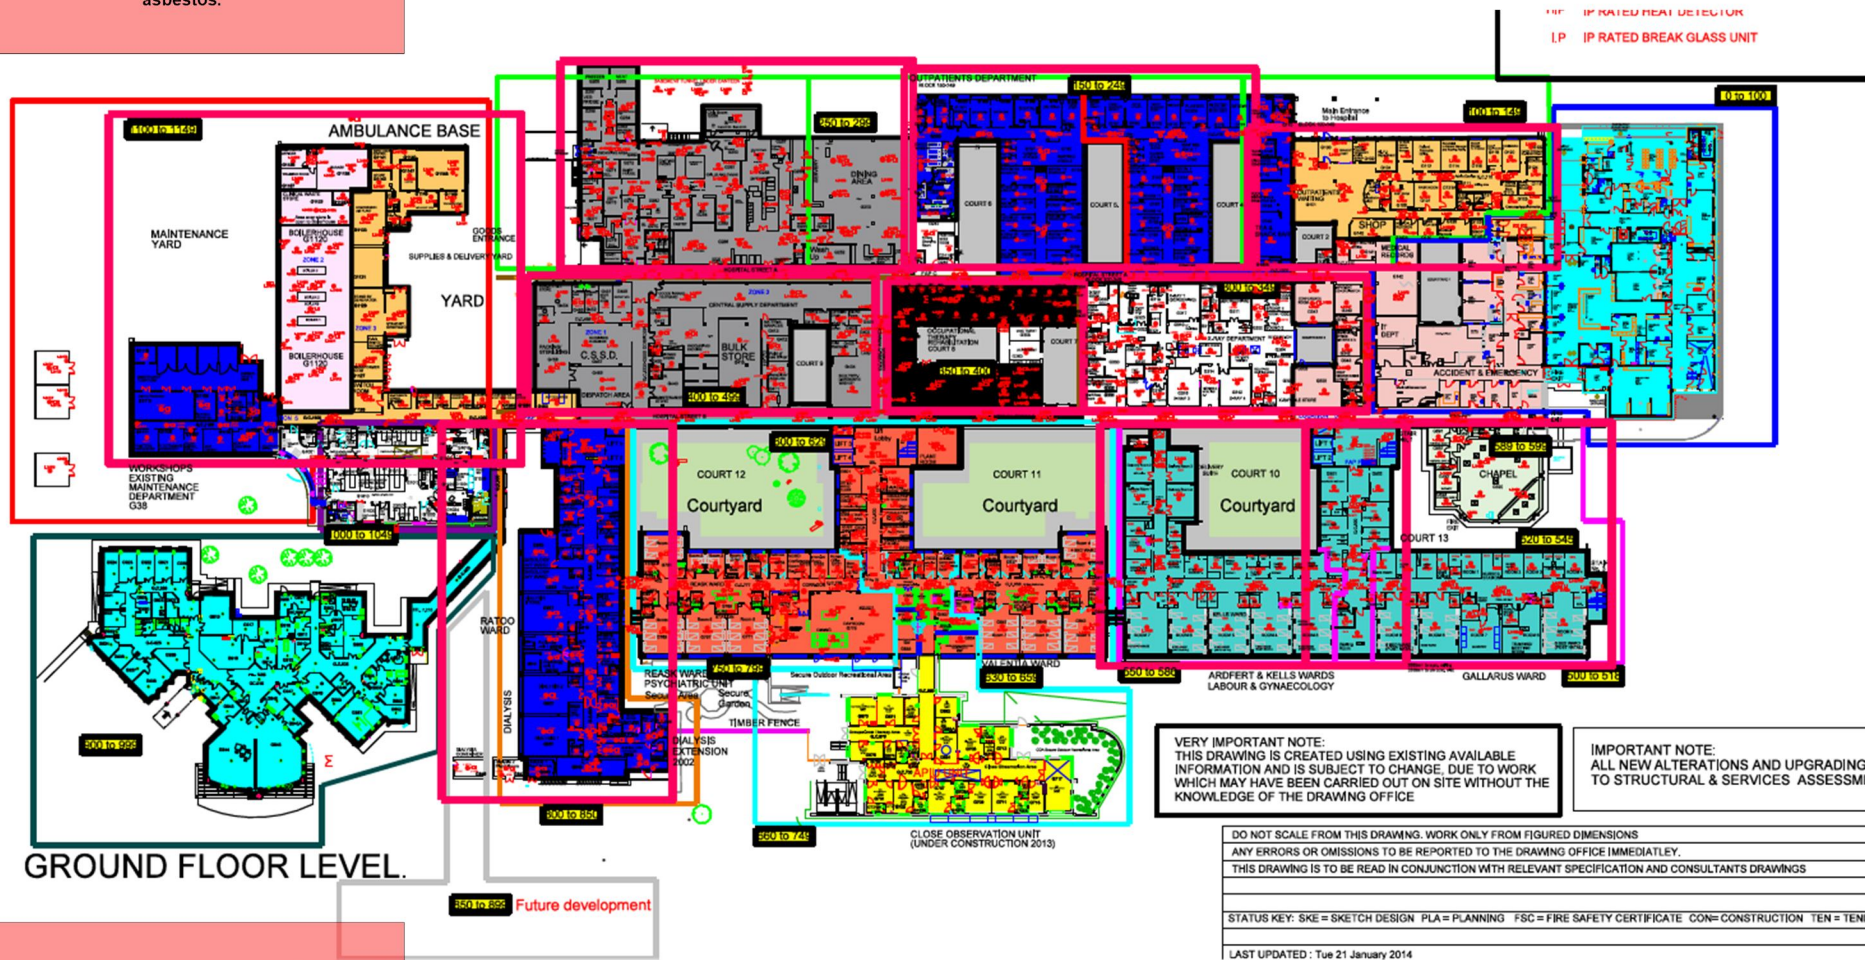
Vinyl floor tiles throughout the building contain asbestos.

Pipework gaskets throughout the building contain asbestos.

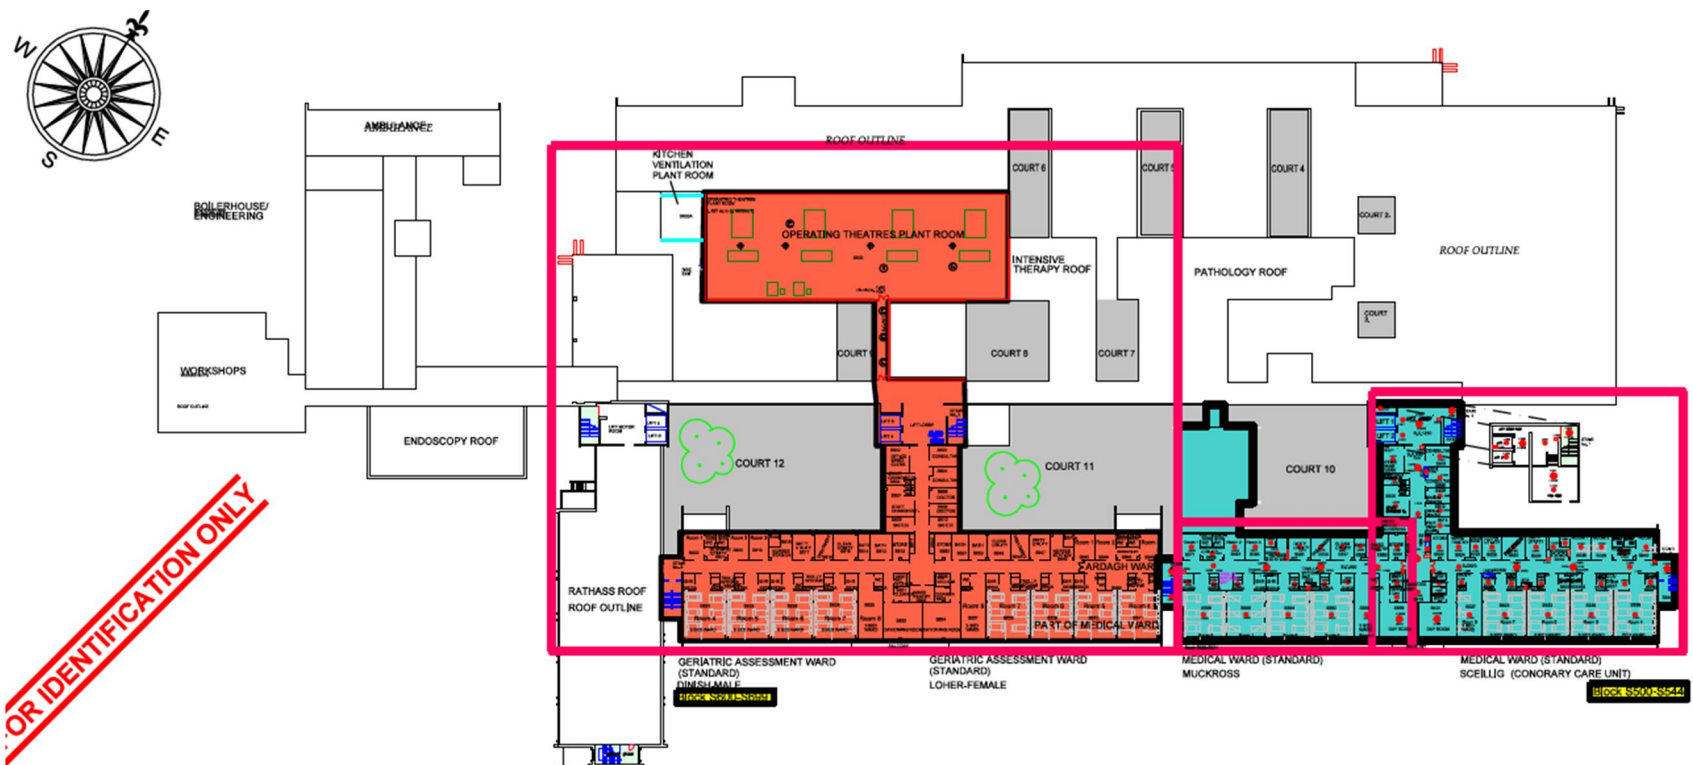
## LEVEL 2 - SECOND FLOOR LEVEL.

Vinyl floor tiles throughout the building contain asbestos.
