# BUILDING CONDITION ASSESSMENT REPORT

**Fairhill Lodge, Dungloe, Co. Donegal**

**7<sup>th</sup> June 2025**

Project Title: Assessment of Fairhill Lodge, Dungloe, Co. Donegal

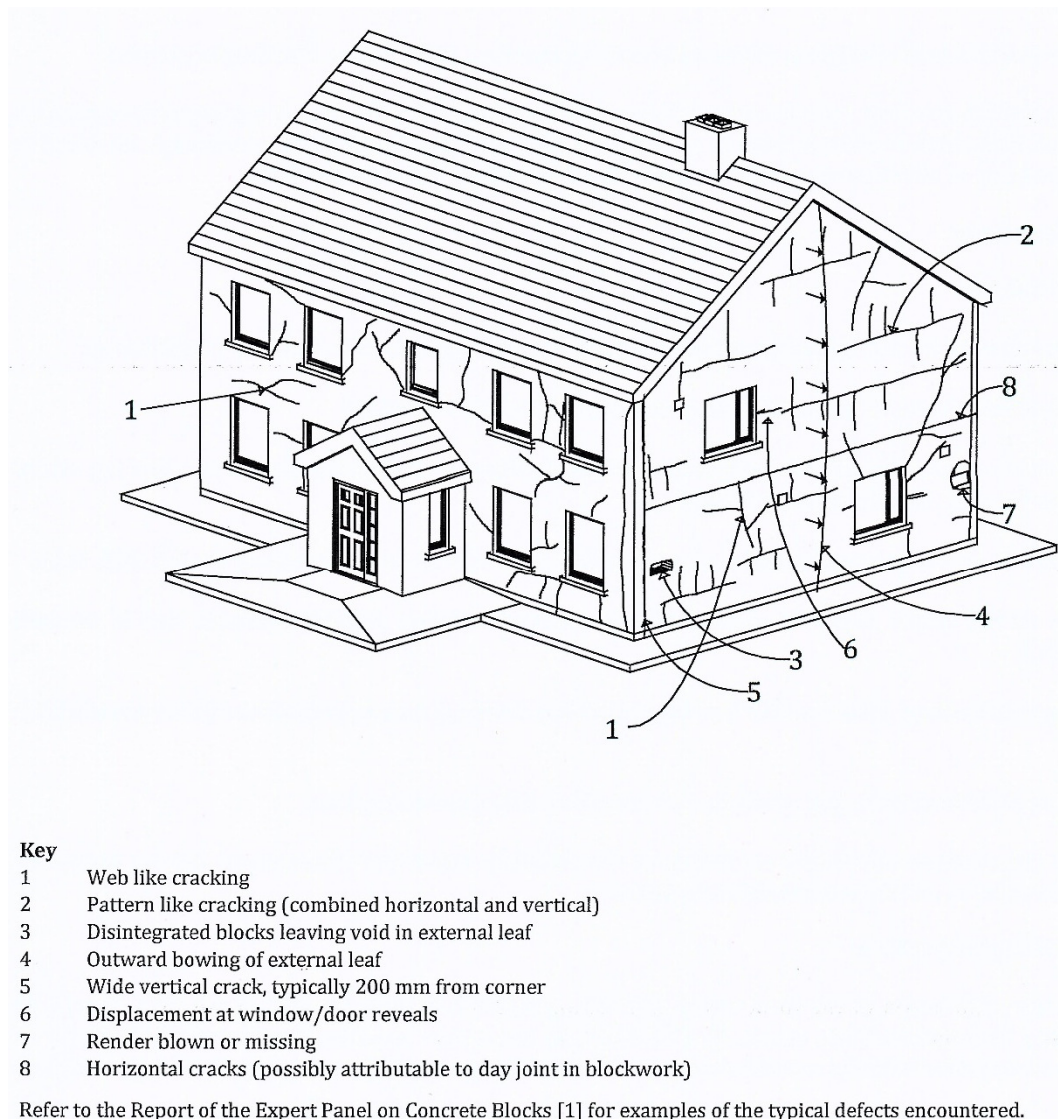
Figure 2 - Typical Defects (Extract from I.S 465:2018+A1:2020)

The property inspected showed similar crack patterns to those suggested in I.S. 465:2018+A1:2020 (See figure 2 for details on crack patterns).
