# SJK Engineering & Surveying Ltd.

**Client:** HSE South Capital and Estates,

**Premises:** Ballyseedy House, Ballyseedy, Tralee, Co. Kerry V92RX49

**Report:** This report is based on a visual only and did not entail the opening up of works which had been fully or substantially completed, were inaccessible or otherwise obscured from view on the said date of inspection of the 9<sup>th</sup> of July 2026. No planning documents were available to me on the day of my inspection.

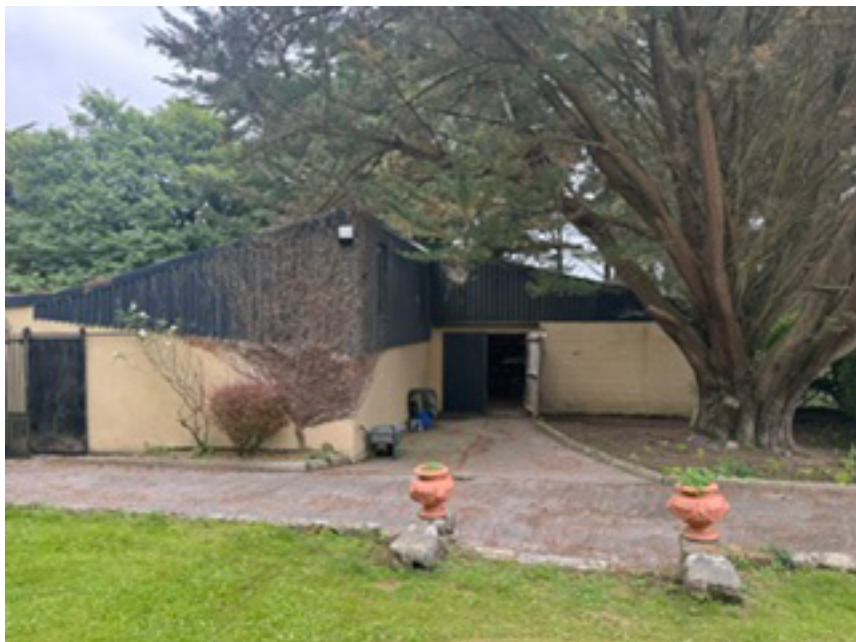
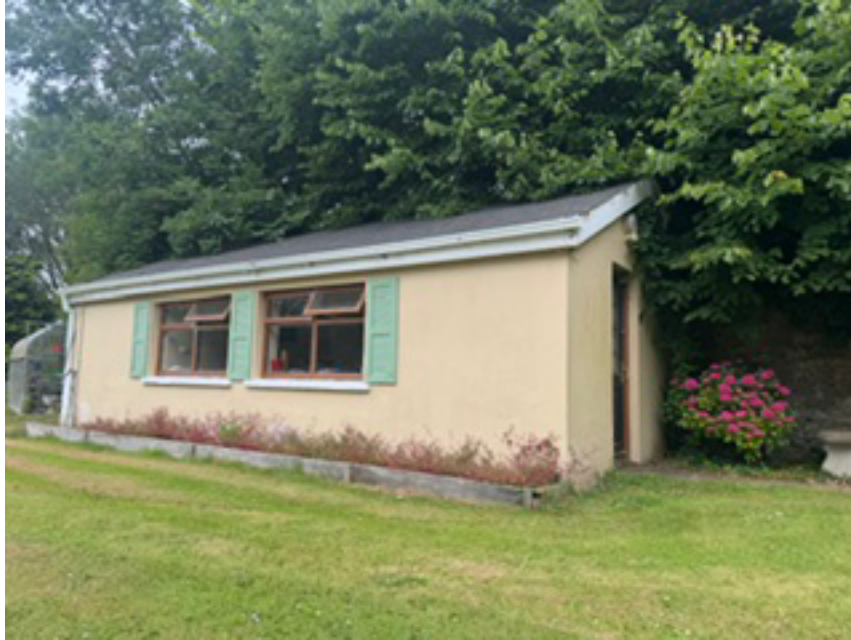
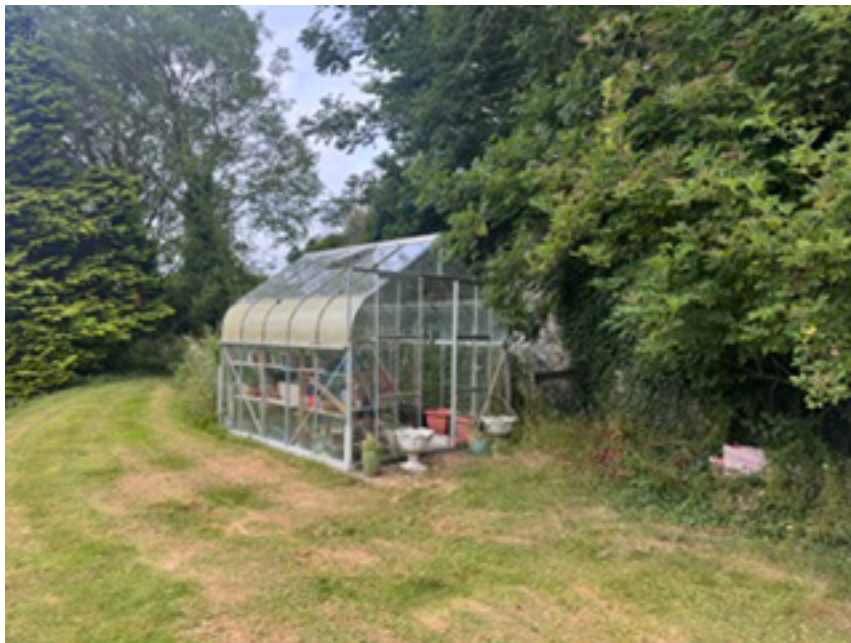
Front Elevation

The external sheds would not qualify as exempted development.

An up-to-date Opinion on Compliance with Planning and Building Regulations should be supplied with contract documents for the dwelling / sheds and glasshouse as constructed and should also certify if the drainage systems have been constructed in compliance with planning requirements.

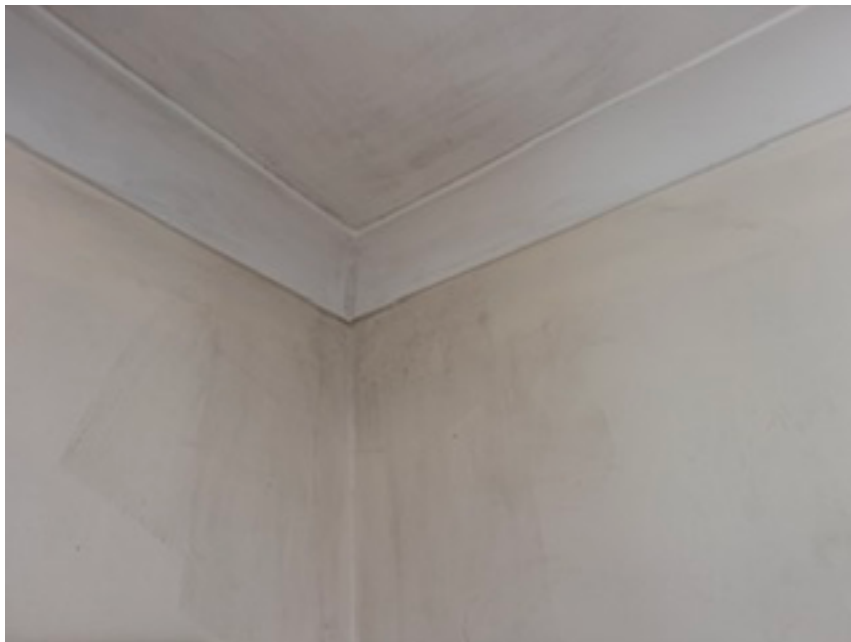
- Slight plaster crack at front left corner.

- Slight plaster crack internally at this front left corner location.

The cracks that are present are not a structural concern in their present condition. I would recommend that some improvement works be undertaken to improve the structural integrity of the roof which in turn will remove the risk of horizontal pressure being incorrectly applied to the external walls which can result in cracking as identified above at high levels on the external walls.

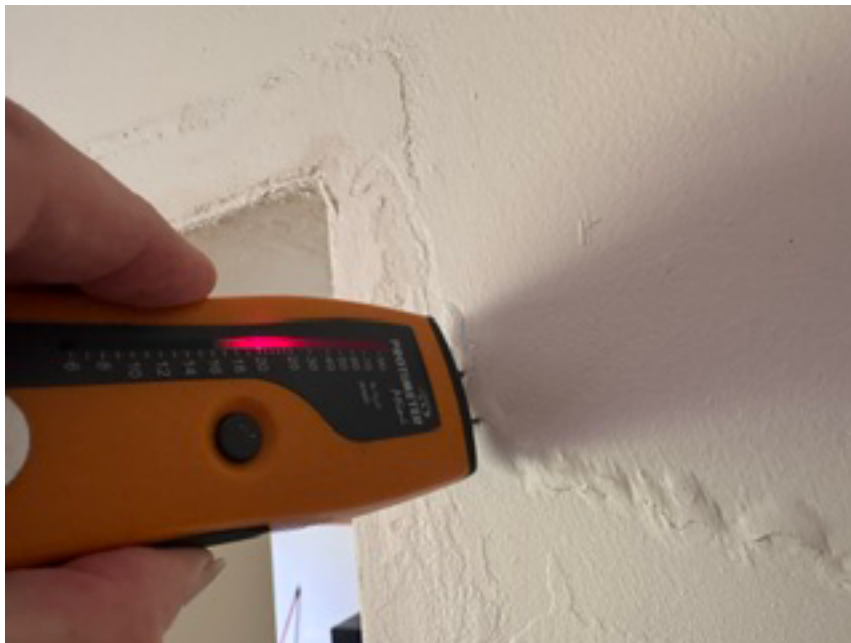
If there was a RH of 70 to 85% in the property there would be significant problems with mould growth on the walls and ceilings, which is occurring in the dwelling. This might have occurred from the dwelling not being ventilated / insulated property and the risks are increased if moisture in the dwelling is high. The fungus growth should be treated, and the house should be kept ventilated. If the problem returns, then improvement works should be considered to improve the thermal properties of the dwelling.

There are no wall vents installed to the habitable rooms as per the requirements of Part F of the Building Regulations where improvement works should be considered / undertaken especially as the thermal values of the dwelling appear to have been improved.

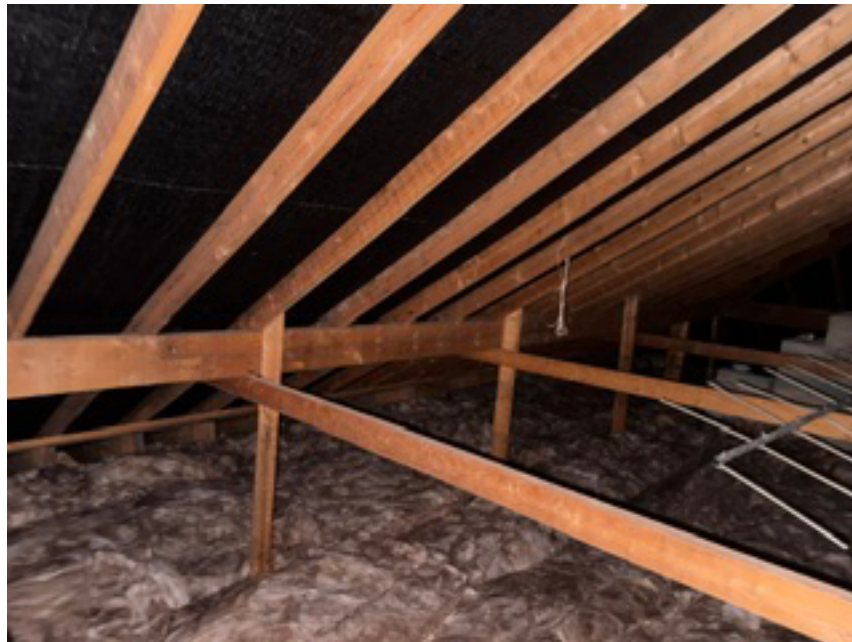
Lack of support to purlins should be improved to improve the structural integrity of the roof

I would recommend that some additional supports are installed vertically under the hip / valley rafters to give some additional support to these rafters.

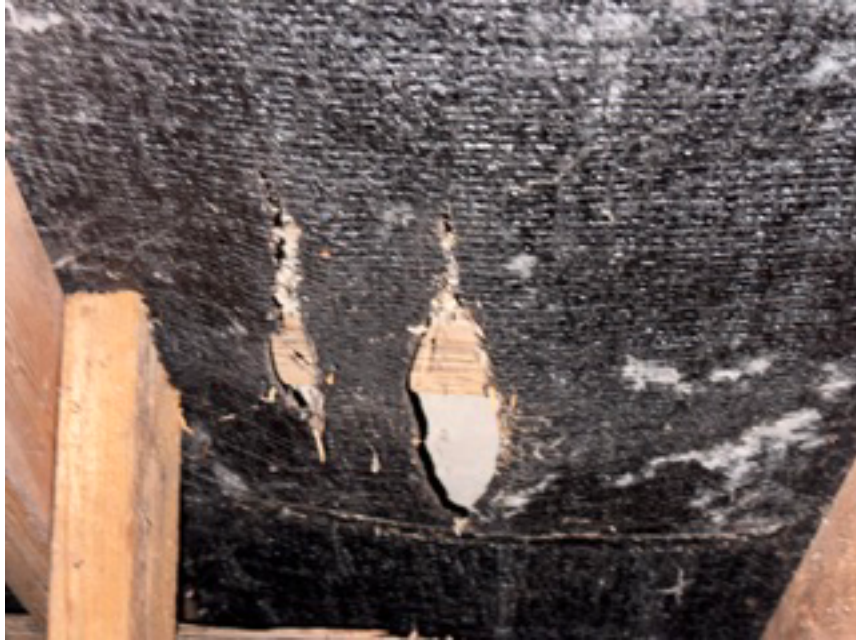
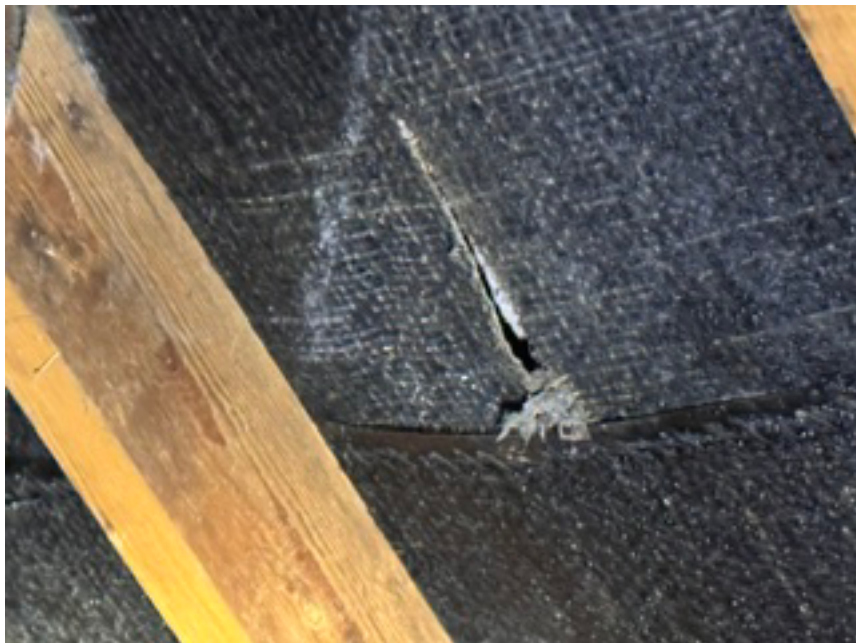
The valley at this location is damaged / decayed and structural repairs at this location are required

Repairs / improvement works to the chimney stacks and structural repairs to the rear valley of roof are required.

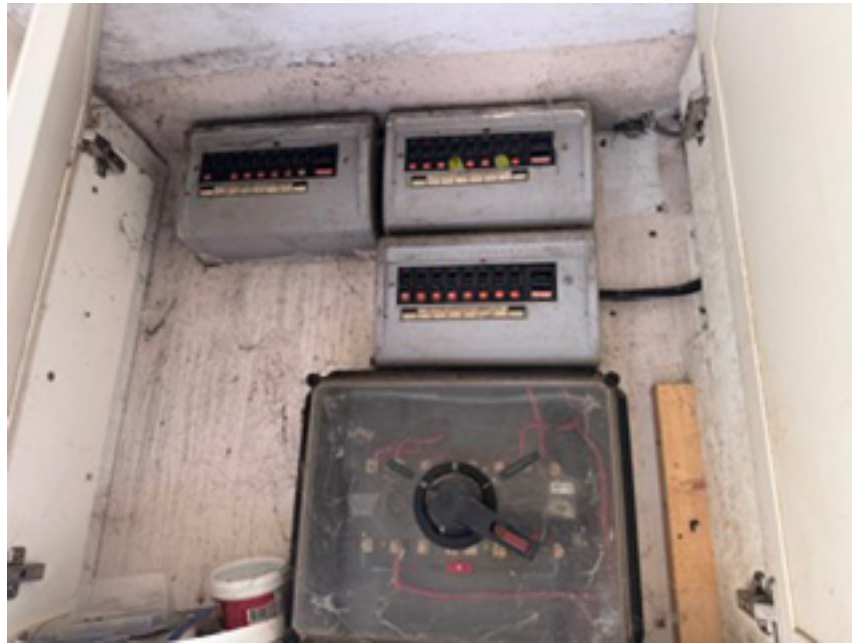
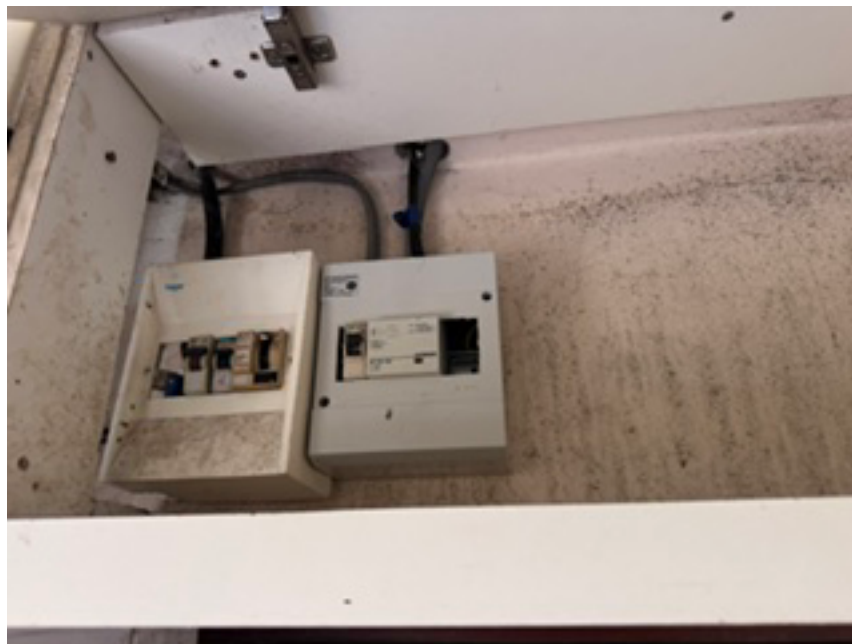
**Services -** Electricity boards in place in the hallway. The quality of the power supply to the sheds / dwelling should be clarified as three phase power might be installed?

I would advise that smoke / heat alarms be installed as part of any upgrade works to the full dwelling for improved safety in accordance with today's regulations.

Due to age of dwelling, I would recommend that all electrics / wiring in the house should be checked by a qualified electrician to ensure that everything is in good order and that no repairs or upgrading works are required.

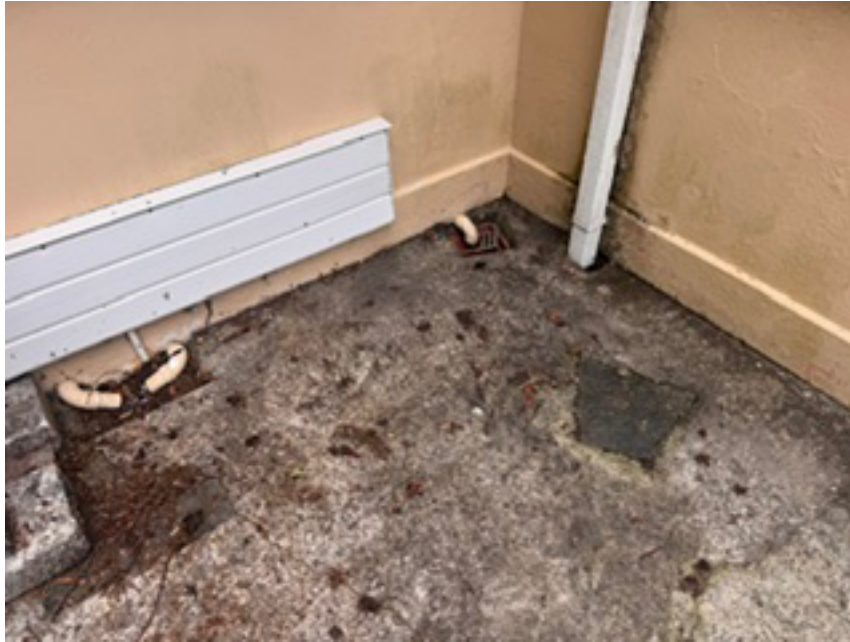
The storm water discharge location from the dwelling cannot be qualified and there is a high risk that the storm water is discharging to the foul system. If this is the case a new storm drainage system would have to be installed.

I believe that that the drainage system that serves the dwelling will have to be upgraded as part of any future works to the property and planning permission for these works will be required.

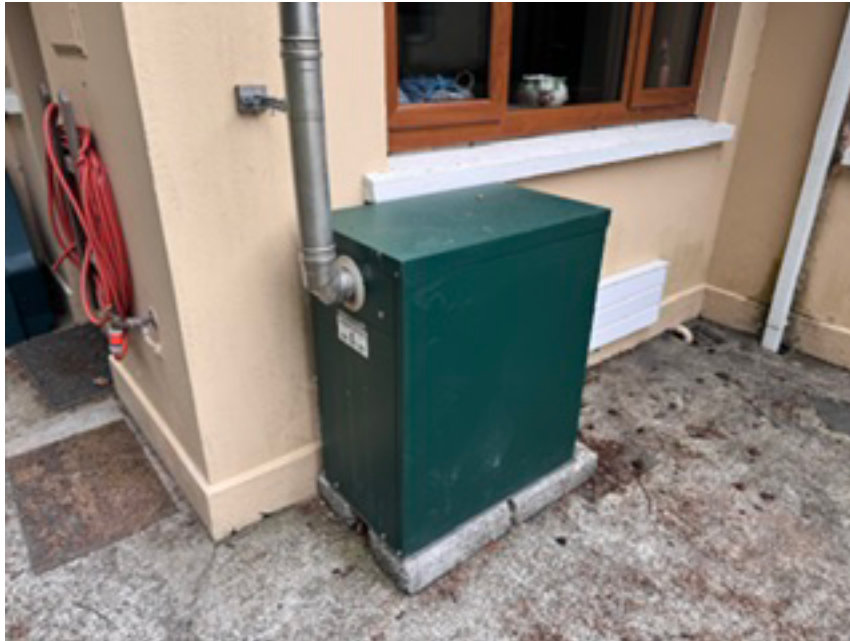
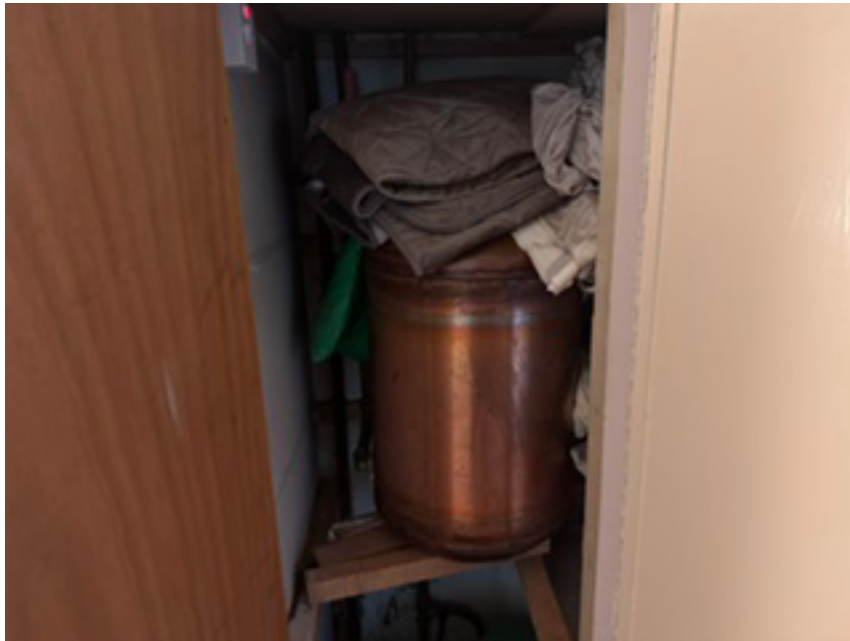
**Heating -** The heating system in the dwelling is an oil boiler located to rear of dwelling with radiators internally and hot water cylinder in hot-press.

As I am not a qualified plumber, I would recommend that the plumbing and heating systems for the dwelling should be inspected / serviced by a suitable qualified plumber to clarify the condition of all systems installed and to clarify the condition of oil line and oil tank.

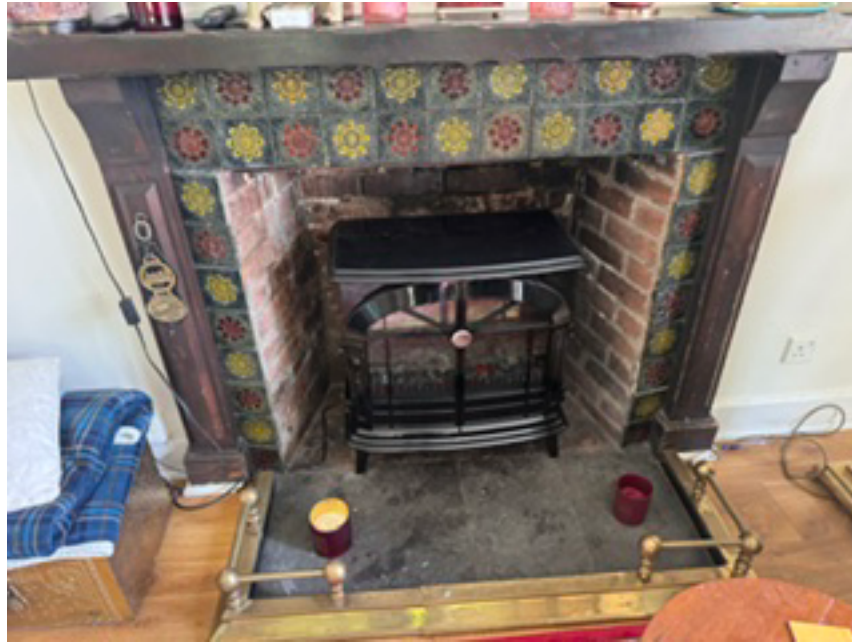
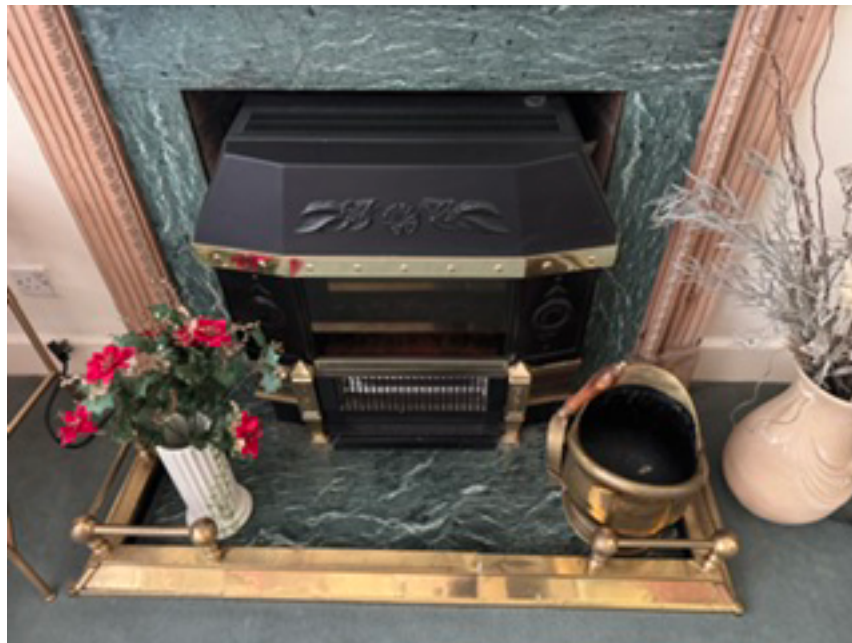
Fireplaces are not in use and if they are to be used in the future the flues should be cleaned and inspected to clarify their condition to ensure that re lining of the flues is not required.

Any flue not in use should be vented.

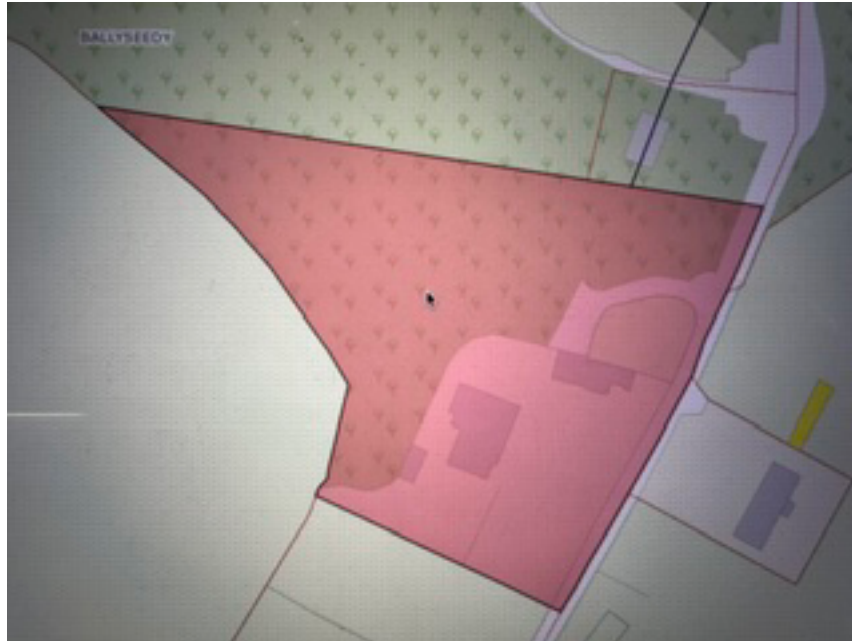
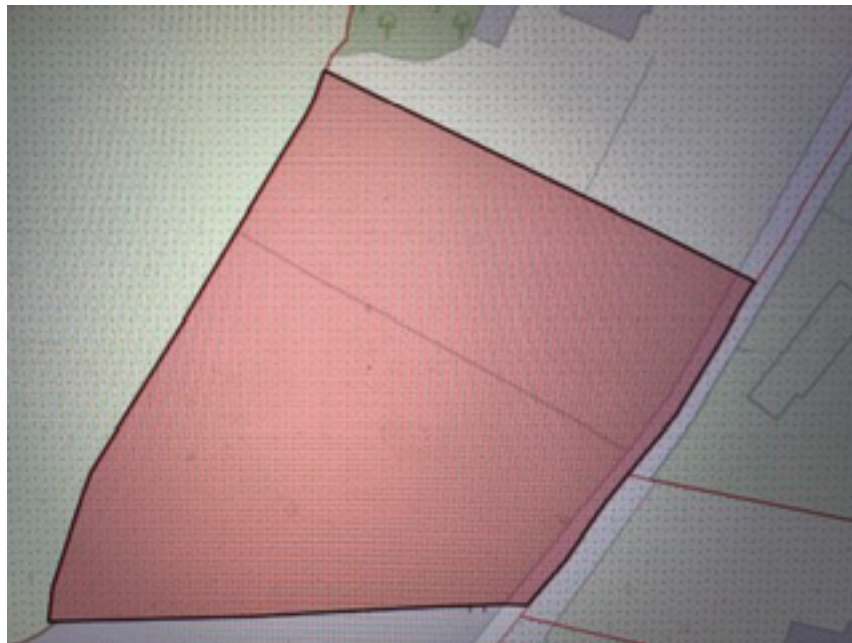
The boundaries are not readily accessible due to overgrowth and cannot be surveyed with a tape.

The eastern boundary of the folio is defined by the public road and the western boundary appears to be defined by a stone boundary wall. The condition of the stone wall cannot be visually inspected.

Due to the size of the site and accessibility on site I would recommend that GPS survey works are undertaken to clarify if the boundaries as defined on the ground, where access is available, are in compliance with the Folio maps that pertain to the dwelling.
