### **SURVEY, SAMPLING AND ASSESSMENT FOR ASBESTOS CONTAINING MATERIALS**

**Bailieborough Community School**

**CMETB**

**Report Date: September 2025**

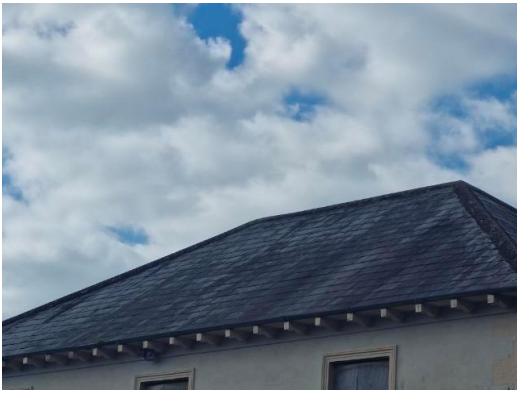
| Type | NAD | |
| Material | Natural quarry slates<br>Cement Product | |
| Location | PE hall<br>External Main roof 026 | |
