### **SURVEY, SAMPLING AND ASSESSMENT FOR ASBESTOS CONTAINING MATERIALS**

**Breifne College  
Cootehill Road  
Cullies  
Co. Cavan**

**BOM Breifne College**

**Report Date: June 2023**

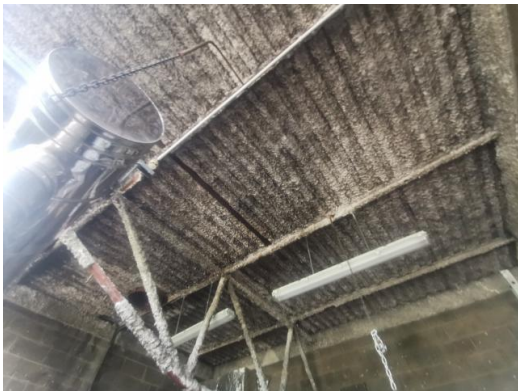
| Type | NAD | |
|---|---|---|
| Sample No. | S004 | |

| Type | NAD | |
| Material | Spray coating to the ceiling | |
| Location | Breifne College<br>Ground Floor Boiler room 004 | |

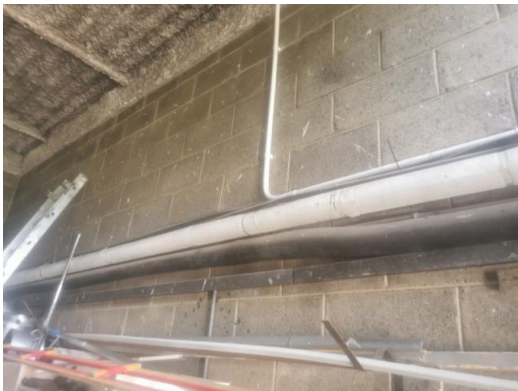
| Type | NAD | |
|---|---|---|
| Sample No. | S005 | |

| Type | NAD | |
| Material | Cloth wrapped pipe insulation.<br>Woven Product | |
| Location | Breifne College<br>Ground Floor Boiler room 004 | |

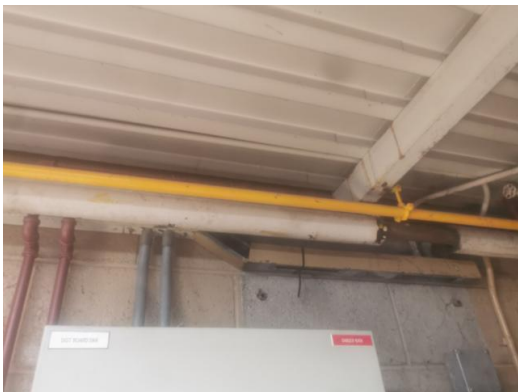
| Type | NAD | |
| Material | Pipe insulation | |
| Location | Breifne College<br>Ground Floor Science labs and<br>prep rooms 005 | |

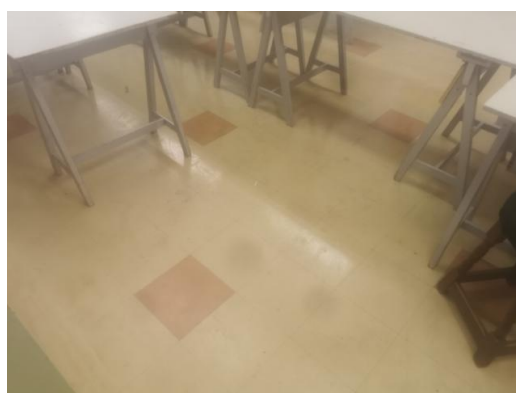
| Type | NAD |
|---|---|
| Sample No. | S012 |

| Type | NAD |
| Material | Mastic to vinyl floor tiles<br>Bituminous Product |

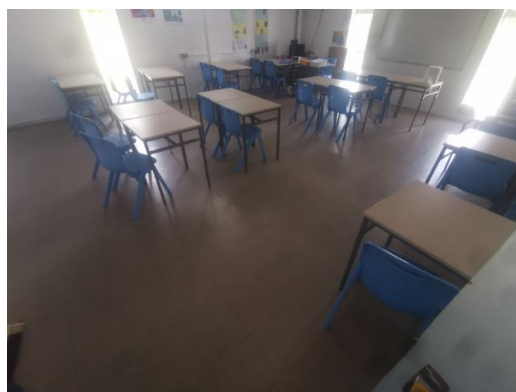
| Type | NAD |
|---|---|
| Sample No. | S013 |

| Type | NAD |
| Material | Mastic to vinyl floor tiles<br>Bituminous Product |

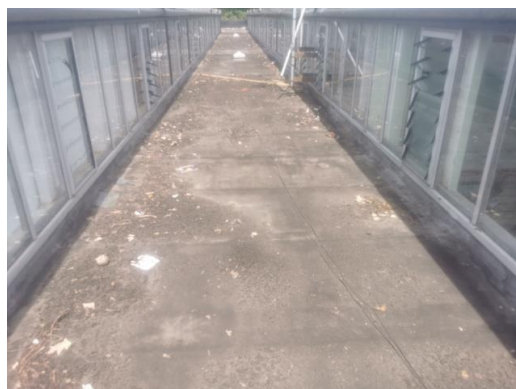
| Type | NAD |
|---|---|
| Sample No. | S002 |

| Type | NAD |
| Material | Felt<br>Bituminous Product |

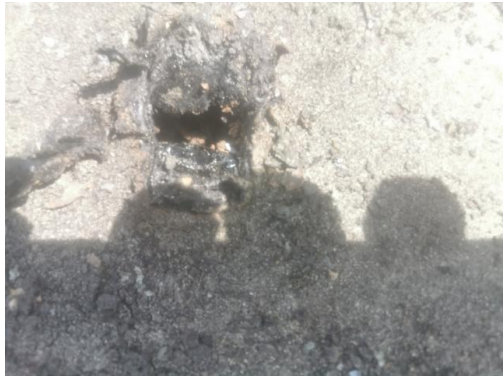
| Type | NAD | |
|---|---|---|
| Sample No. | S003 | |

| Type | NAD | |
| Material | Cork board beneath felt.<br>Insulating Board | |
| Location | Breifne College<br>External Flat roofs 002 | |

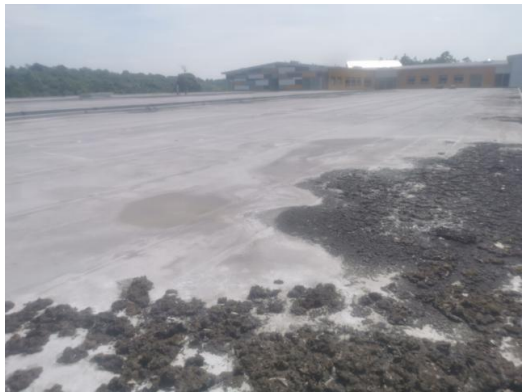
| Type | NAD | |
| Material | Roof membrane | |
| Location | Breifne College<br>External Flat roofs 003 | |
