ATTIQUIN    CASTLEMARTYR    CO. CORK		
Tel: 021 4667073    Email: info@jbarch.ie    www.jbarch.ie		
Job Title: REPAIR / UPGRADE WORKS AT KINSALE REGIONAL MUSEUM		
Client: CORK COUNTY COUNCIL		
Drg Title: COMPOUND PLAN		
Scale: 1:250@A3	Drg No.:	
Date: MAY 2026	250102-T-001	
Drn: MS		
<b>TENDER DRAWINGS</b>

<b>James Bourke Architects</b>	
ATTIQUIN    CASTLEMARTYR    CO. CORK Tel: 021 4667073    Email: info@jbarch.ie    www.jbarch.ie	
<b>Job Title:</b> REPAIR / UPGRADE WORKS AT KINSALE REGIONAL MUSEUM	
<b>Client:</b> CORK COUNTY COUNCIL	
<b>Drg Title:</b> SITE PLAN	
<b>Scale:</b> 1:100@A3	<b>Drg No.:</b> 250102-T-002
<b>Date:</b> APRIL 2026	
<b>Drn:</b> MS	
<b>TENDER DRAWINGS</b>

<b>JAMES BOURKE ARCHITECTS</b>	
<b>James Bourke Architects</b>	
ATTIQUIN    CASTLEMARTYR    CO. CORK	
Tel:021 4667073    Email:info@jbarch.ie    www.jbarch.ie	
<b>Job Title:</b> REPAIR / UPGRADE WORKS AT KINSALE REGIONAL MUSEUM	
<b>Client:</b> CORK COUNTY COUNCIL	
<b>Drg Title:</b> FLOOR PLANS	
<b>Scale:</b> 1:100@A3	<b>Drg No.:</b> 250102-T-003
<b>Date:</b> APRIL 2026	
<b>Drm:</b> MS	
<b>TENDER DRAWINGS</b>

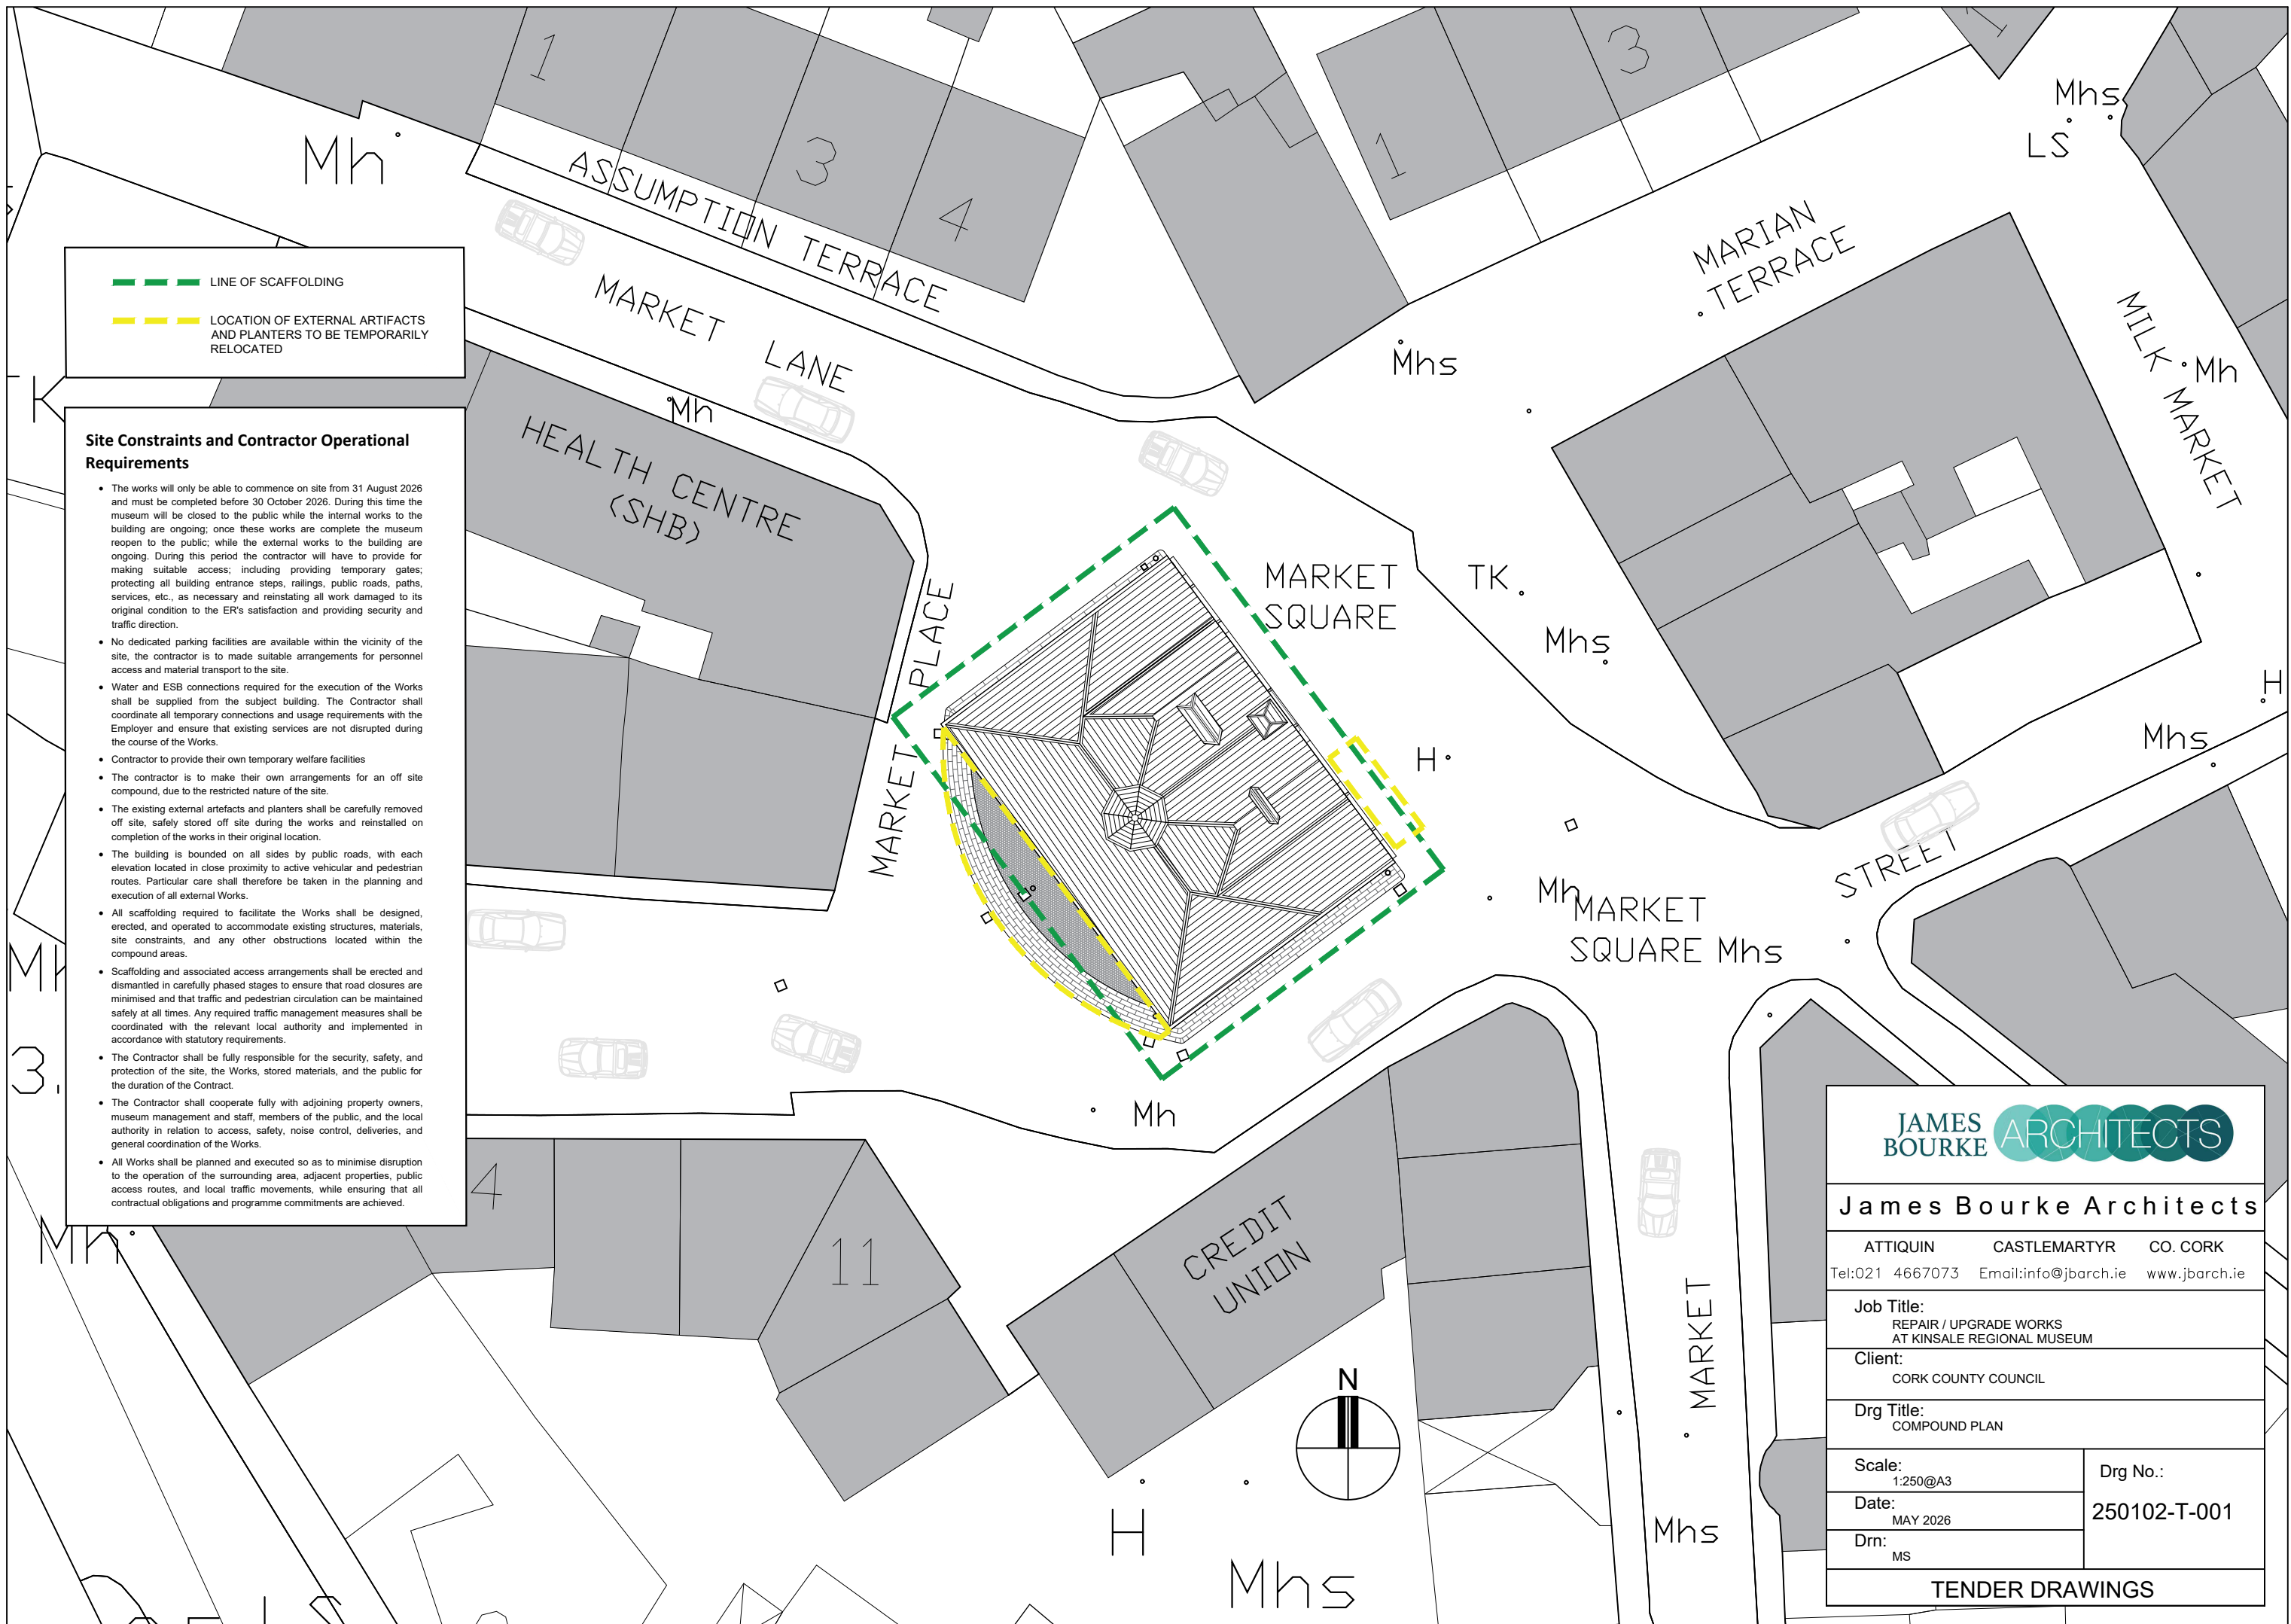
- LINE OF SCAFFOLDING
- LOCATION OF EXTERNAL ARTIFACTS AND PLANTERS TO BE TEMPORARILY RELOCATED

- The existing external artefacts and planters shall be carefully removed off site, safely stored off site during the works and reinstalled on completion of the works in their original location.

- All scaffolding required to facilitate the Works shall be designed, erected, and operated to accommodate existing structures, materials, site constraints, and any other obstructions located within the compound areas.

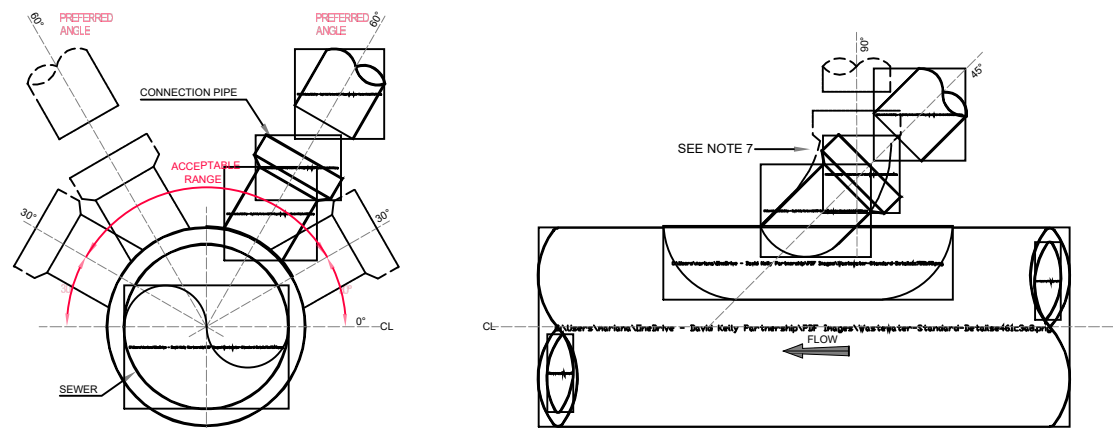
CROSS-SECTIONAL VIEW OF SEWER

TYPICAL 45° SADDLE CONNECTION  
(Existing Sewers Only)

6. CONNECTION USING SADDLES MAY ONLY BE USED IN EXCEPTIONAL CIRCUMSTANCES AND ONLY TO WHERE THE CONNECTION IS TO AN EXISTING SEWER. CONNECTIONS MADE WITH SADDLE FITTINGS SHALL BE MADE BY CUTTING AND SAFELY REMOVING A CORE FROM THE PIPE AND JOINTING THE SADDLE FITTING TO THE PIPE IN ACCORDANCE WITH THE MANUFACTURER'S INSTRUCTIONS TO ENSURE A WATERTIGHT JOINT. THE CONNECTING PIPE SHALL NOT PROTRUDE INTO THE SEWERS.

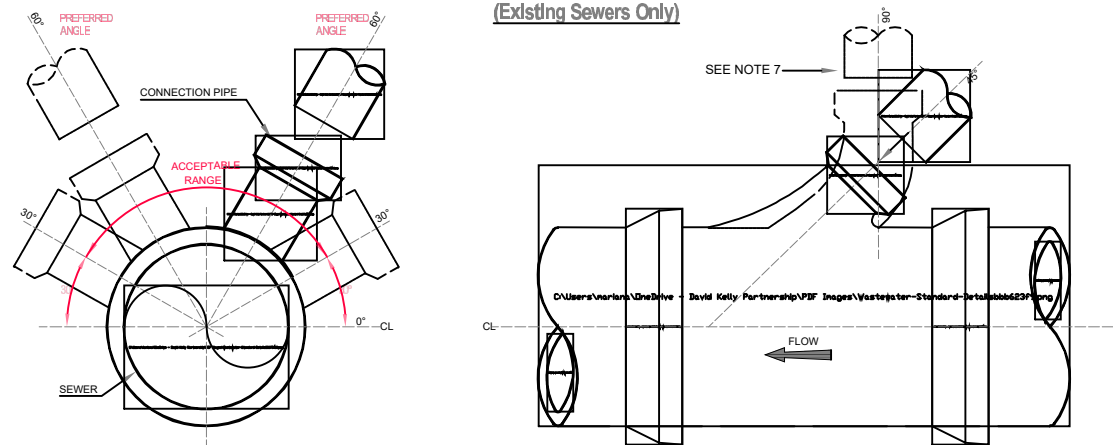
CROSS-SECTIONAL VIEW OF SEWER

45° "Y" BRANCH

TYPICAL SEWER / SERVICE PIPE CONNECTION @ NTS  
(IRISH WATER REF. STD-WW-04)

7. THE USE OF 90° "Y"-BRANCH OR SADDLE CONNECTIONS TO THE SEWER MAY BE ALLOWED, PROVIDED THE SADDLE OR BRANCH INCORPORATES A SWEEP TEE CONNECTION TOWARDS THE DIRECTION OF FLOW OF THE SEWER.
