PROPOSED SOUTH ELEVATION  
Scale 1:100

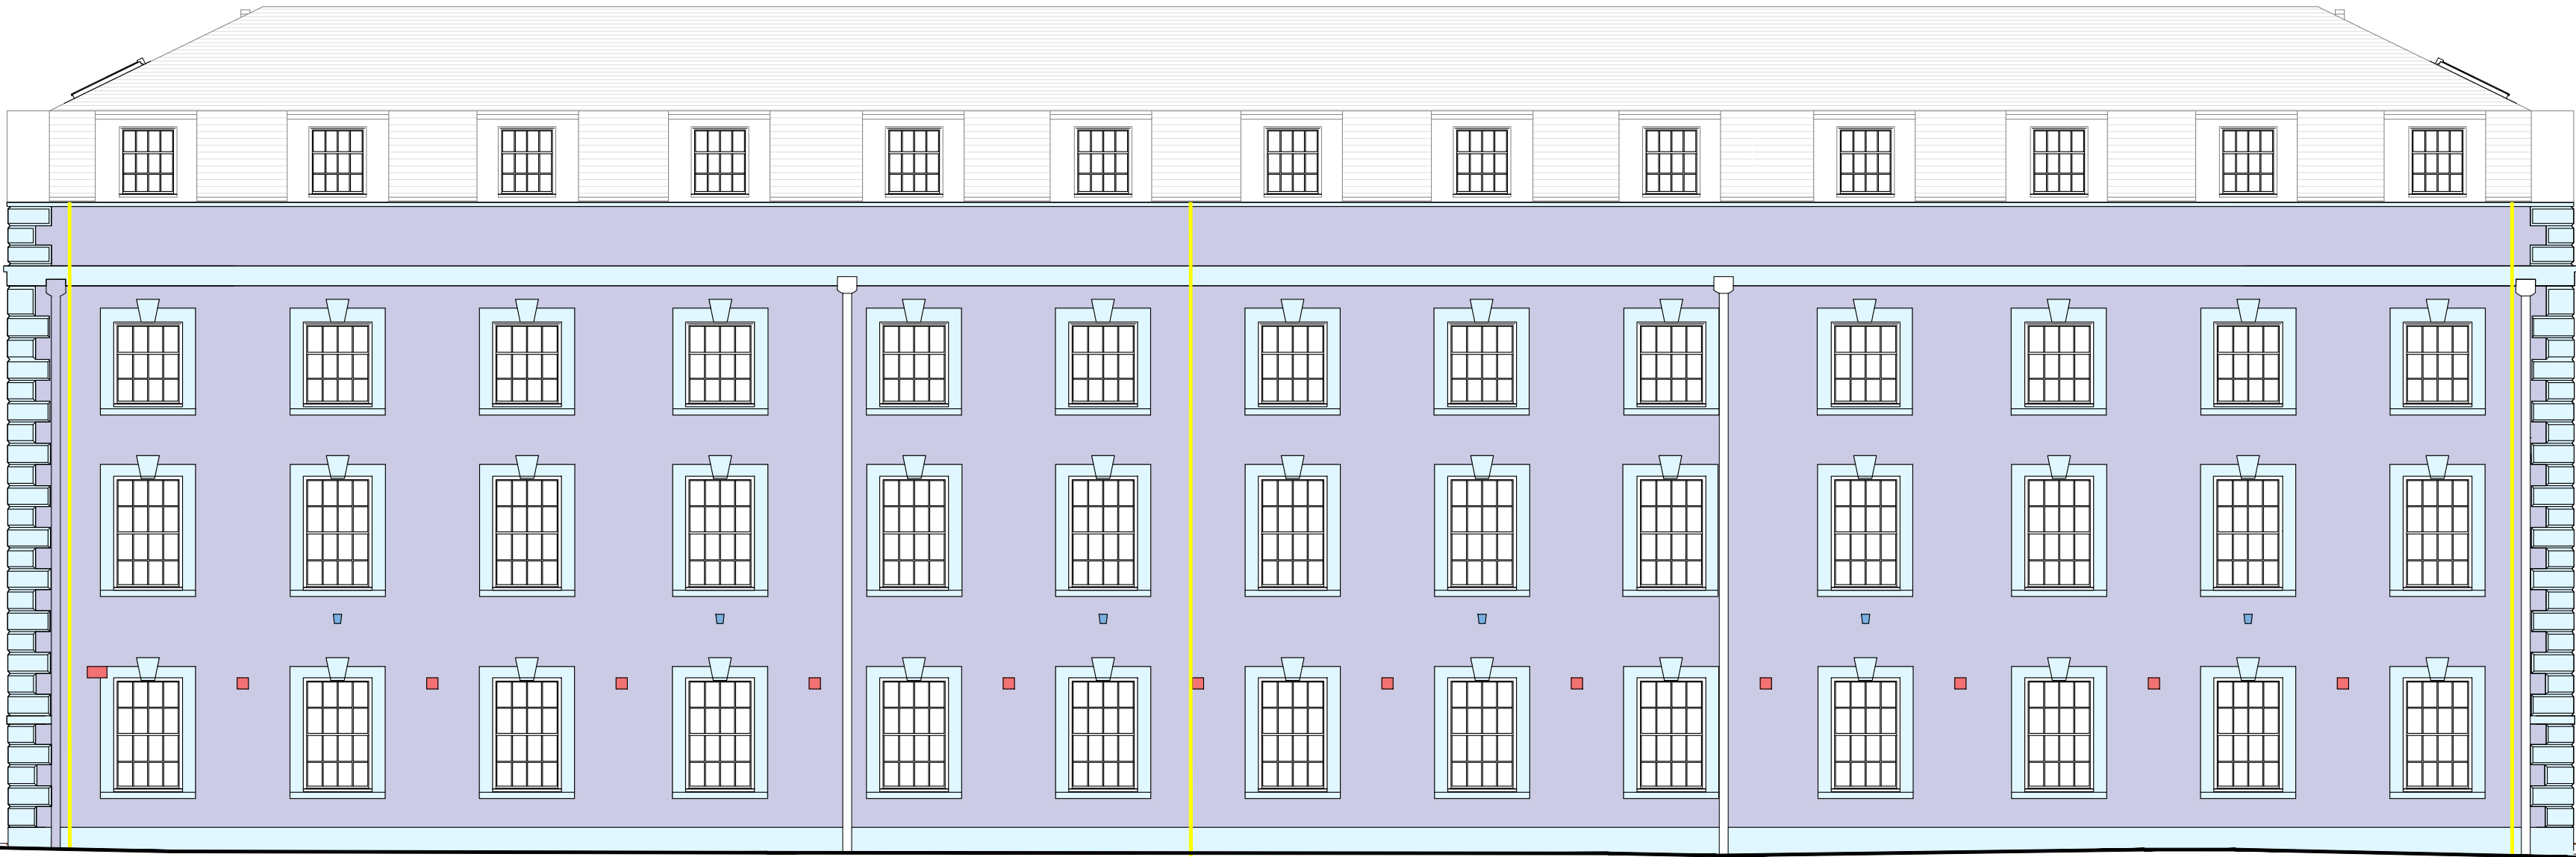
- ▼RIDGE  
FFL 18.045 m
- ▼LEVEL 03  
FFL 13.367 m
- ▼LEVEL 02  
FFL 10.352 m
- ▼LEVEL 01  
FFL 7.050 m
- ▼GROUND FLOOR LEVEL  
FFL 3.080 m
