# **Galway Simon Community – Market Street**

Residential Development at 13 Market Street,  
Galway City

Engineering Desk Study

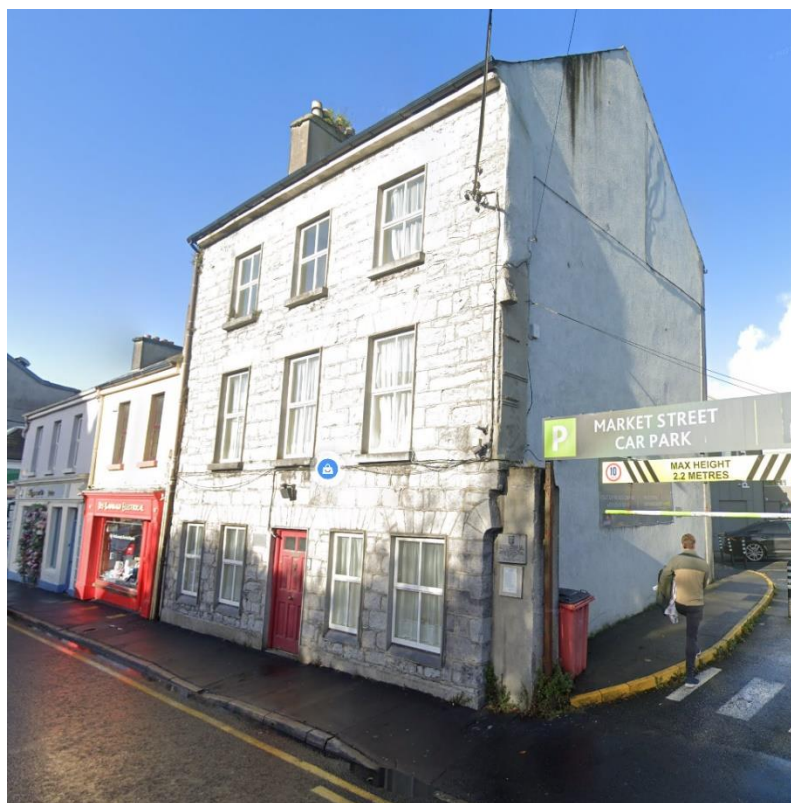
*Figure 1-2 Existing Building, Market Street Galway*

The building is a 4-storey building. The building is vacant but was previously used as long-term homeless accommodation by the Society of St. Vincent de Paul. It is laid out into small cellular one person rooms, with shared bathroom facilities at 1<sup>st</sup>, 2<sup>nd</sup> and 3<sup>rd</sup> floor level. The 3<sup>rd</sup>/top floor of accommodation is in the original attic space. The bottom floor contains shared living areas and kitchen facilities.

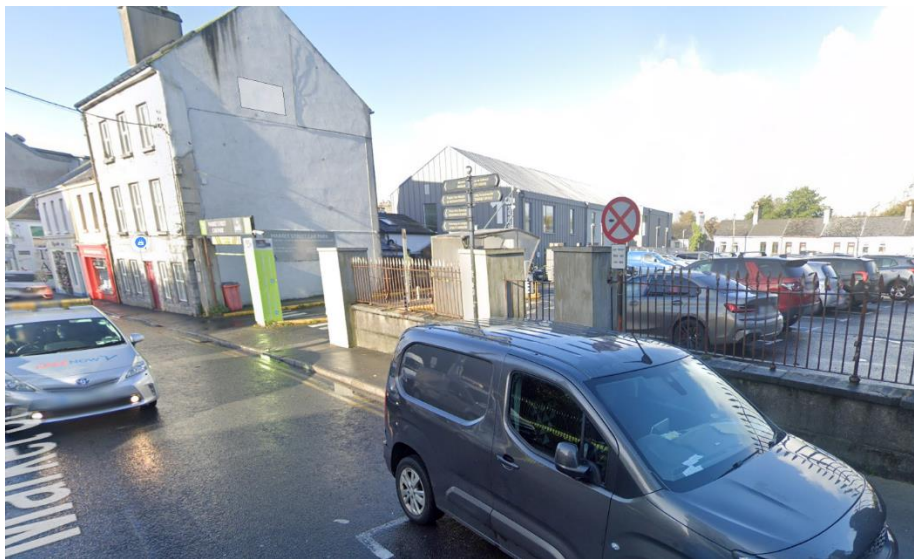
*Figure 2-3 View of Porterhouse building as it currently exists*

The building is very close to the "Portershed" offices to the rear. This building is clad but may be very old because buildings occupying that footprint are shown on the historic OS Maps and older photos of the site indicate a masonry building. Refer to Figure 2-3 and Figure 2-4.

It is likely that structural repairs were carried out during the refurbishment of the Portershed

but given its age it will still be brittle and potentially vulnerable to damage. The proximity to this building, the access constraints and the restricted space available on the site will result in construction challenges that will be require careful design and execution. Written agreements or at least outreach to and ongoing liaison with the neighbours will be required in relation to boundary walls. Temporary Works to protect structures and other perhaps weathering and reinstatement measures may be required. Galway Simon may consider enabling the project by demolishing the structures to the rear in a separate phase but this is likely to be less cost effective that a single phase project.

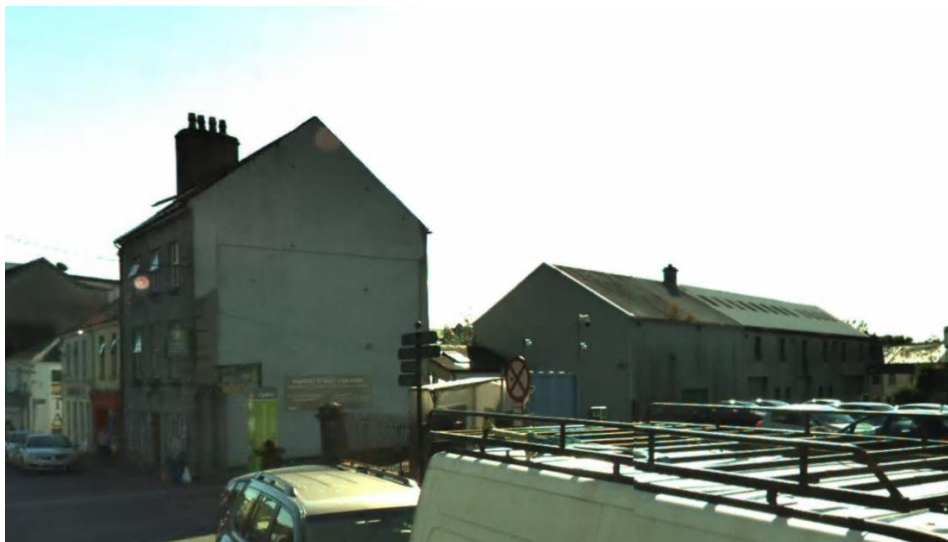
*Figure 2-4 View of Porterhouse prior to refurbishment*

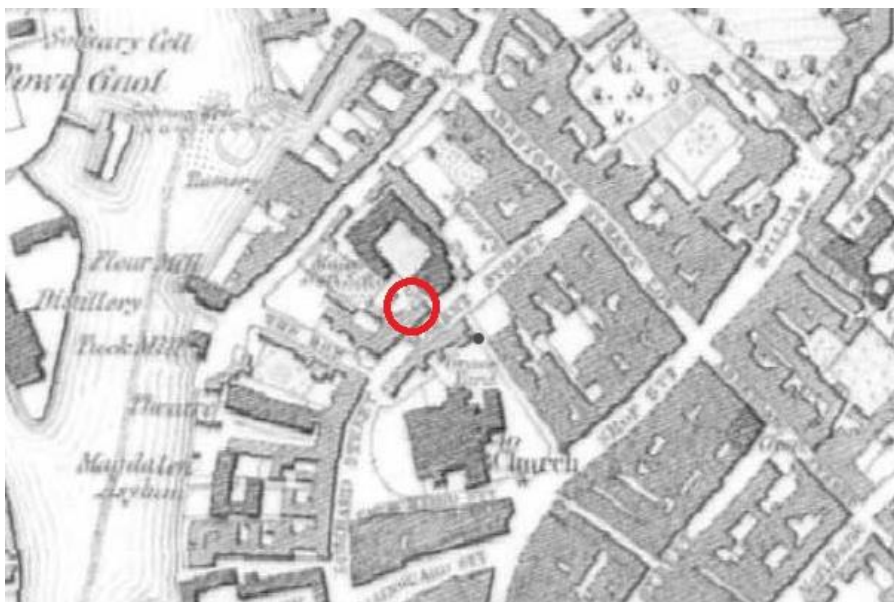
Figure 3-1 6" Maps - First Edition (1829-1841), OSI

Reference was made to historical Ordnance Survey maps of the area. The map shown in Figure 3-1 below indicates that there was a structure on the site in the early part of the 19<sup>th</sup> century. There is an old rubble wall at the northwest of the car park. This is likely to be remains of the structure shown on the map below on what is the northeastern boundary to the car park.

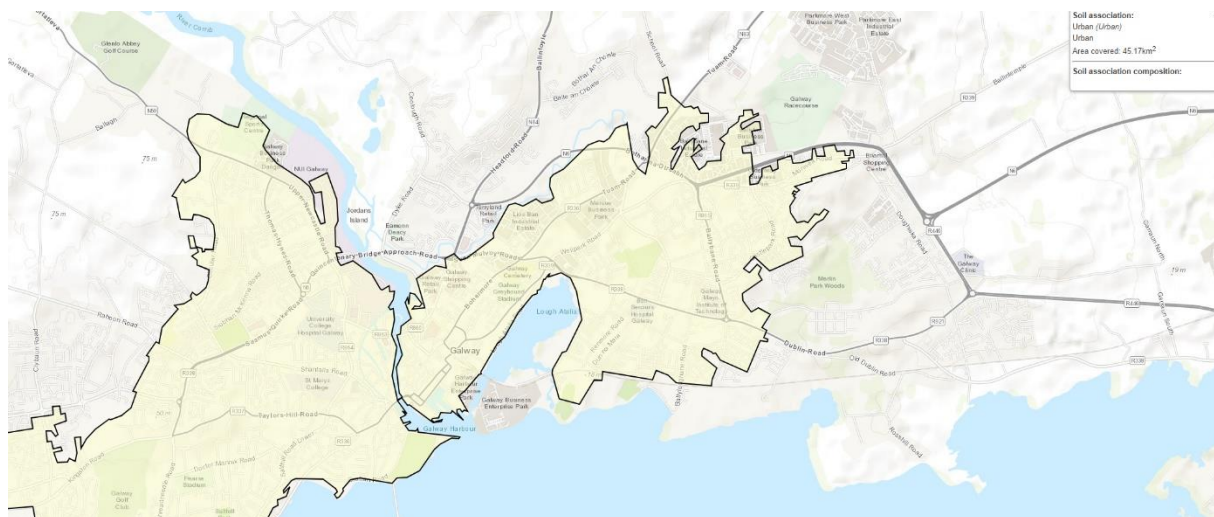
*Figure 3-7 Soils Map indicating Coarse Loamy material surrounding, Teagasc*
