Ballingaddy Wall Reconstruction

Project Brief & Instruction to Tenderers

251262-PUNCH-XX-XX-D003-RO

September 2026

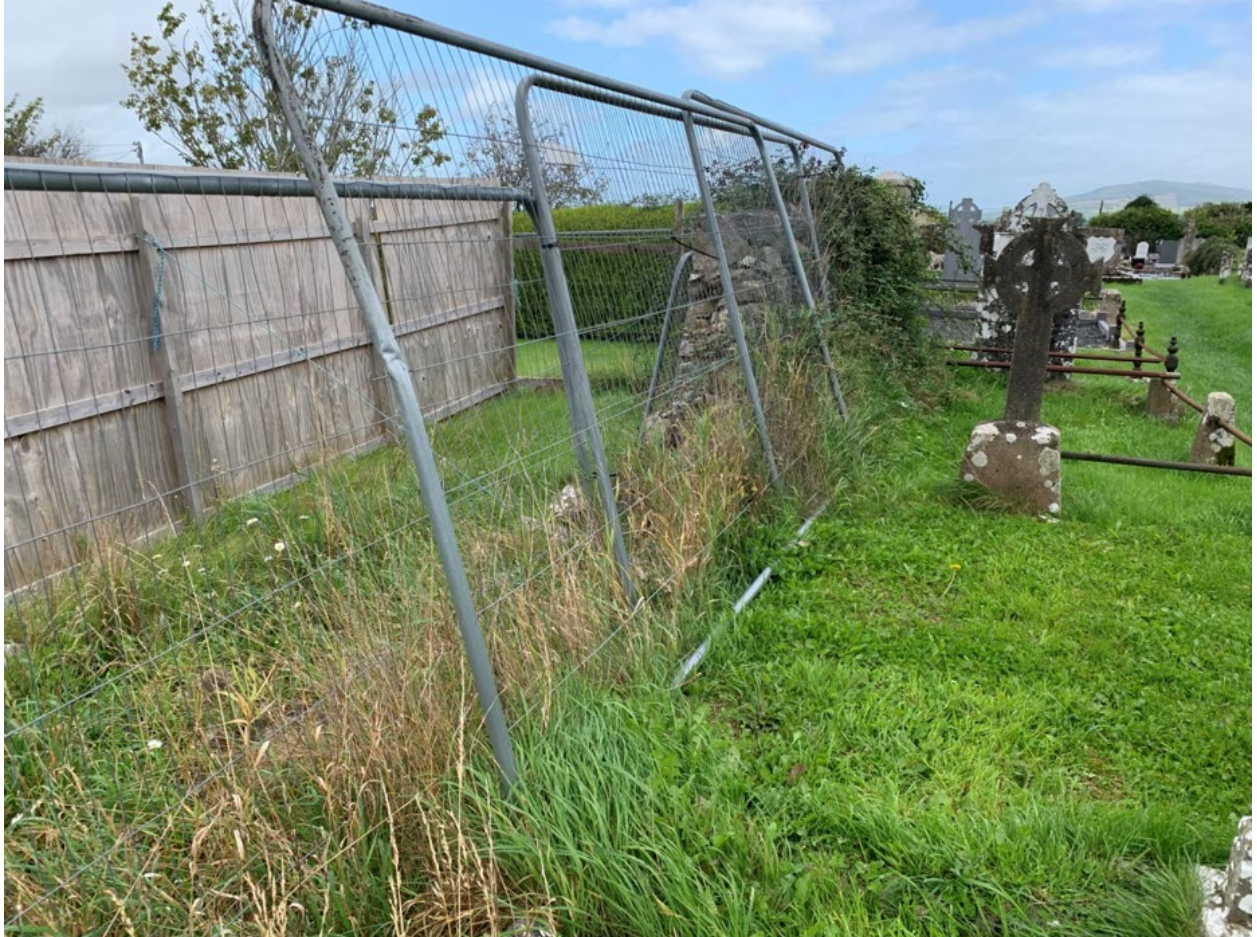
Figure 1-1: Collapsed Wall

The intention is to rebuild this wall now as part of this project.

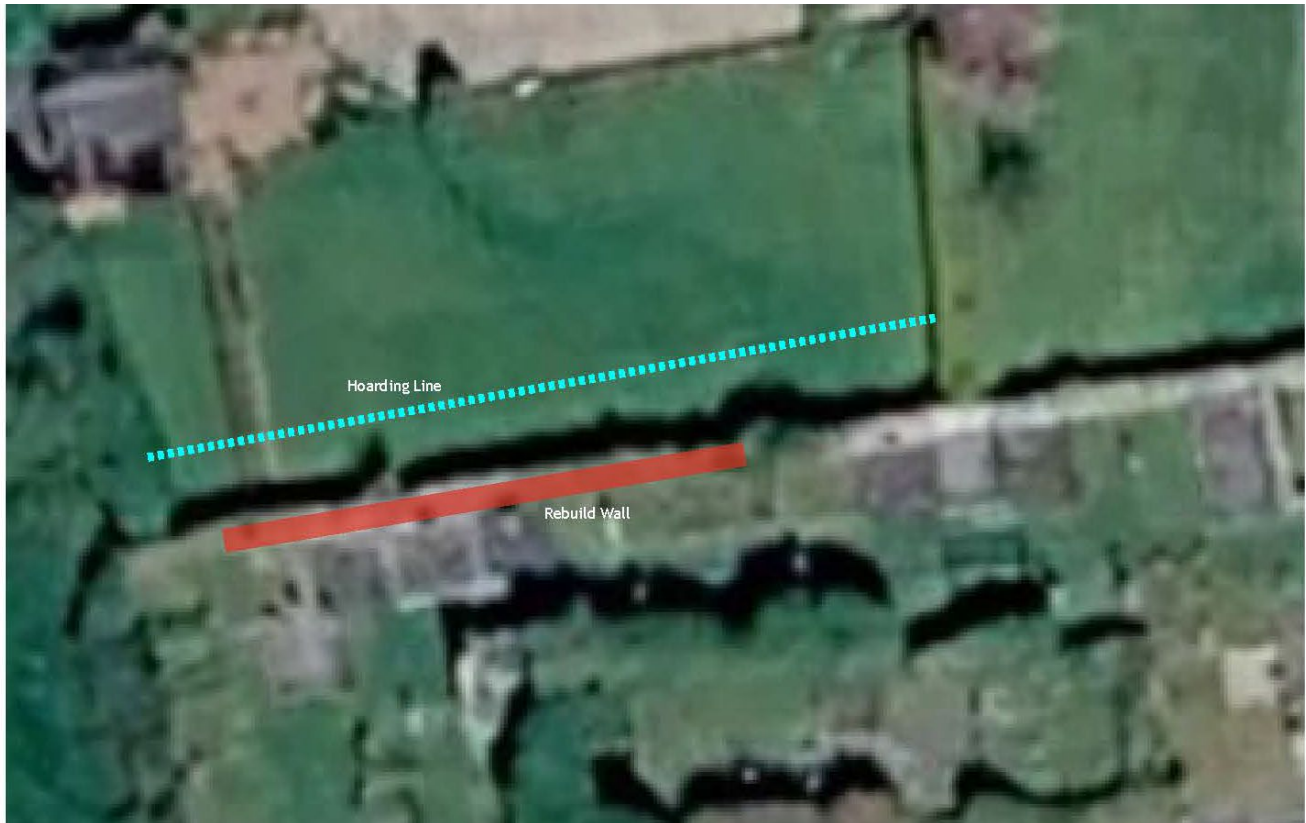
Figure 2-1: Site Plan

The scope involves reconstructing the existing stone wall and removal of existing hoarding.

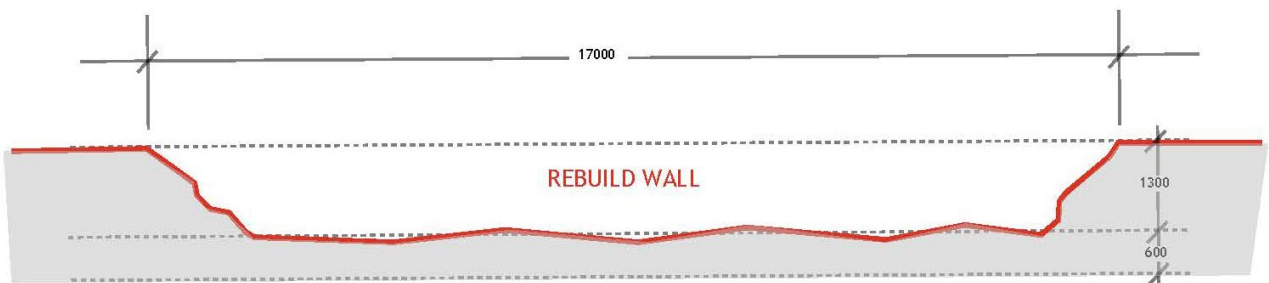
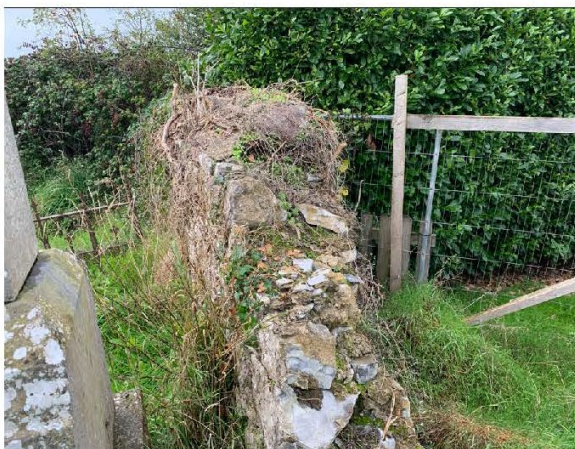
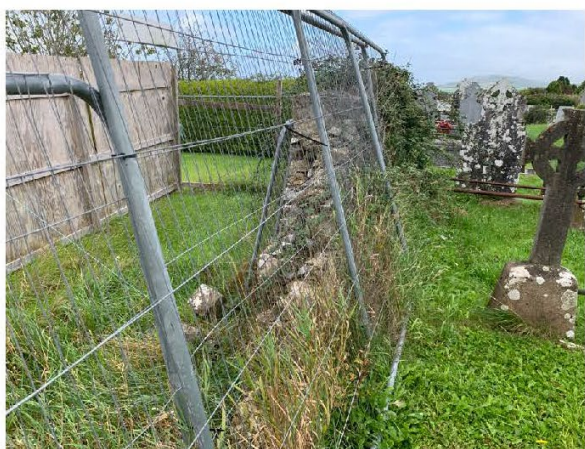
Figure 2-2: Dimensions

The wall is a coursed masonry wall and must be rebuilt in the same style and only use the material on site. The dimensions of the wall to be rebuilt are roughly 12m in length with a tie-in to the existing wall at either end.

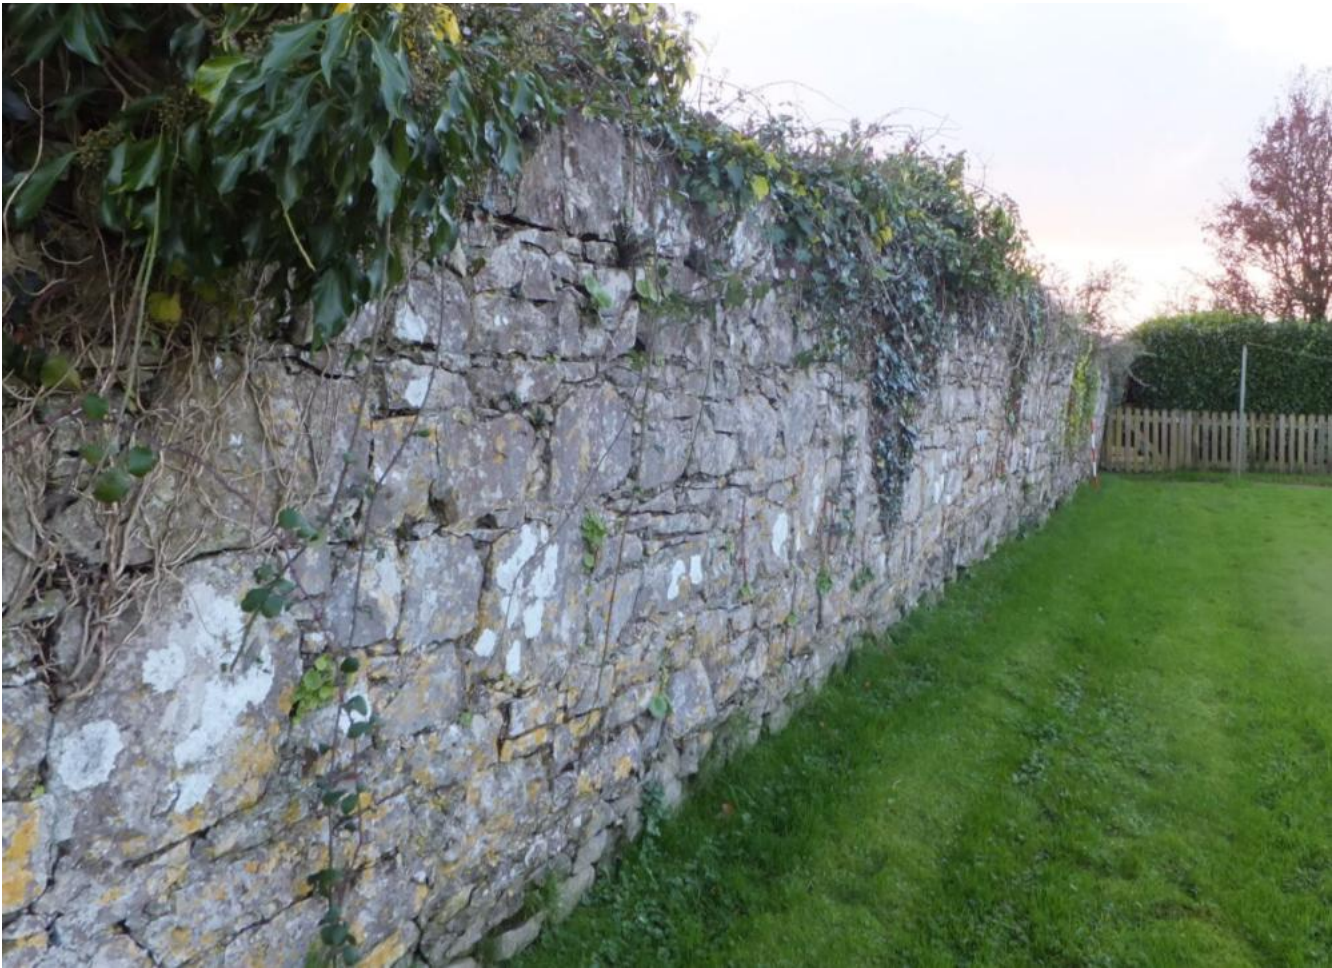
Long view of outer face of wall, prior to collapse; from east

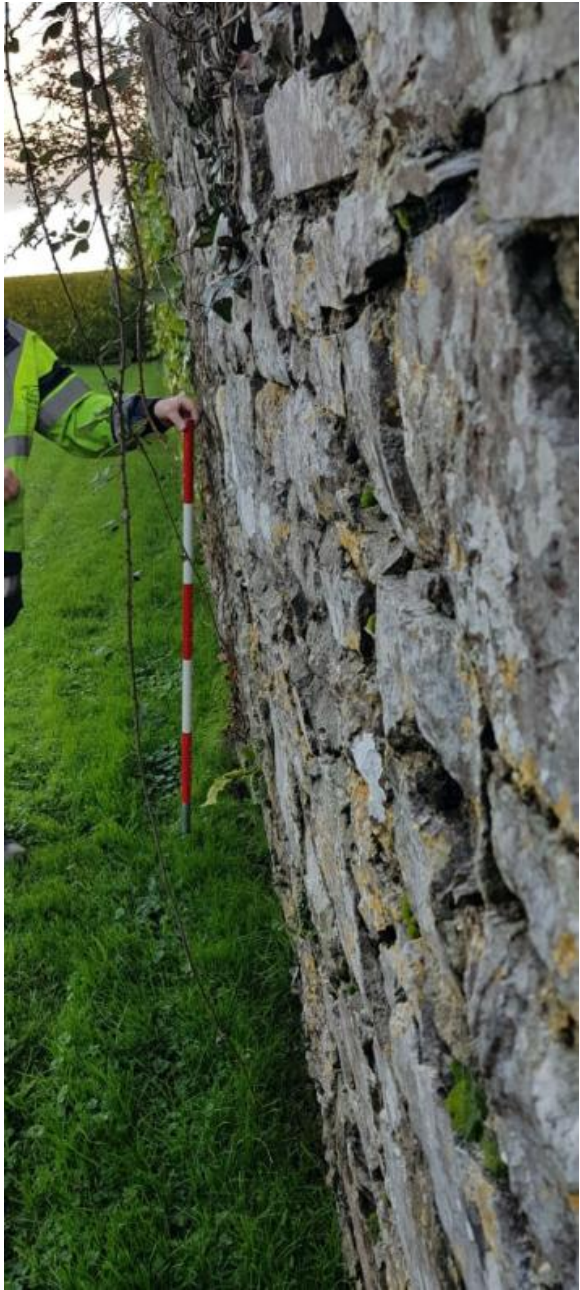
From W  
To indicate lean  
prior to collapse

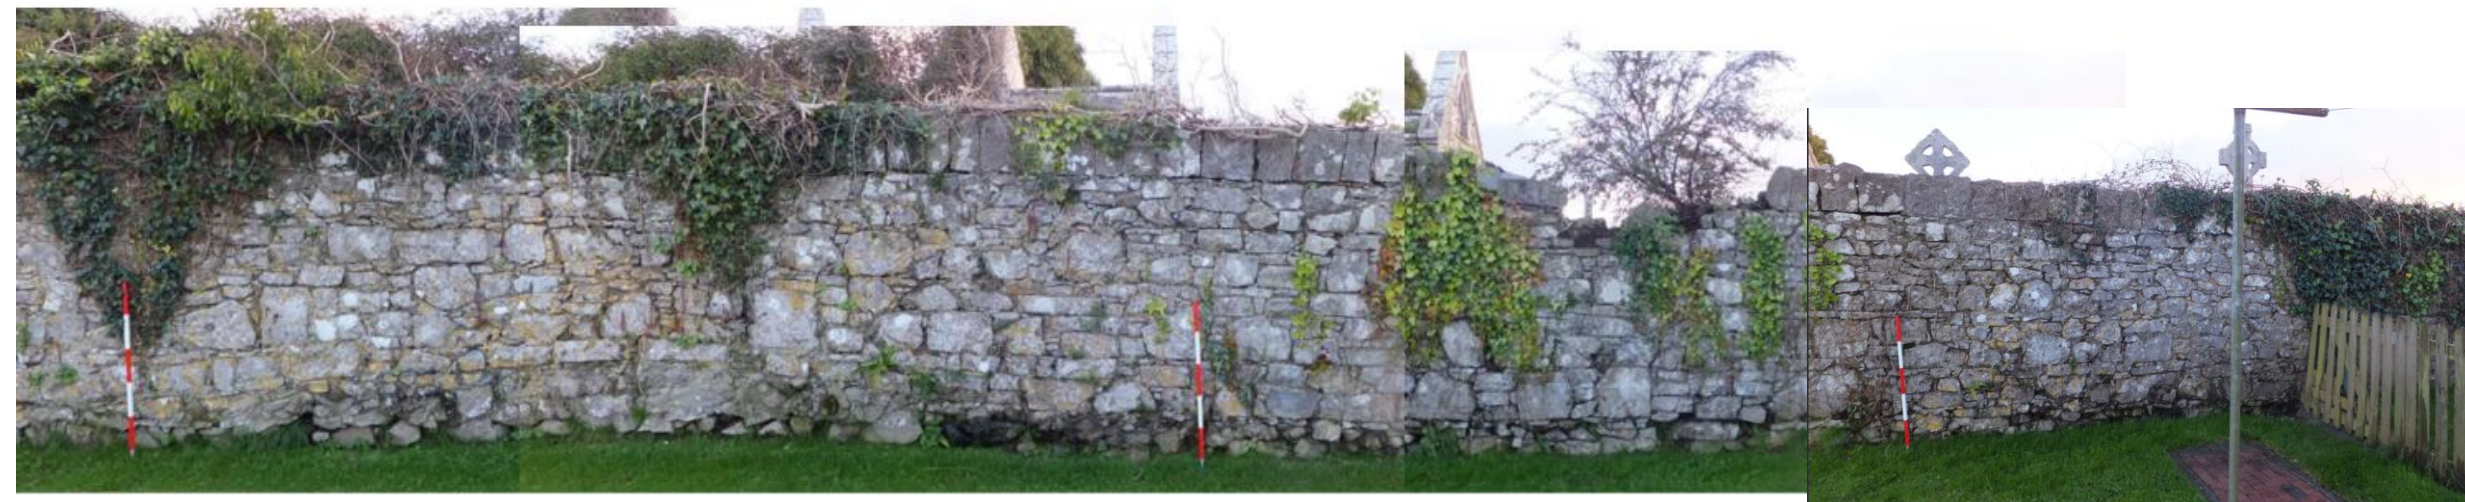
Outer face prior to collapse left to right east to west

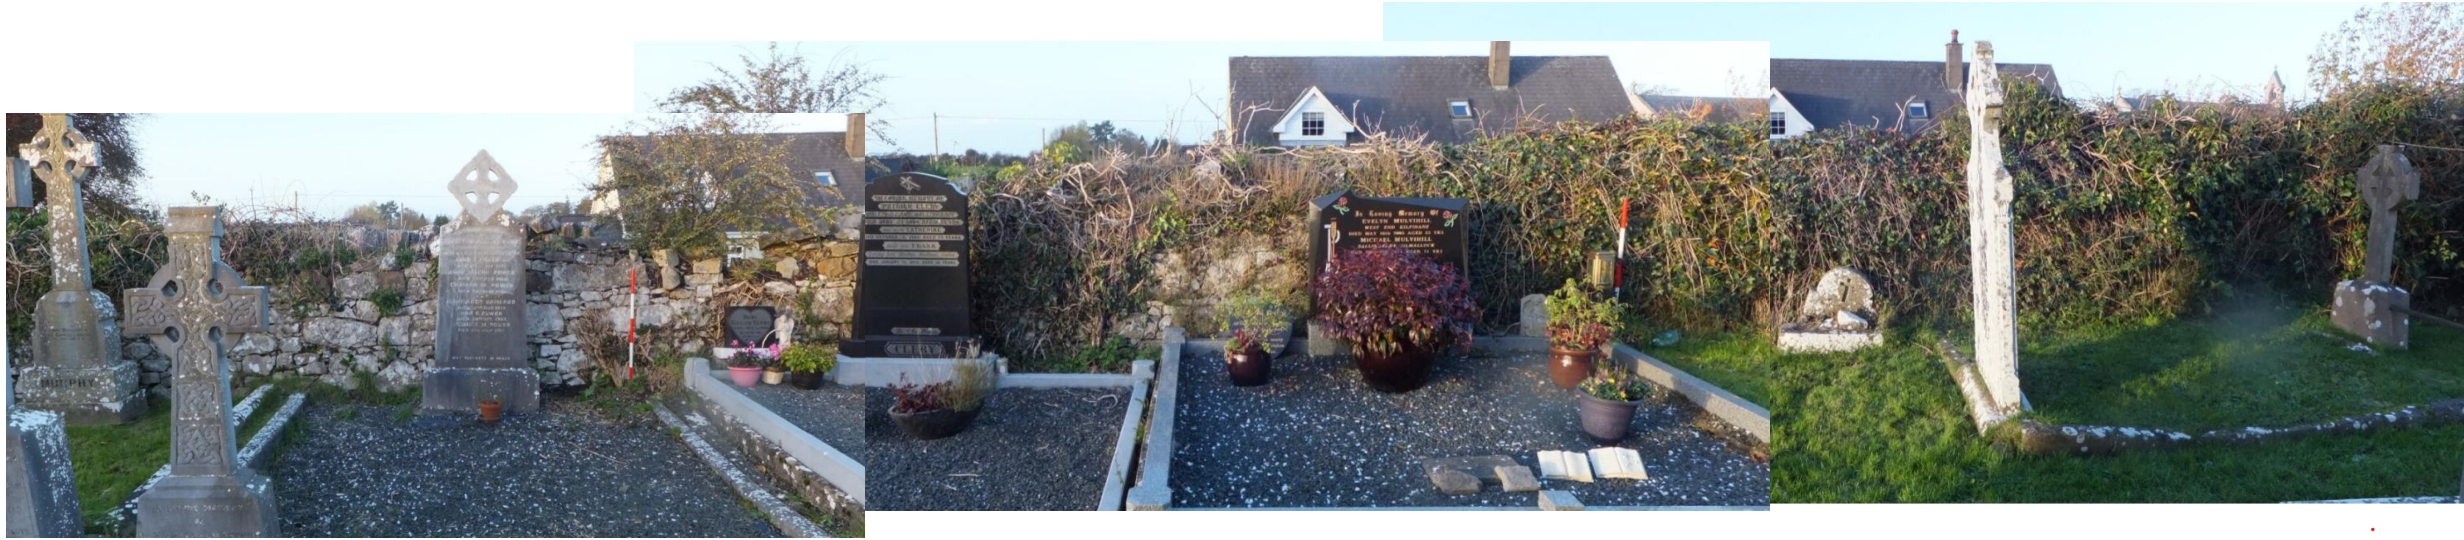
Interior view of wall prior to collapse

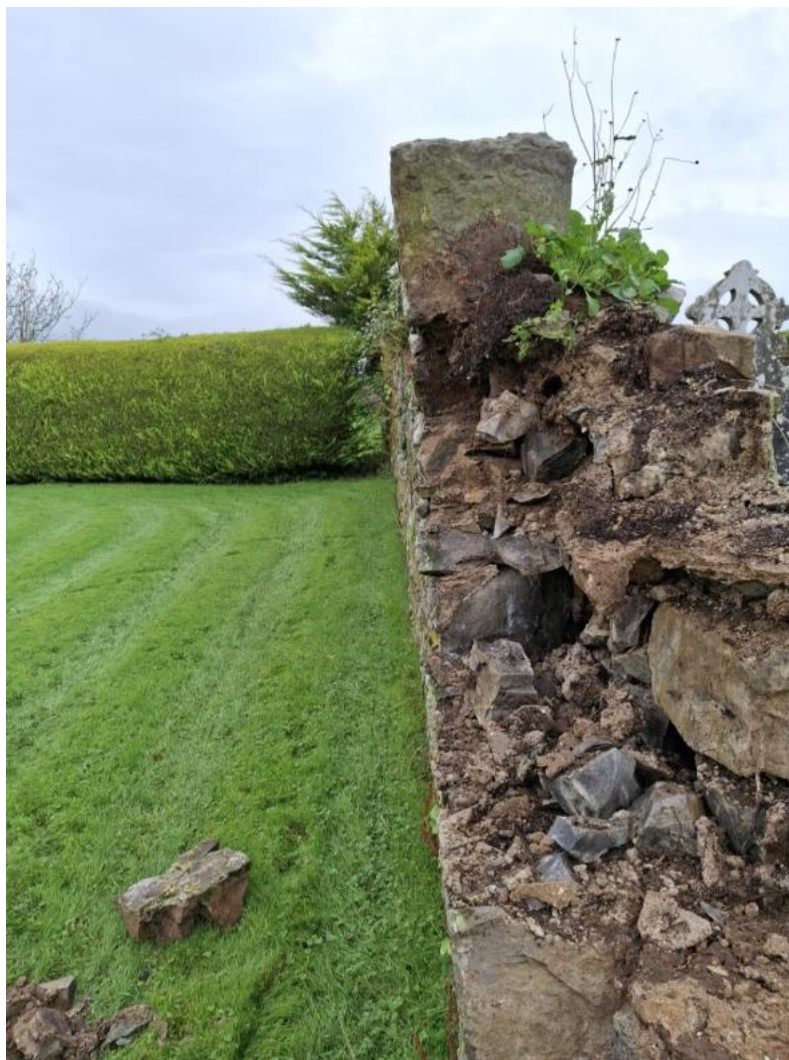
Section of wall, looking east

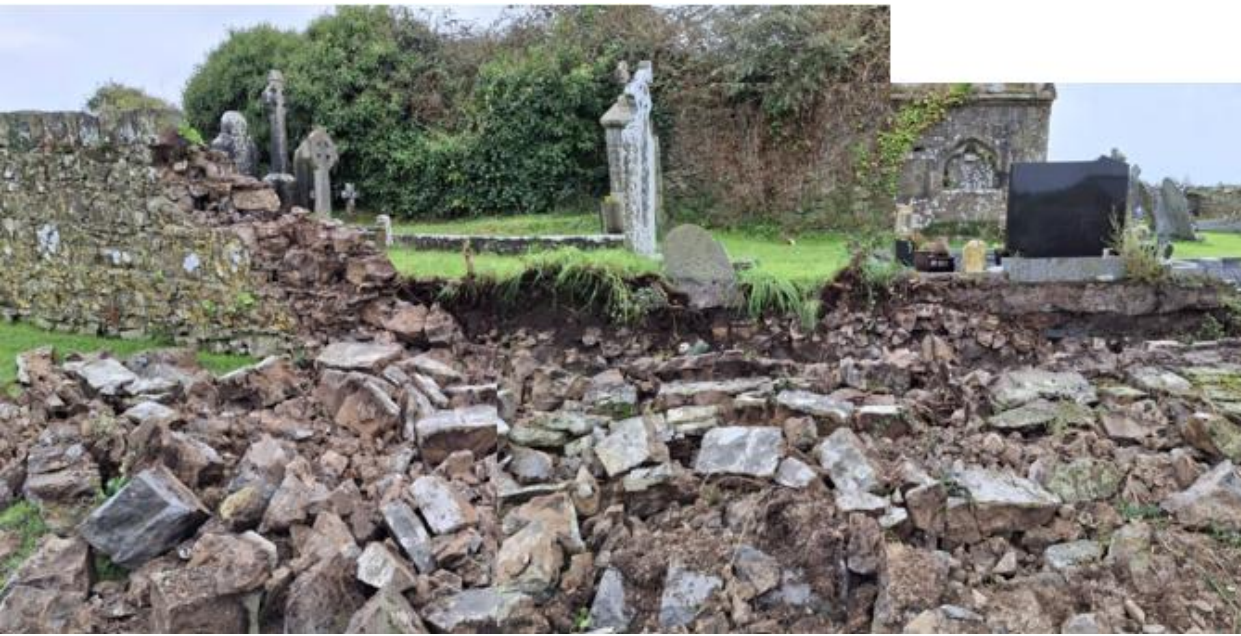
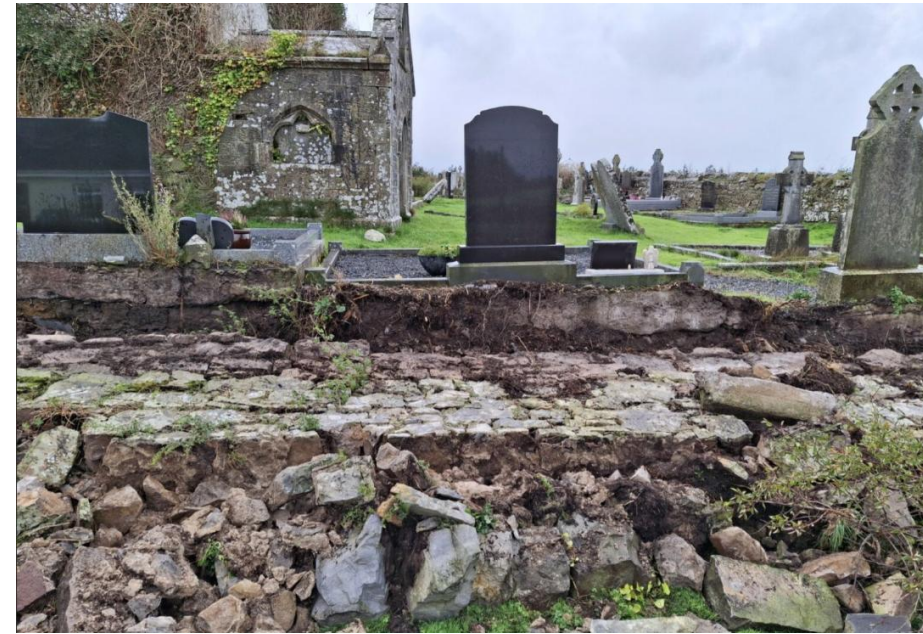
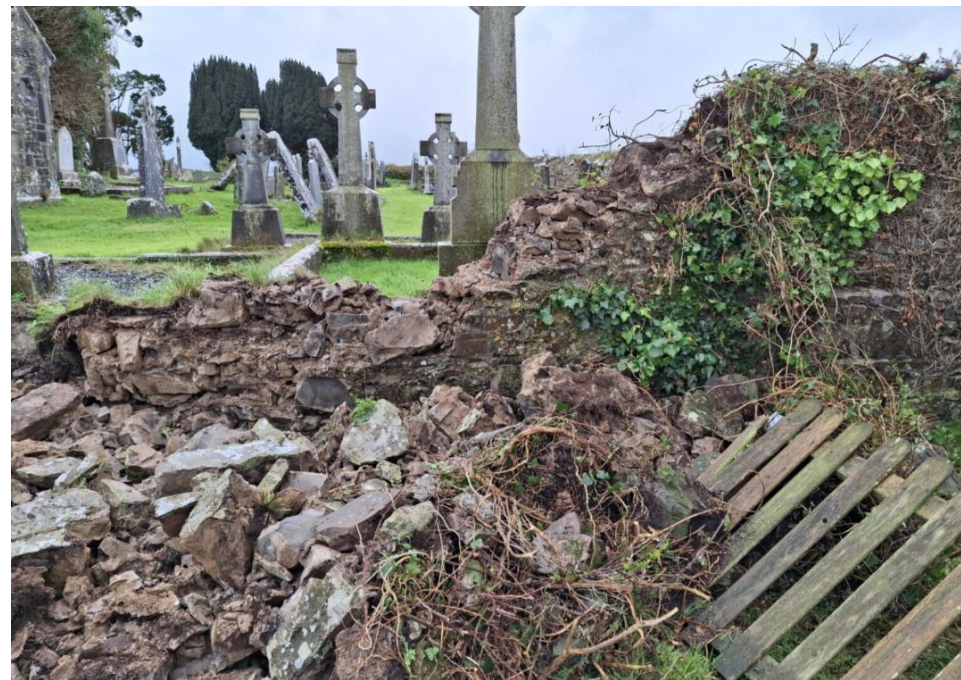
Left to right, East to West  
 Inner face of wall as  
 collapsed into private  
 garden.  
 Also showing exposed  
 section of higher burial  
 ground strata.  
 Headstones were largely  
 abutting the inner face of  
 the wall.
