# **Preliminary Report on Source Protection**

## **Brackloon-Spaddagh Group Water Scheme County Mayo**

**Dr Elizabeth Ryder and Dr Alec Rolston**

**Centre for Freshwater and Environmental Studies**

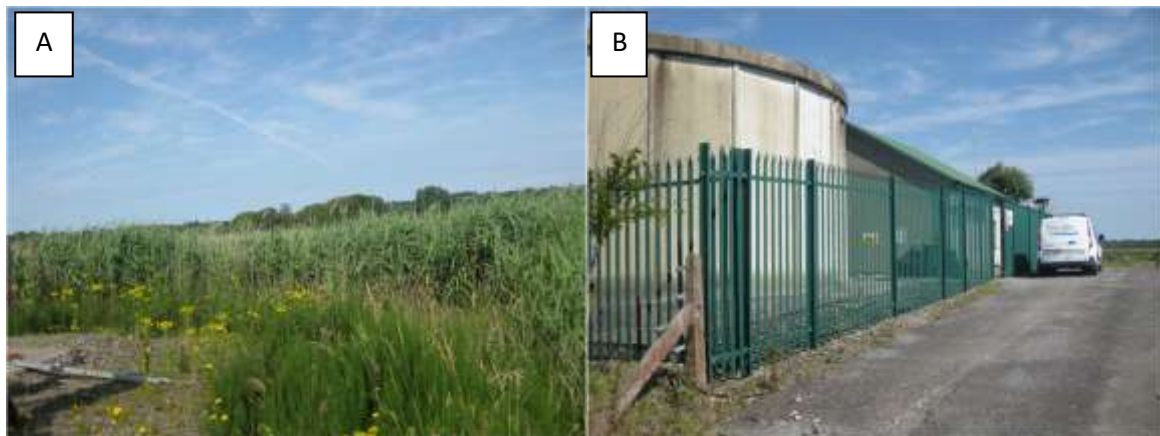
**Figure 1:** Site Location: A) Lough Caheer is surrounded by reeds, with raw water storage tank to the left of the photo. B) Brackloon Spaddagh GWS water treatment plant and storage reservoir.

Müller *et al.* (2006) describe the morphology of Caheer Lough as having a surface area of 0.13 km<sup>2</sup>, with a mean depth of 5.7 m and a maximum depth of 11.4 m. The lake is categorised as typology type 11 (as designated by the EPA for the purposes of the Water Framework Directive), i.e. deep (>4 m), less than 50 ha and high alkalinity (>100 mg/l CaCO<sub>3</sub>). In Lough Caheer, there is a known population of brown trout present and in the past the lake was stocked with rainbow trout. Lough Caheer is surrounded by reeds to a depth of approximately 4 m and lies with a low lying catchment with a large flood plain. Water is abstract by gravity flow from the intake pipe (which lies in the line of the inflowing Mannin River at a depth of 13 feet or 4 m) from Lough Caheer and is stored in a underground storage tank until it is pumped to the nearby water treatment plant and reservoir approximately 300 m away (Figure 1 A and B). The elevation is greatest to the south west of the catchment reaching a maximum of approximately 100 m.
