# Site Inspection Report

Site inspection of Kells Theatre which is access via an alley way from Kenlis Place. The existing property consists of a flat roof entrance foyer with male and female toilets. The main theatre appears to consist of an A-type slated roof which has steel rafters and piers to external walls. There is terraced seating which appeared to have a solid concrete slab supported on steel beams/columns. A link/fire escape corridor is provided to the left hand side of the theatre which has external fire exist doors through the adjoining Boys School site and also to the rear. A more recent rear extension appears to have been provided which has 300mm thick walls and raised concrete floors which are level with the stage. A modular building has been provided to the rear of the site to allow for additional toilets and changing facilities.

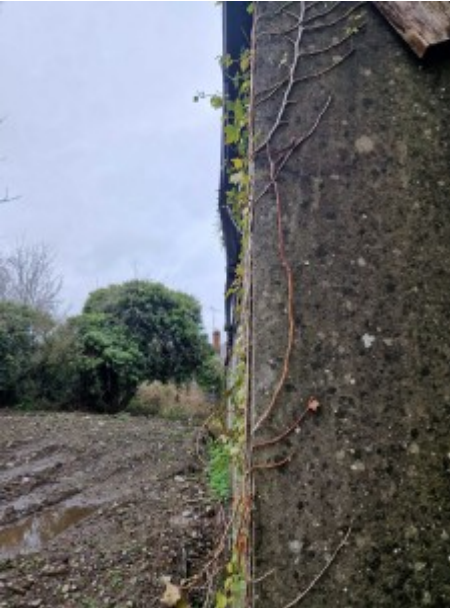
# 001 / 031

Side wall steps out which may indicate that building was constructed inside old stone boundary wall. Wall is not plumb or straight.

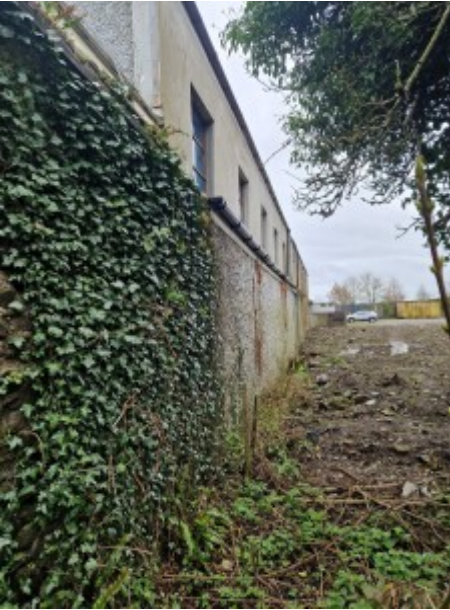
# 001 / 035

Current Status  
No issue

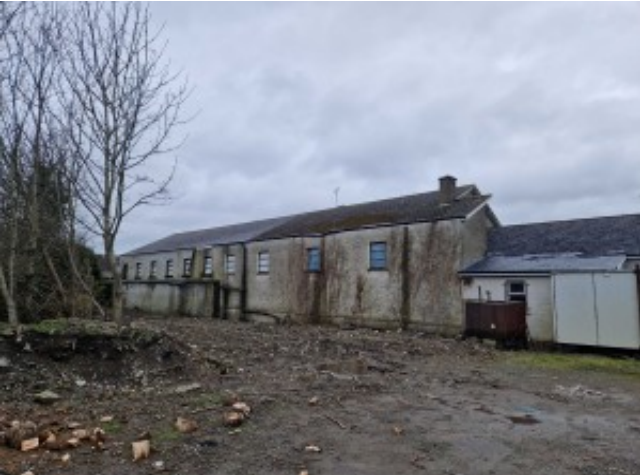
# 001 / 037

Current Status  
No issue

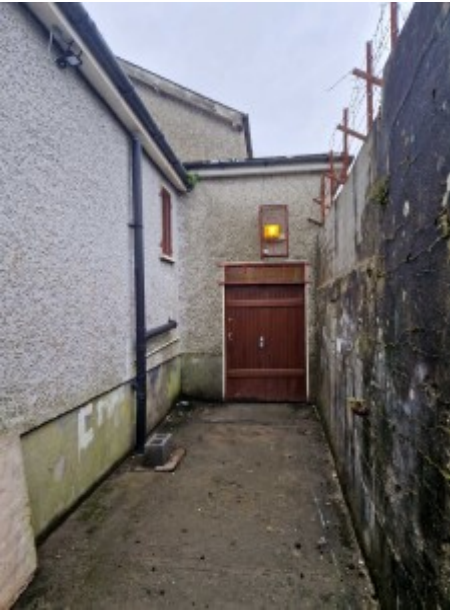
# 001 / 040

Rear fire exit doors.

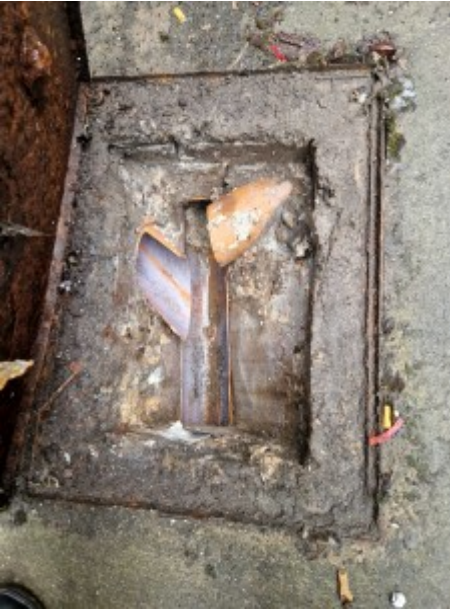
# 001 / 041

Evidence of blockages to foul sewer. Below ground services to be jetted iut and cleaned and services CCTV surveyed.

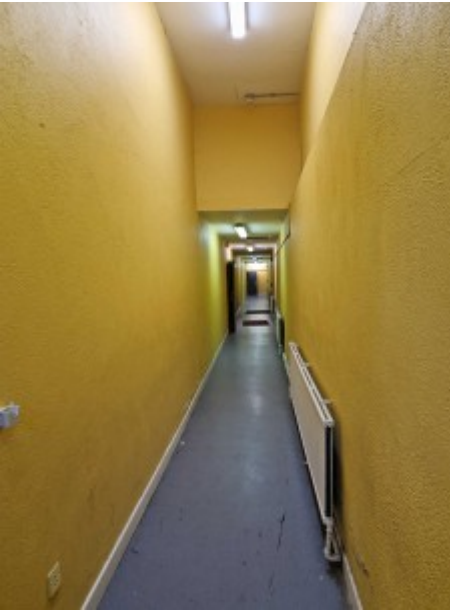
# 001 / 044

Comment  
Internal fire escape corridor which appears to have a flat roof structure. Roof covering and insulation to be inspected.

Current Status  
**Requires Attention**

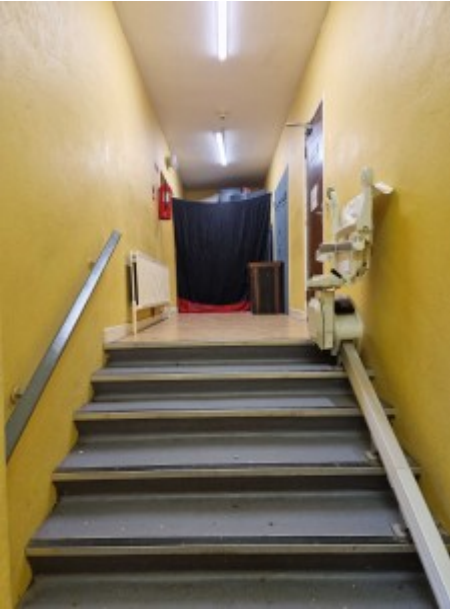
# 001 / 045

Comment  
Concrete steps to rear extension to access stage area and changing rooms.

Current Status  
No issue

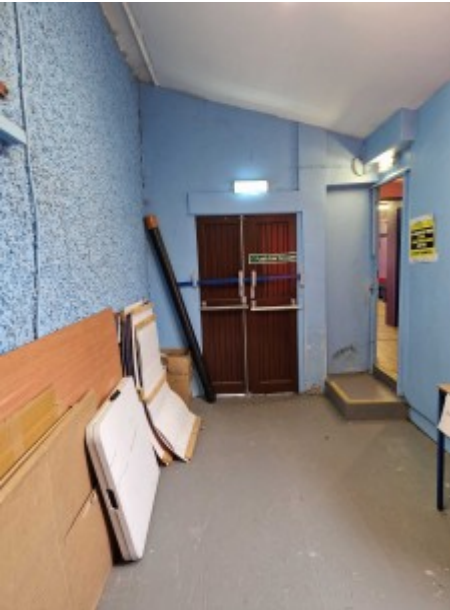
# 001 / 048

Fire exit to rear at link extension to modular unit.  
Steel security bars over fire exit doors which would not permitted under Part B (fire) of building regulations. Bars should be removed when property is in use.

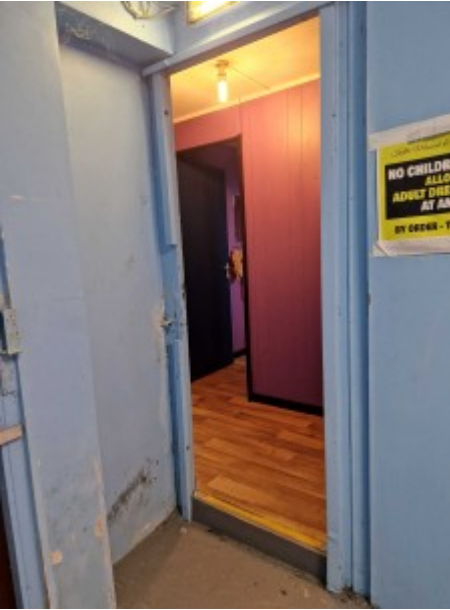
# 001 / 051

Comment  
Entrance to modular unit extension

Current Status  
No issue

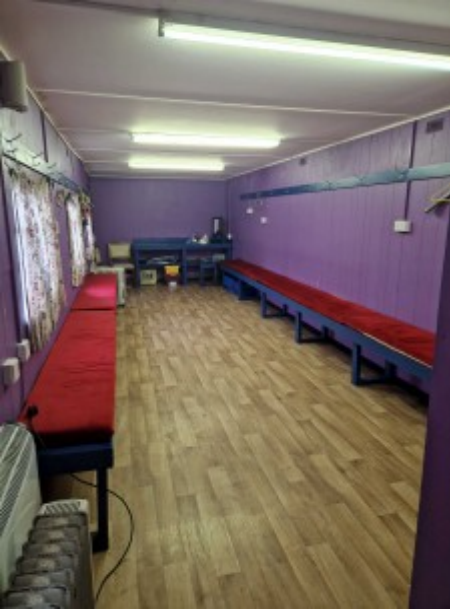
# 001 / 052

Comment  
Modular unit extension

Current Status  
No issue

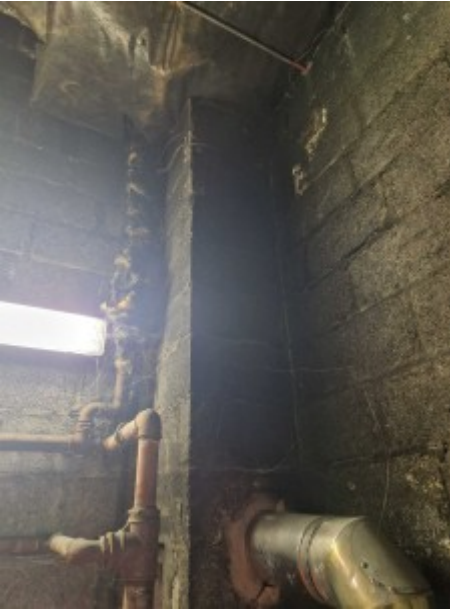
# 001 / 055

Comment  
Oil Boiler flue connected to rear chimney.

Current Status  
No issue

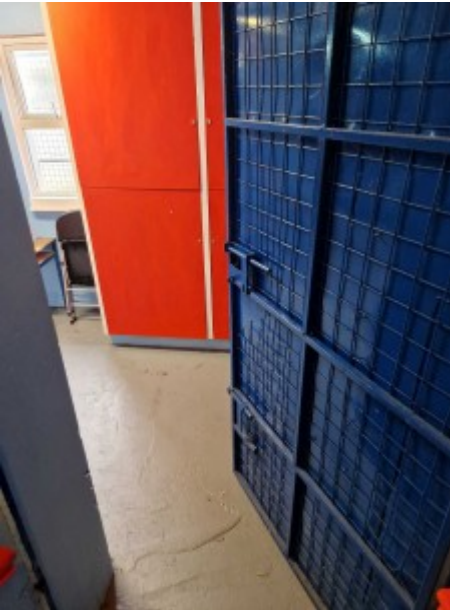
# 001 / 056

Comment  
Lockable door/gate on escape route which is not permitted.

Current Status  
**Requires Attention**

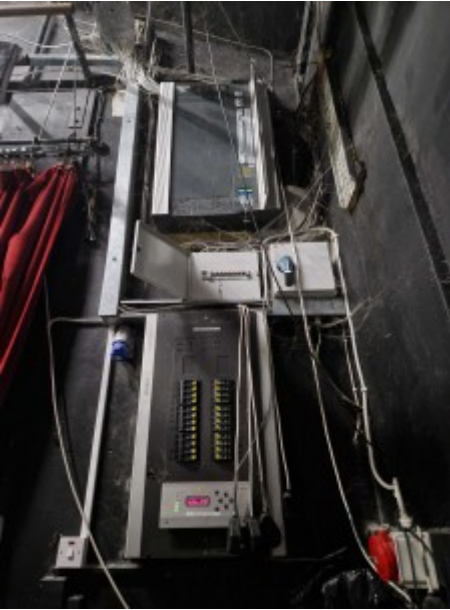
# 001 / 057

Entire electrical installation to be inspected by suitably qualified electrician.

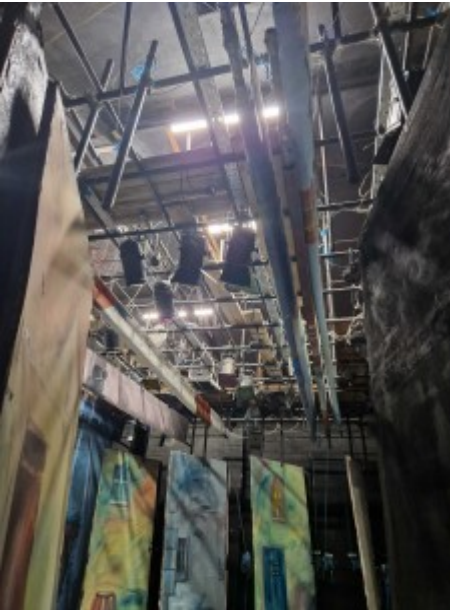
# 001 / 058

Entire electrical installation to be inspected by suitably qualified electrician.

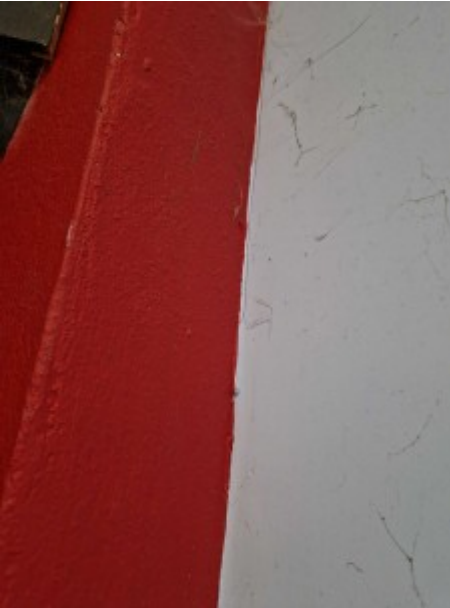
# 001 / 069

Walls of theatre drylined between column .

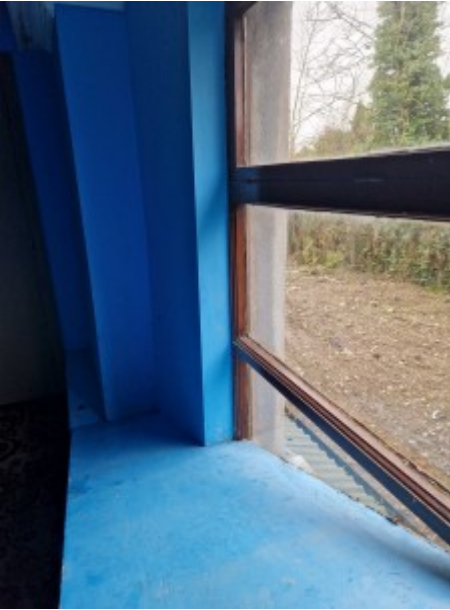
# 001 / 073

Comment  
Old single glazed timber windows to be upgraded to double glazed units to reduce heatloss.

Current Status  
**Requires Attention**

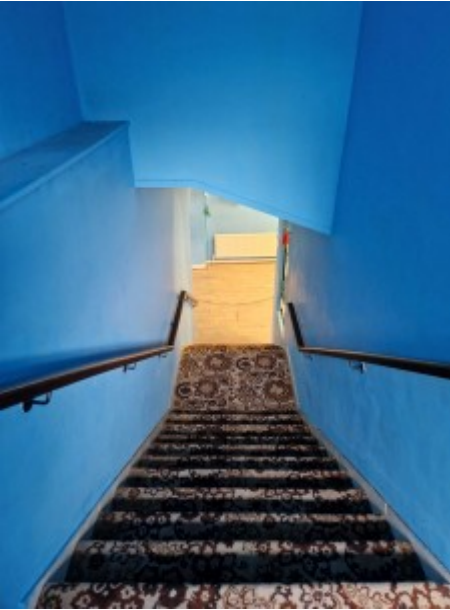
# 001 / 077

Comment  
Concrete access stairs from toilets to theatre.

Current Status  
No issue
