**Project Name:** Shannon Valley House Connections 08-01-25  
**Project Description:** CCTV Survey  
**Project Number:** CES 11740  
**Project Status:** Complete  
**Project Date:** 08/01/2026

Project Name Shannon Valley House Connections 08-01-25 Project Number CES 11740 Project Date 08/01/2026

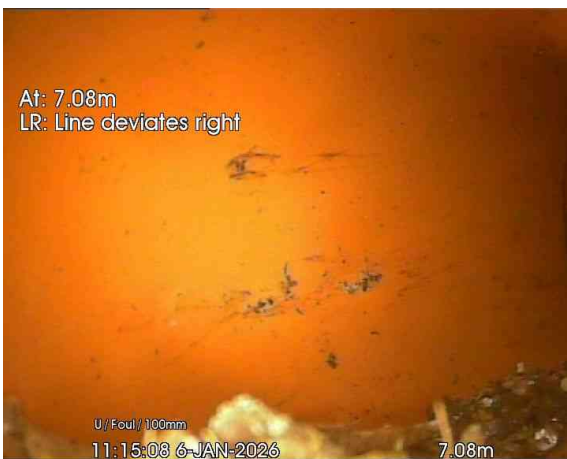
3, 00:00:16, 7.08 m  
 Line deviates right

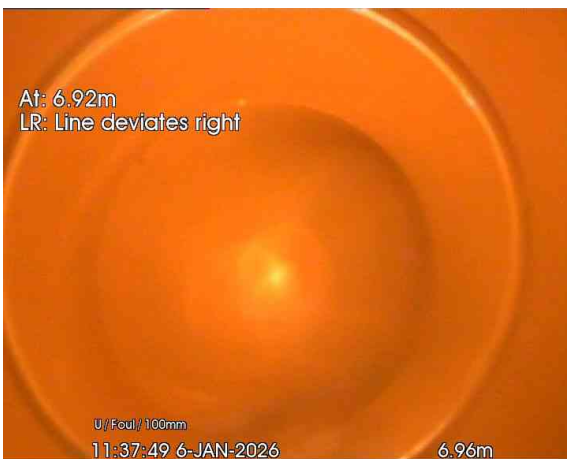
3, 00:00:13, 6.98 m  
 Line deviates right

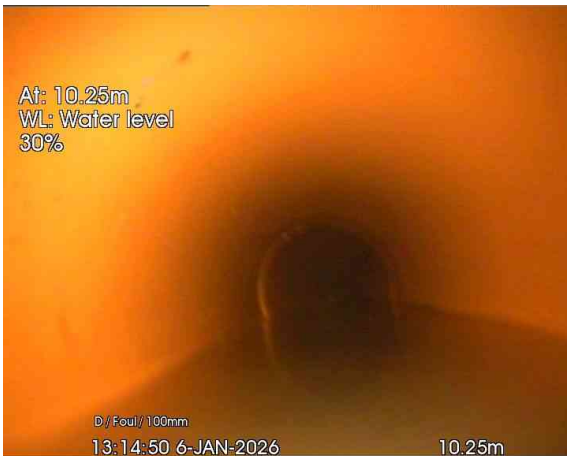
3, 00:01:31, 10.25 m  
 Water level, 30% of the vertical dimension

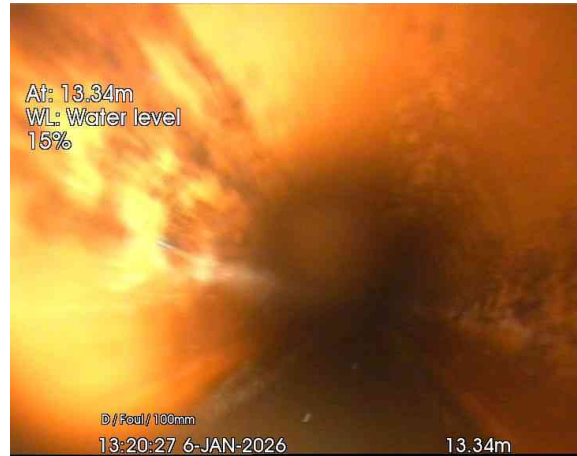
2, 00:00:29, 13.34 m  
 Water level, 15% of the vertical dimension

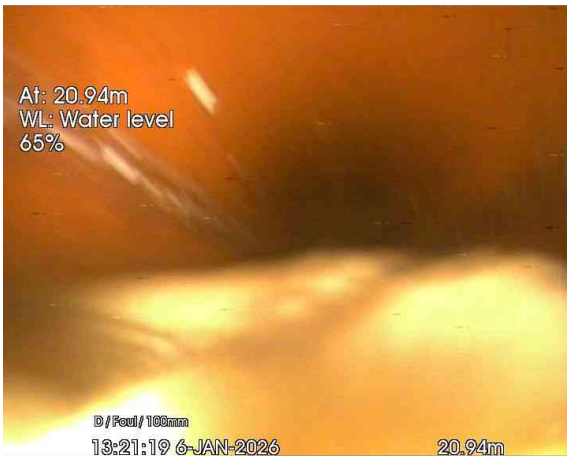
3, 00:01:03, 20.94 m  
 Water level, 65% of the vertical dimension

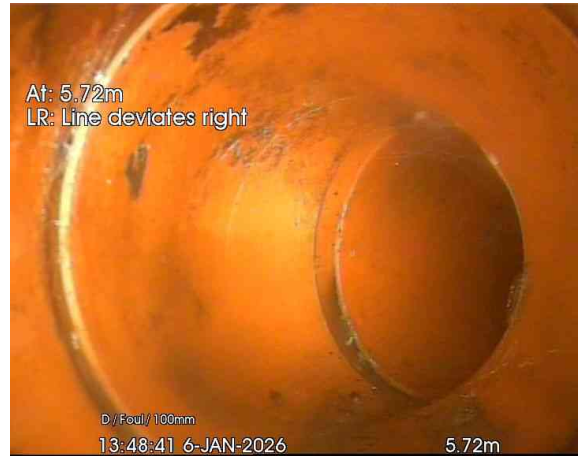
2, 00:00:12, 5.72 m  
 Line deviates right
