Project Name: Shannon Valley Foul Water 10-11-25
Project Description: CCTV Survey
Project Number: CES 11659
Project Status: Complete
Project Date: 10/11/2025
Inspection Standard: MSCC5 Sewers & Drainage GB (SRM5 Scoring)

Project Name: Shannon Valley Foul Water 10-11-25
Project Number: CES 11659
Project Date: 10/11/2025

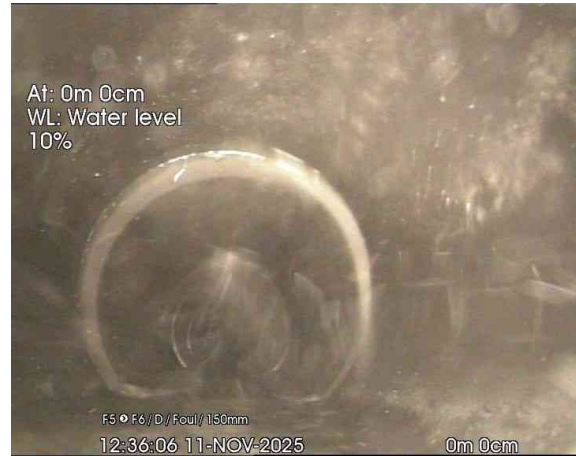
2, 00:00:04, 0.00 m
 Water level, 10% of the vertical dimension

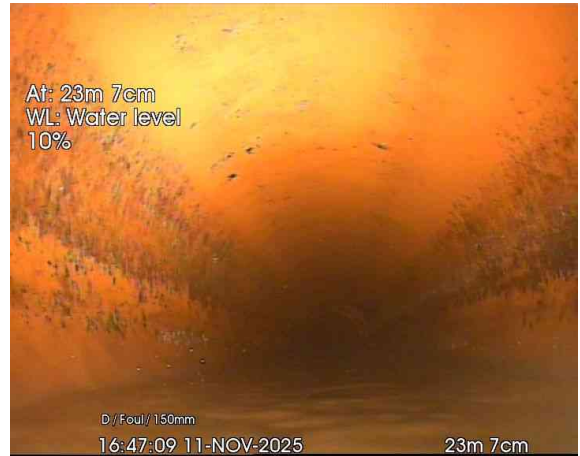
6, 00:01:24, 23.07 m
 Water level, 10% of the vertical dimension

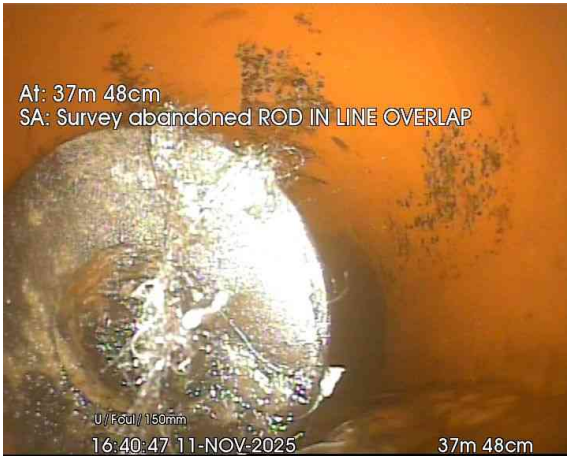
9, 00:03:12, 37.48 m
Survey abandoned, ROD IN LINE OVERLAP
