Project Name: Shannon Valley Surface Water 10-11-25
Project Description: CCTV Survey
Project Number: CES 11659
Project Status: Complete
Project Date: 10/11/2025
Inspection Standard: MSCC5 Sewers & Drainage GB (SRM5 Scoring)

Section Inspection - 11/11/2025 - S1.1X

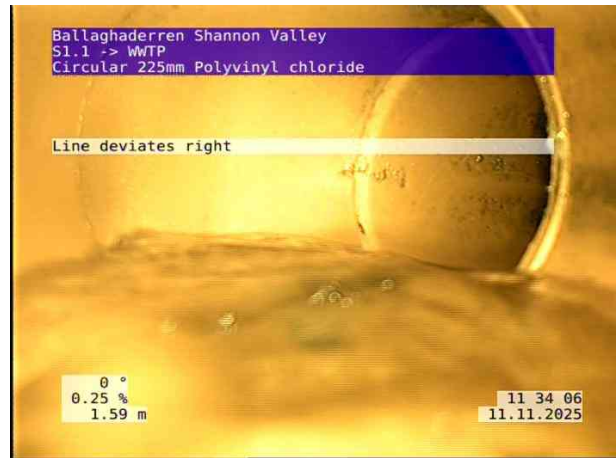
2, 00:00:17, 1.59 m
 Line deviates right

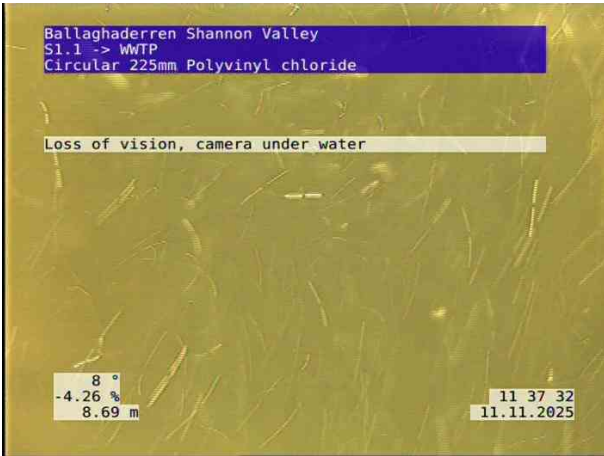
5, 00:03:13, 8.69 m
 Loss of vision, camera under water

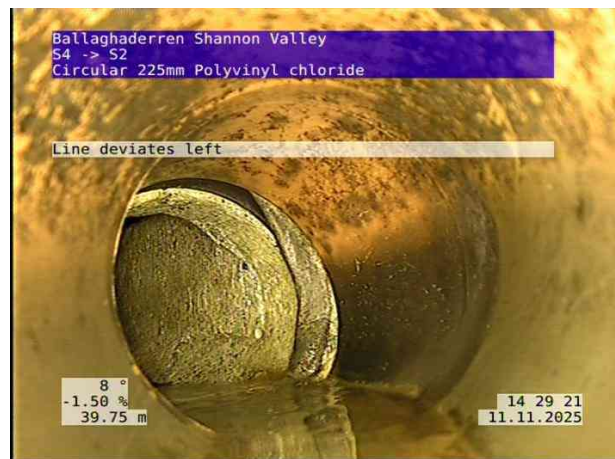
8, 00:05:30, 39.75 m
 Line deviates left

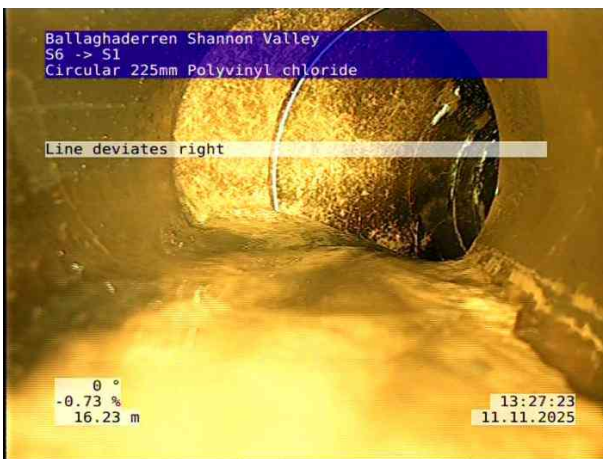
3, 00:01:27, 16.23 m
 Line deviates right

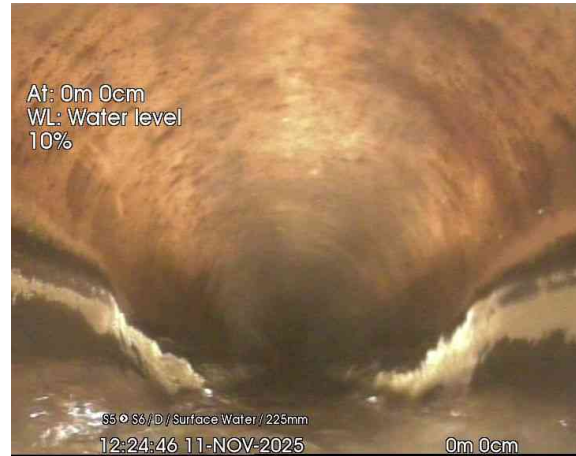
2, 00:00:04, 0.00 m
 Water level, 10% of the vertical dimension

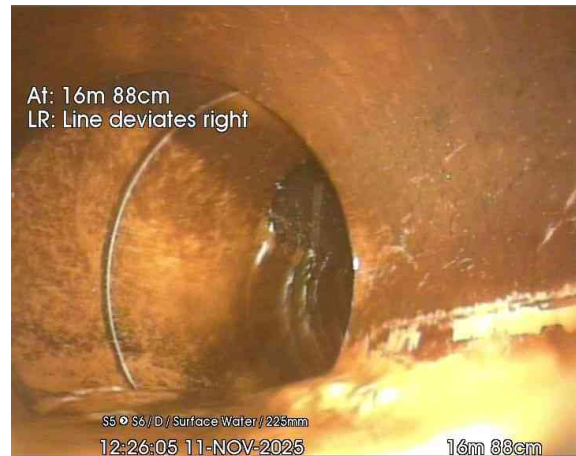
4, 00:01:07, 16.88 m
 Line deviates right

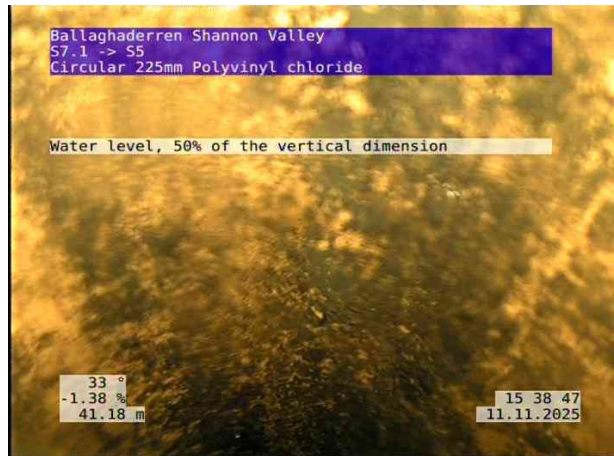
4, 00:04:49, 41.18 m
 Water level, 50% of the vertical dimension

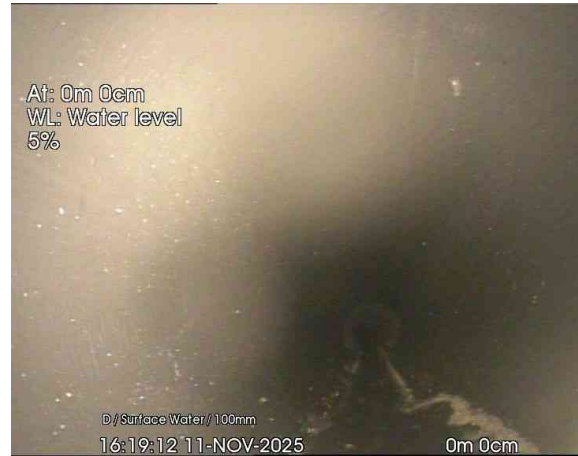
2, 00:00:03, 0.00 m
 Water level, 5% of the vertical dimension

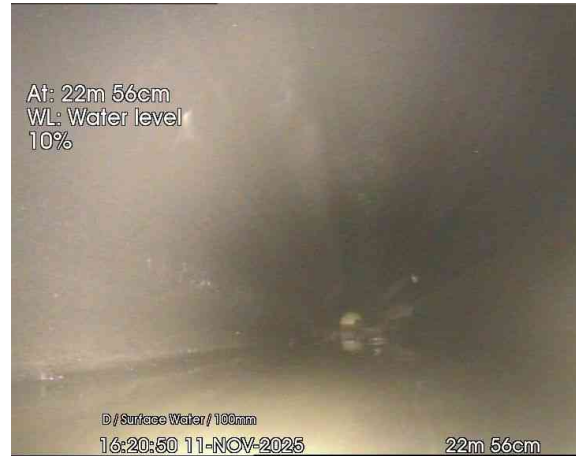
6, 00:01:11, 22.56 m
 Water level, 10% of the vertical dimension
