**TEM**  
**Engineering and Management**

**PROJECT: 26 McCurtain Street Fermoy Condition Report**

**Building Services Condition Report**

**Document Number: 18613 – 100 – R1**

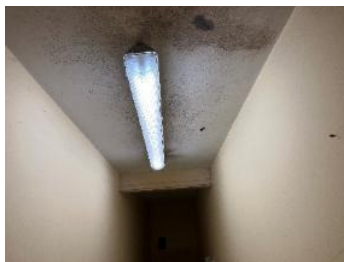
1.5 Light fitting

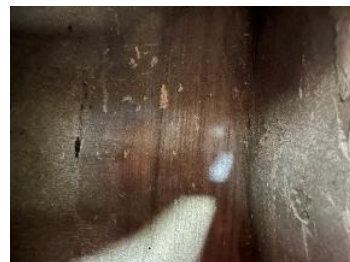
1.6 Concrete Tank

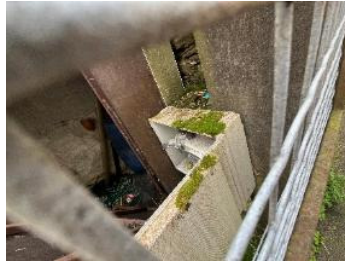
1.14 Gas Meter

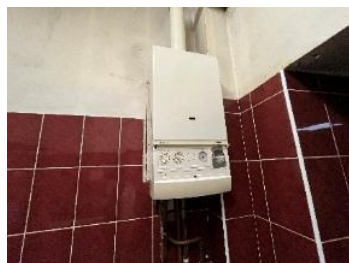
1.23 Gas boiler

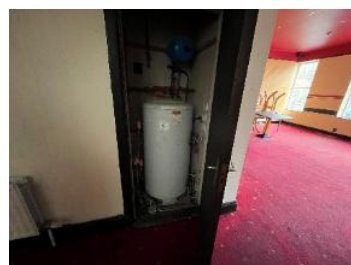
1.38 Hot water cylinder

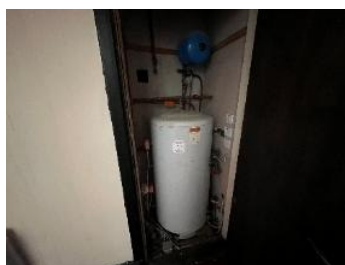
1.39 Hot water cylinder

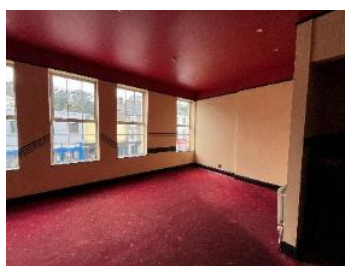
1.42 Room

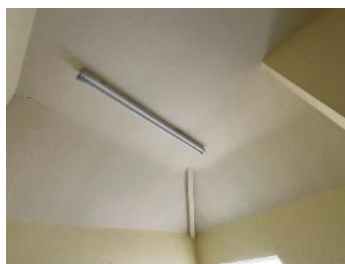
1.72 DADO trunking

Dado trunking restaurant missing covers
