# **DMA ARCHITECTS**

## **CONDITION REPORT**

Client: Marillac Housing Association  
Property: Templemore Road, Roscrea, Co. Tipperary  
Date of Inspection: 08 February 2024  
Folio: TY35006  
Eircode: E53EC67  
Document Ref: DMA-CR-2024-001 Rev 1

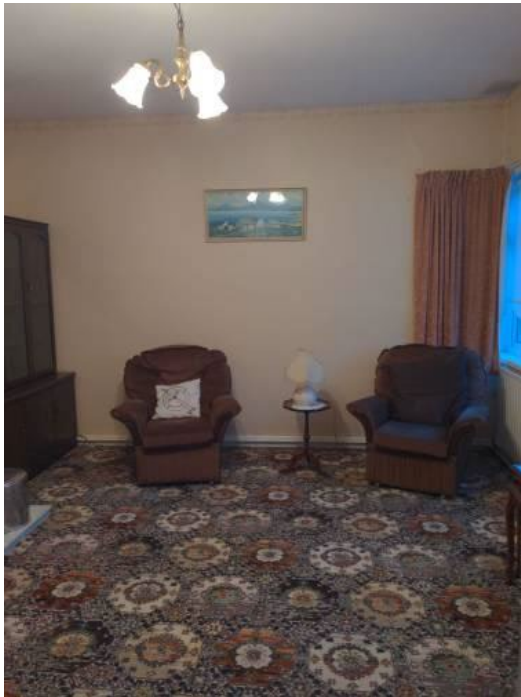
Photo 001 — Sitting Room - no vent

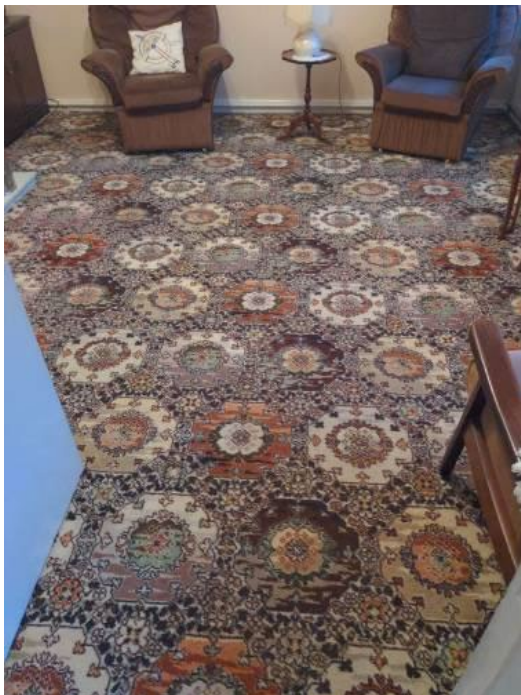
Photo 003 — Carpet on wood vented floors

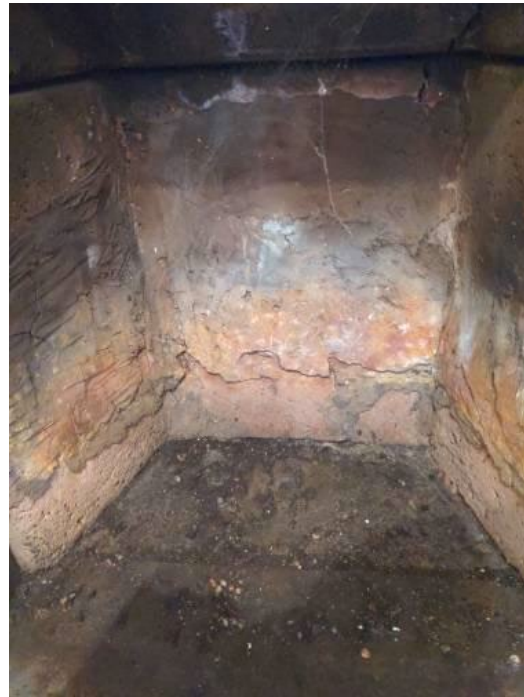
**Photo 008 — Damaged**

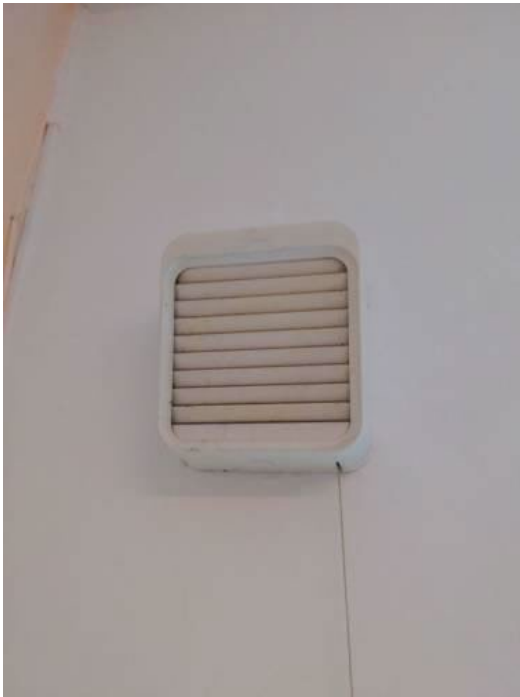
**Photo 015 — Retrospectively installed**

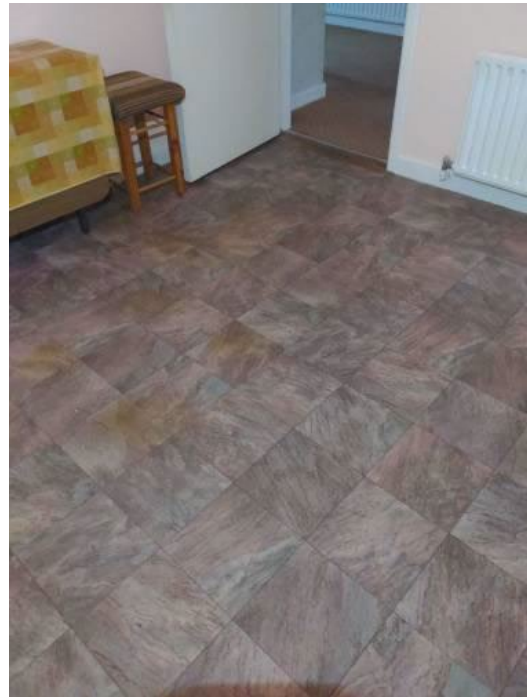
**Photo 016 — Vinyl on concrete**

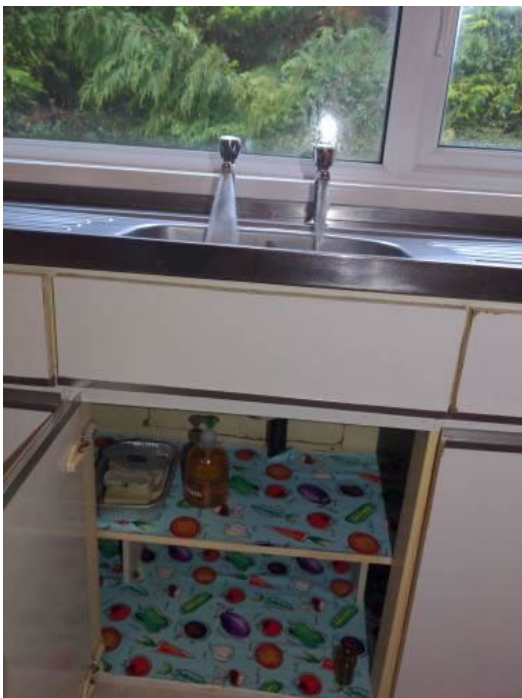
**Photo 019**

- 4.3.1** The room is in satisfactory visual condition with no structural deficiencies noted. [\[Ref photo 14\]](#)
- 4.3.2** The kitchen sink was operational and no leaks were observed. [\[Ref photo 19\]](#)

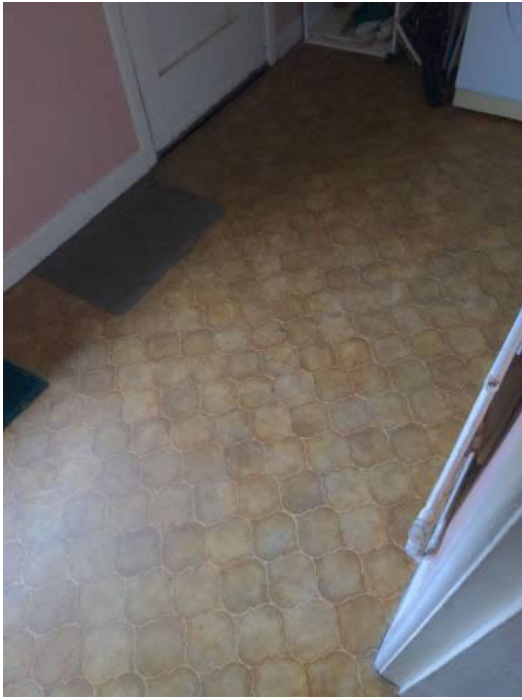
**Photo 021 — Vinyl on concrete**

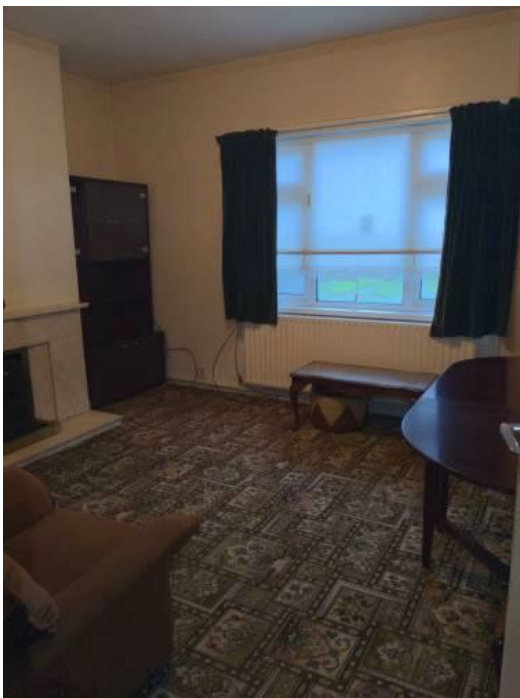
- 4.5.1** The room is in satisfactory visual condition. Structural issues are noted below. [\[Ref photo 27\]](#)
- 4.5.2** The open fire surround and hearth are safe and secure, with the chimney visibly clay-flue-pot lined. Minor thermal cracking in the chimney breast is not considered structurally significant. [\[Ref photos 31, 32 & 33\]](#)
- 4.5.3** The chimney in this room is leaking extensively. The cause may be a cracked internal flue pot, defective flashing, a failed chimney capping, or a combination thereof. [\[Ref photo 34\]](#)
- 4.5.4** Cracking is present in the ceiling. See Section 4.13 for the probable cause. [\[Ref photo 35\]](#)

Photo 027 — Rear living Room - no vent

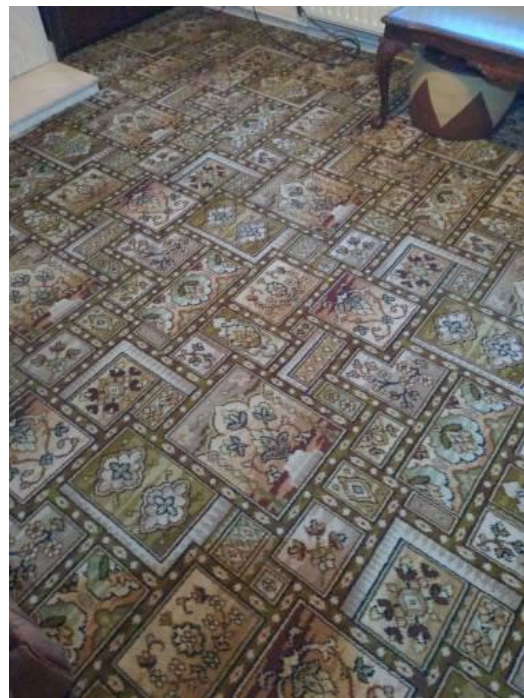
Photo 028 — Carpet on timber

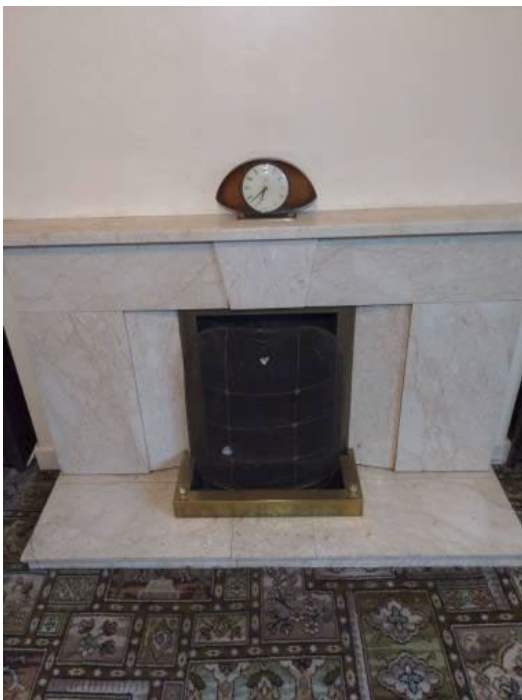
**Photo 031 — Great quality marble fire place**

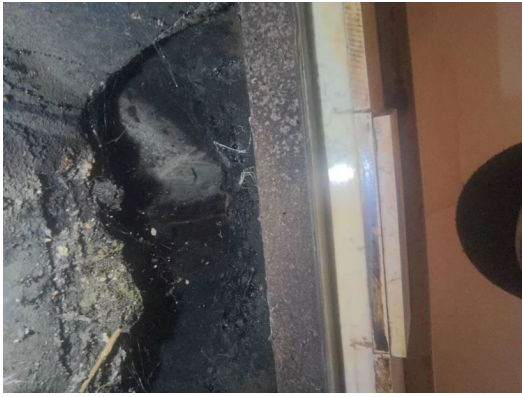
**Photo 033 — Clay lined**

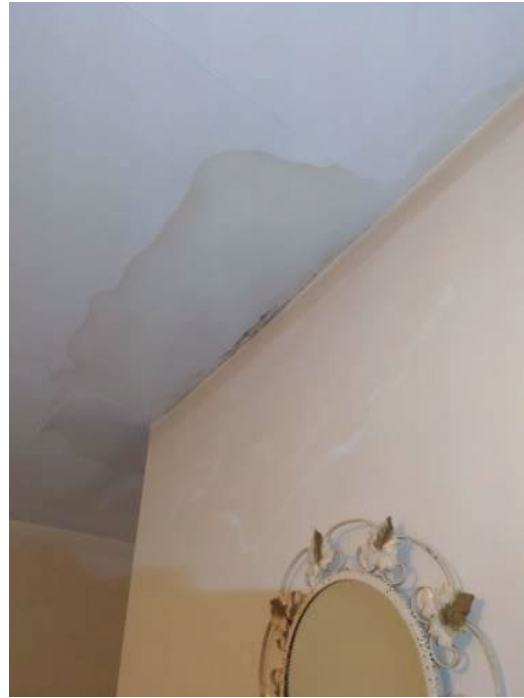
**Photo 034 — Chimney leaking**

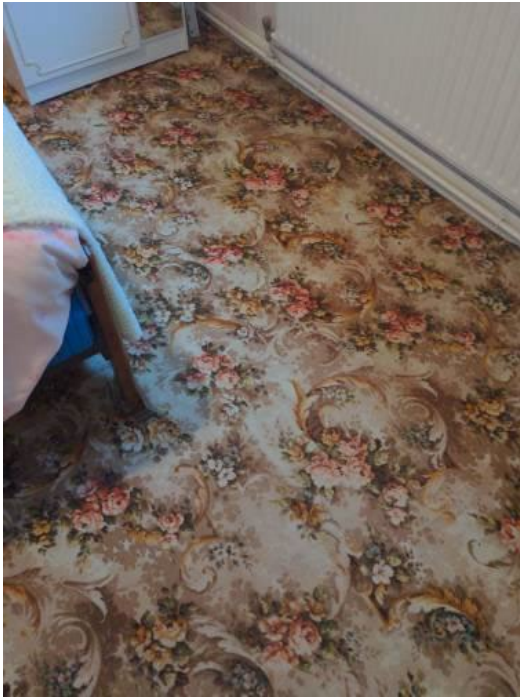
**Photo 037 — Carpet on timber, not vented**

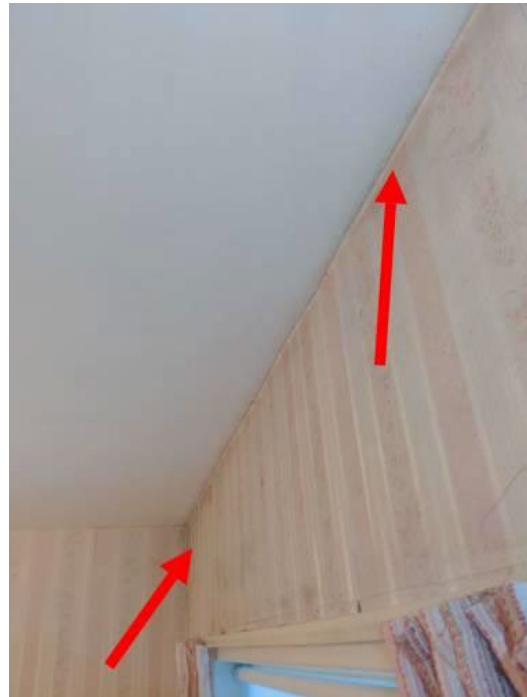
- 4.6.2** Damp patches are present on the front-facing wall, most likely caused by cold bridging at the in-situ concrete beam visible in the attic space above this area. [\[Ref photo 40; beam shown in Ref photo 88\]](#)
- 4.6.3** Cracking is present in the ceiling. See Section 4.13 for the probable cause. [\[Ref photo 41\]](#)

**Photo 040 — Damp**

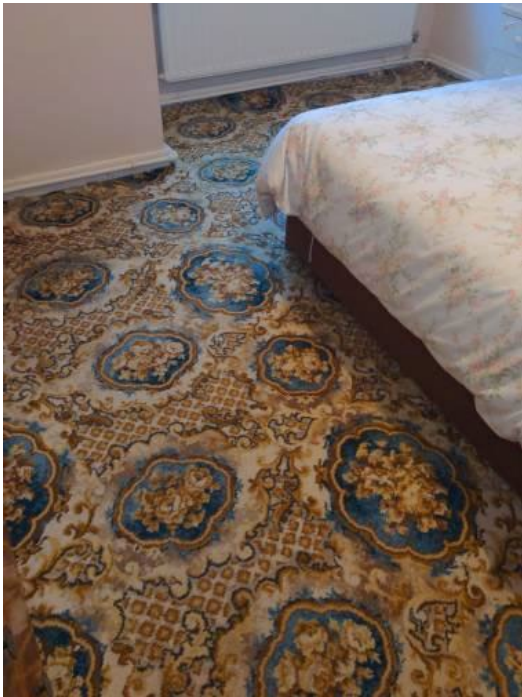
**Photo 043 — Carpet on timber**

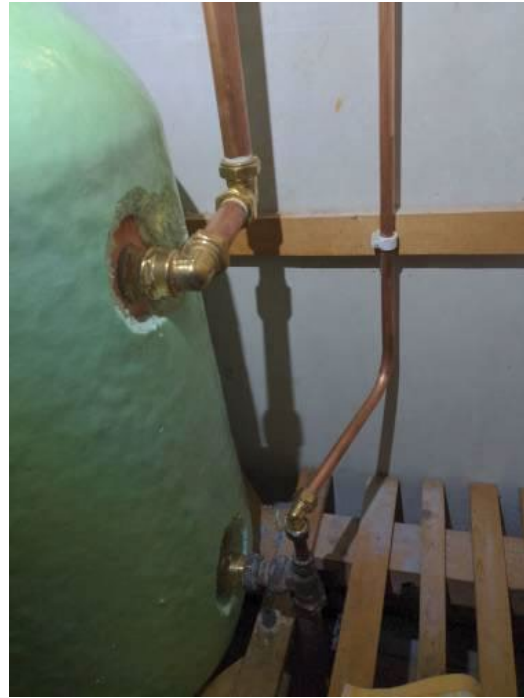
**Photo 077 — Boiler was working**

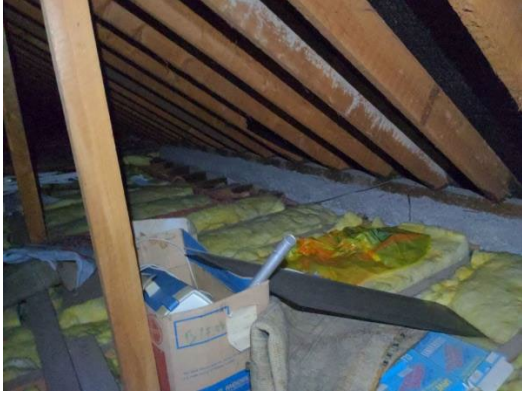
**Photo 085 — Poorly jointed joists, light in cross-section**

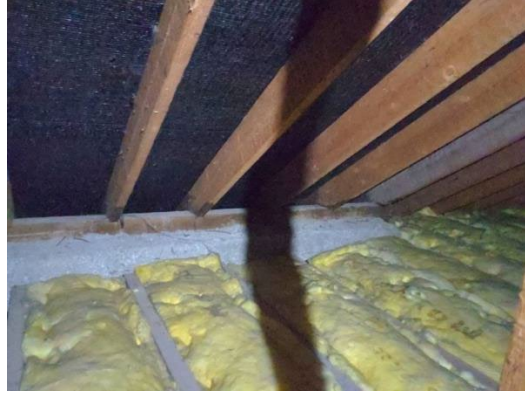
**Photo 089 — 150mm of insulation**

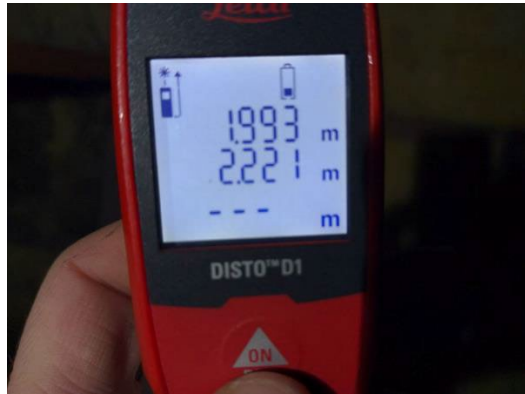
Photo 093 — No support

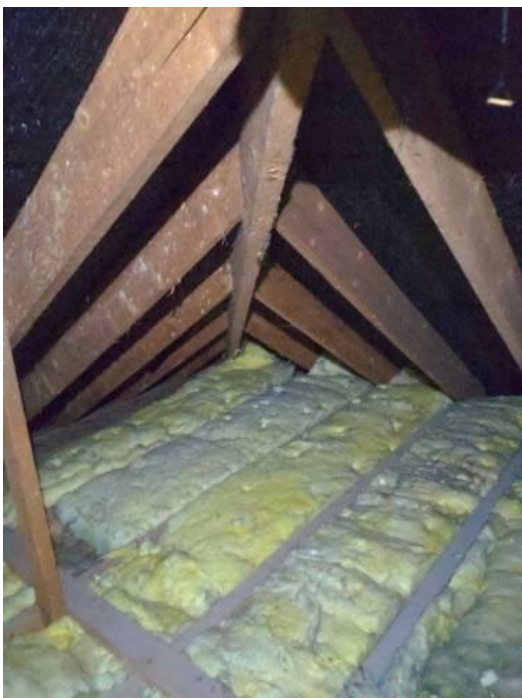
Photo 094 — 2.2m Purlin cantilever

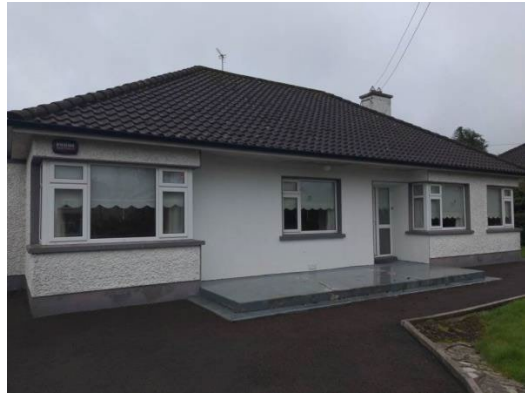
**Photo 102**

- 4.15.3** The front elevation is in good condition with minor fine cracking in places. [\[Ref photos 102, 105 & 106\]](#)
- 4.15.4** The concrete path to the front of the dwelling exhibits significant cracking and is obstructing the sub-floor ventilation opening serving the suspended timber floor in the adjacent bedroom. [\[Ref photo 104\]](#)

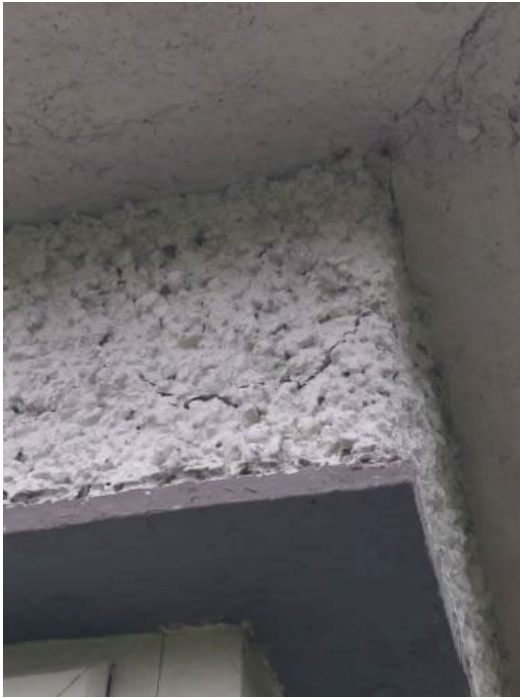
**Photo 105 — Bay window cracked**

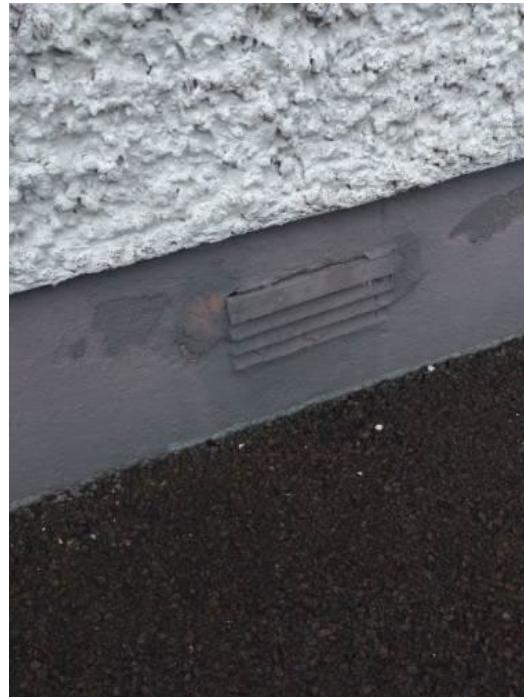
- 4.15.5** The western elevation is in good condition with minor fine cracking in places. [\[Ref photos 107 & 108\]](#)
- 4.15.6** The rear elevation is in good condition with minor fine cracking in places. [\[Ref photos 109, 110, 111 & 112\]](#)

**Photo 108 — Vents for wood floors**

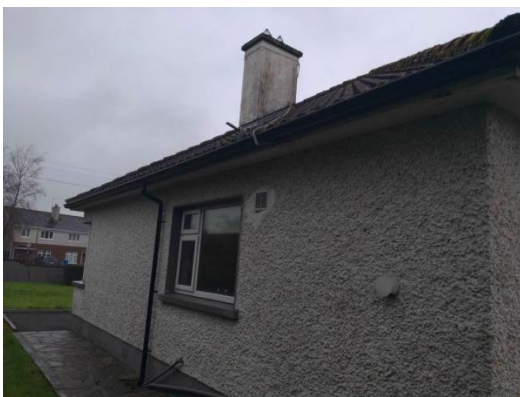
**Photo 113**

- 4.15.7** The eastern elevation is in good condition with minor fine cracking in places. [\[Ref photo 113\]](#)

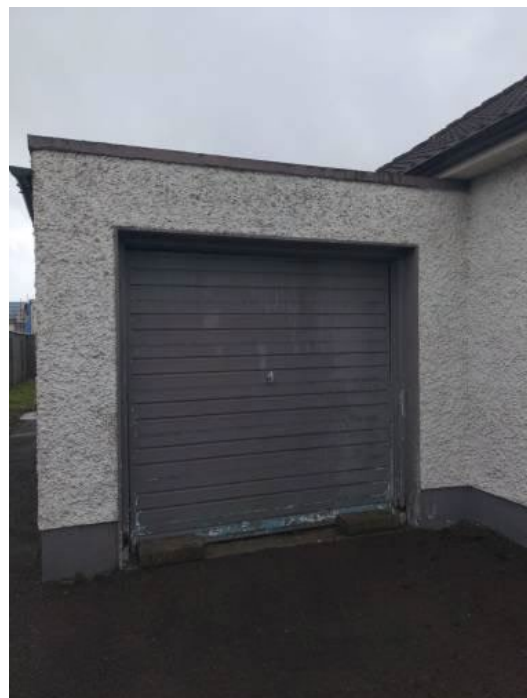
Photo 114 — Out Building 01

**4.16.1** The masonry walls and concrete floor slab are in acceptable structural condition. Both the front roller door and rear door are severely decayed and beyond repair. The roof structure is substantially deteriorated and approaching collapse. [\[Ref photos 114, 115, 116, 117, 118, 119 & 121\]](#)

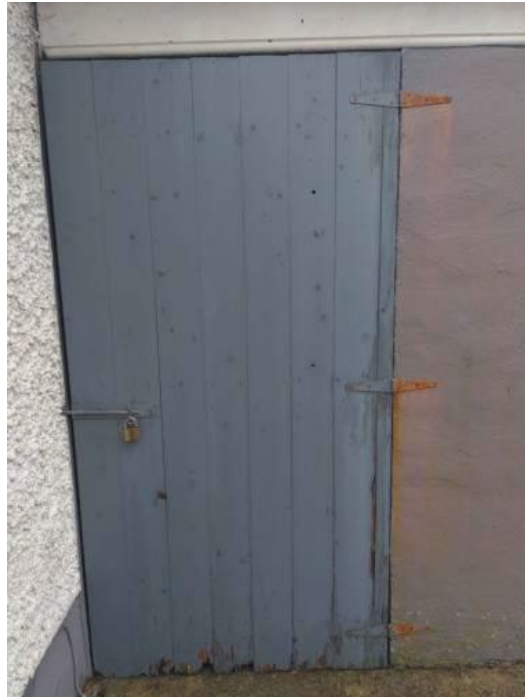
Photo 120

**4.17.1** Walls and floor slab are in poor structural condition. The door is severely decayed and beyond repair. The roof is substantially deteriorated and approaching collapse. [\[Ref photos 120, 122, 123 & 124\]](#)

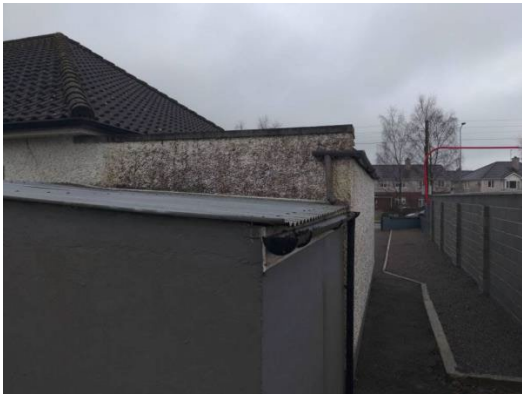
Photo 121 — Poor quality roof

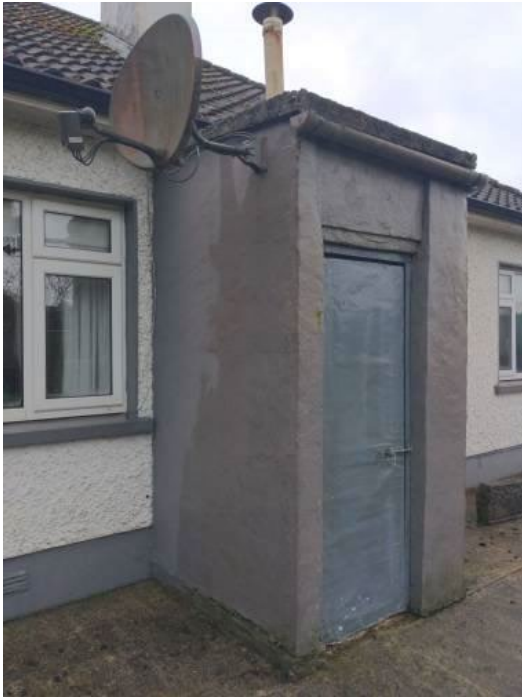
Photo 125 — Outbuilding 03 boiler house

**4.18.1** This structure is in very poor condition. The room is not fire-separated to an adequate standard and has insufficient ventilation. The flue sleeve material may contain asbestos and should be tested. [\[Ref photos 125, 126, 127, 128 & 129\]](#)

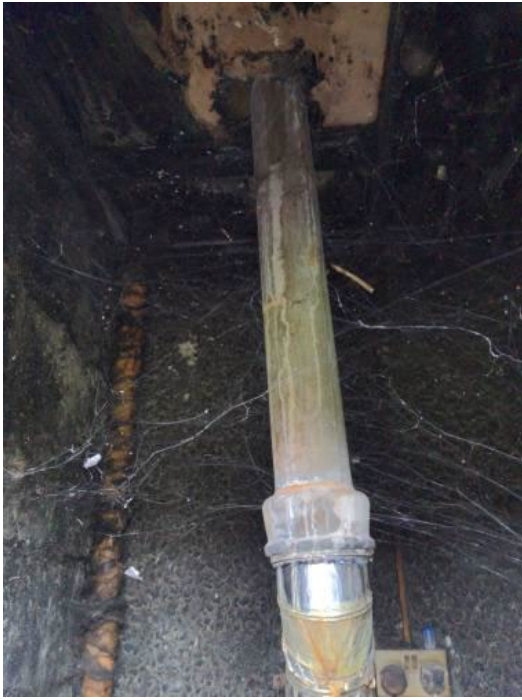
- 5.2.1 Potential Asbestos-Containing Materials:** The flue sleeve in the external boiler house [\[Ref photo 129\]](#) and the floor tiles (and their adhesive) beneath the hall carpet [\[Ref photo 71\]](#) may contain asbestos. This report does not constitute a specialist asbestos survey and other materials within the building may also be affected. A Refurbishment/Demolition Asbestos Survey (RDAS) is required before any upgrade, refurbishment or demolition works commence. Specialist testing companies operating in this area include:

**Photo 129 — No venting**
