### **SURVEY, SAMPLING AND ASSESSMENT FOR ASBESTOS CONTAINING MATERIALS**

**Loreto College  
Drumkeen  
Co. Cavan**

**CMETB**

**Report Date: September 2025**

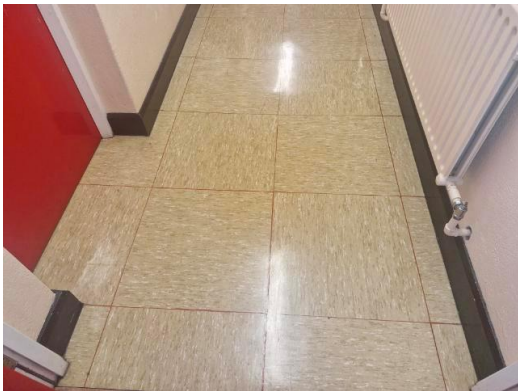
| Type | NAD | |
| Material | Lino tiles | |
| Location | Building 2<br>Ground Floor Corridors 024 | |
| Sample No. | No Asbestos Suspected | |

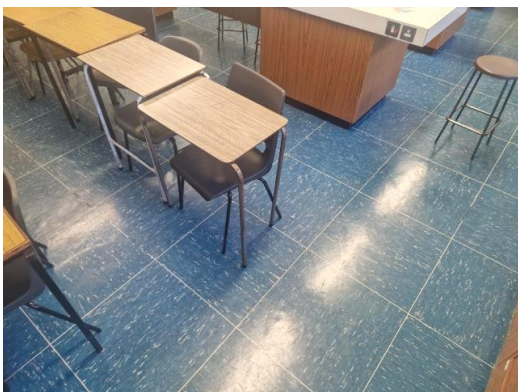
| Type | NAD | |
| Material | Lino tiles | |
| Location | Building 2<br>Ground Floor Science labs 025 | |
| Sample No. | No Asbestos Suspected | |

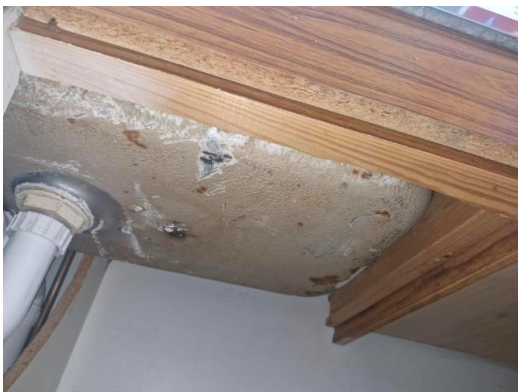
| Type | NAD | |
| Material | Sink heat coating<br>Friction Material | |
| Location | Building 2<br>Ground Floor Science labs 025 | |

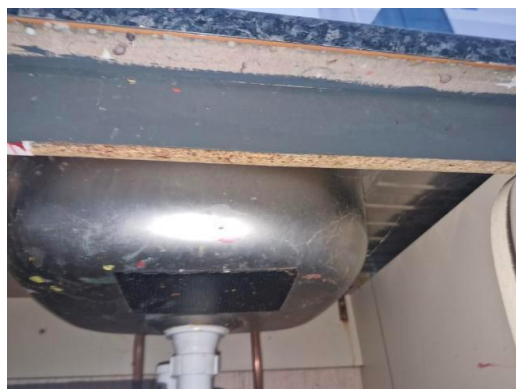
| Type | NAD |
|---|---|
| Sample No. | S014 |

| Type | NAD |
| Material | Plasterboard |

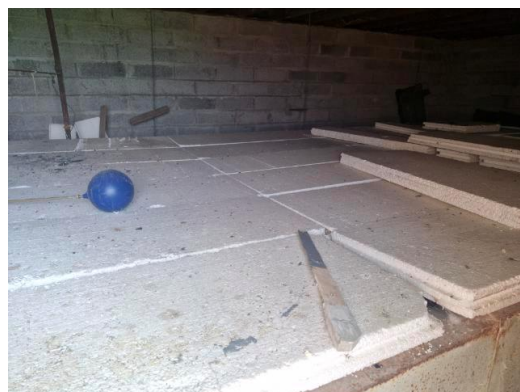
| Type | NAD |
|---|---|
| Sample No. | No Asbestos Suspected |

| Type | NAD |
| Material | Plaster ceilings |

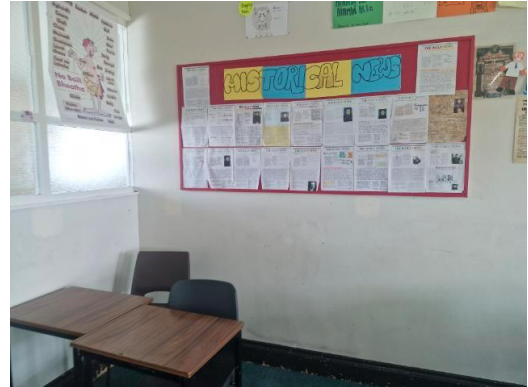
| Type | NAD |
|---|---|
| Sample No. | No Asbestos Suspected |

| Type | NAD |
| Material | Wood board walls |

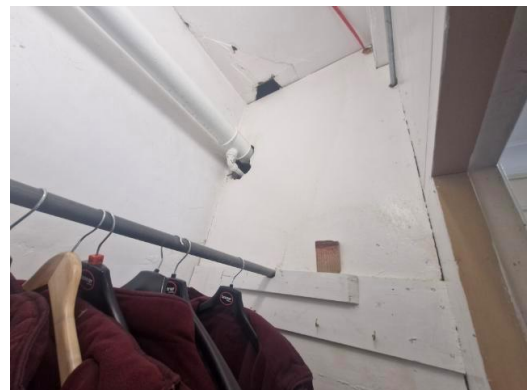
| Type | NAD |
|---|---|
| Sample No. | No Asbestos Suspected |

| Type | NAD |
| Material | Strawboard |
